Carnarvon Fascine Wall Independent Review

R972 Rev 1

December 2017

**Carnarvon Fascine Wall
Independent Review**

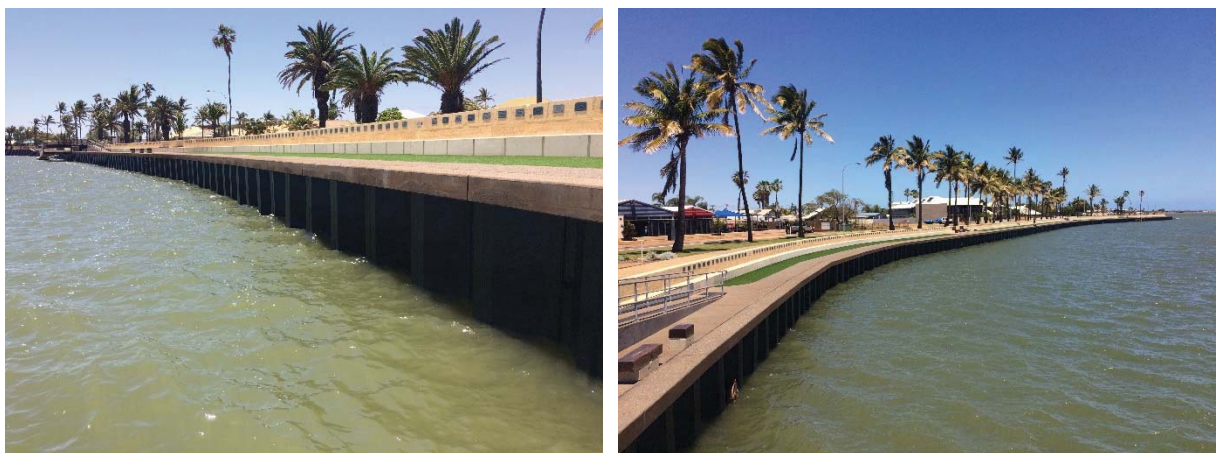
Figure 1.2 Photographs of the Fascine Wall (October 2017)

Since construction, the wall has experienced significant corrosion of the steel sheet piles, which has raised concerns over the durability of the structure. To address these concerns the Western Australian State Government, through the Department of Primary Industries and Regional Development (DPIRD) sought an independent structural engineering assessment of the Royalties for Regions funded wall. This assessment will be used to assist in planning maintenance, future works and informing the community.

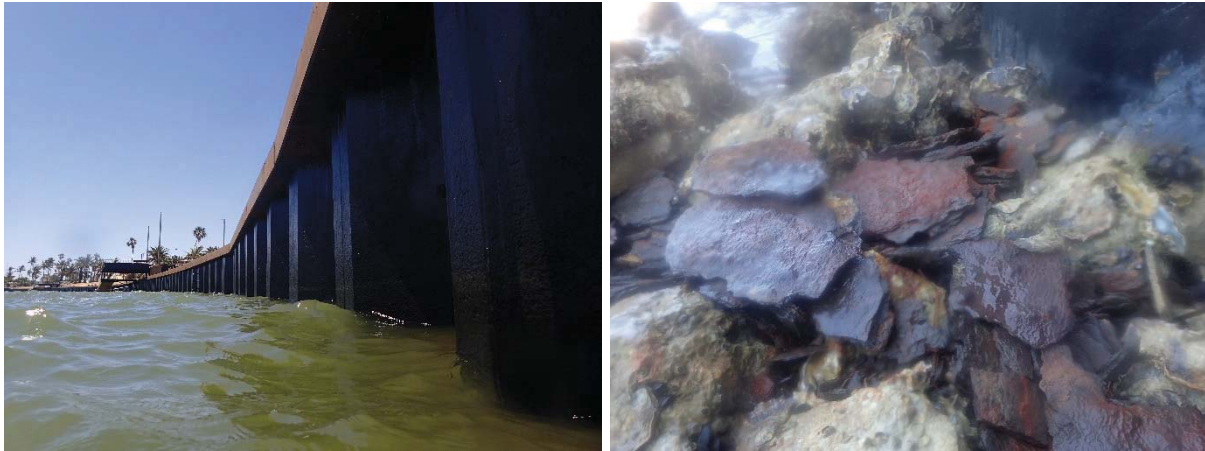
- The wall at the time of inspection had recently being painted from the top of the sheet pile down to around the low tide level. A large amount of corrosion products were left on the seabed likely from when the wall was blasted prior to painting.

Figure 3.2 Paint Coating and Corrosion Products

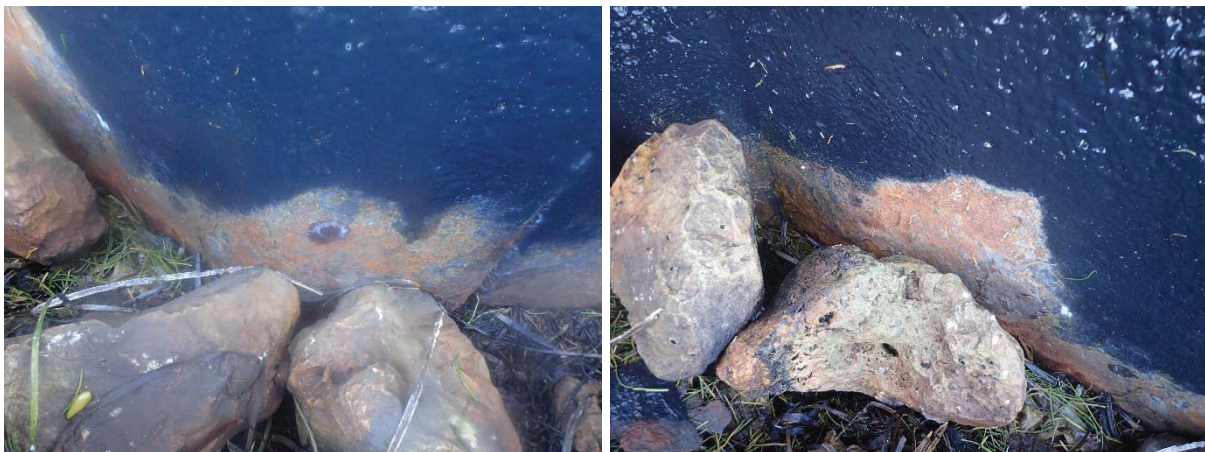
- Where there was scour protection rock at the base of the sheet pile wall there were sections that were not painted.

Figure 3.3 Incomplete Paint Coating

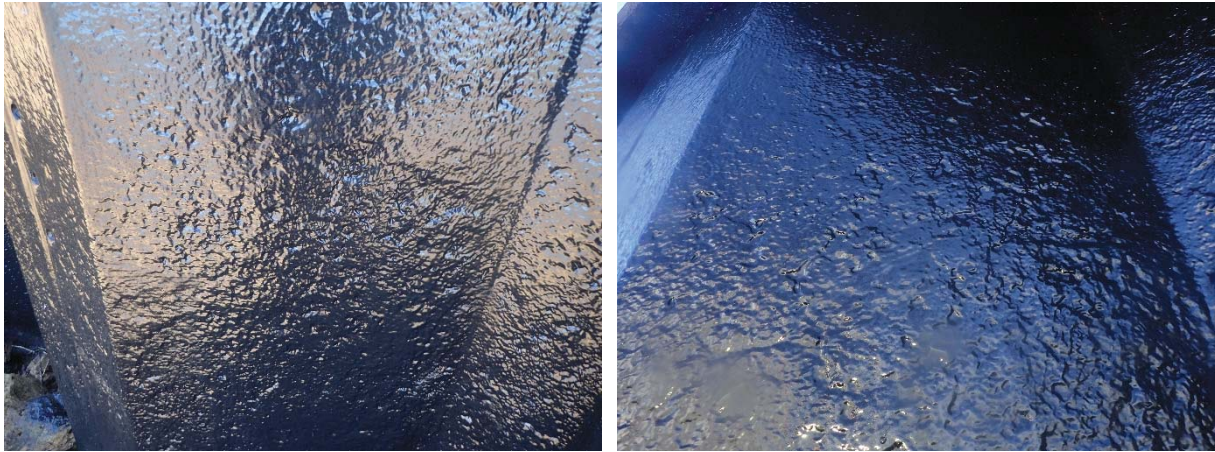
- The condition along the length of the wall was fairly uniform with the highest levels of corrosion typically in about a 1.5m strip covering the intertidal zone. This was evidenced by the rough texture on the front of the wall where steel had been lost.

Figure 3.4 Loss of Thickness in Intertidal Zone

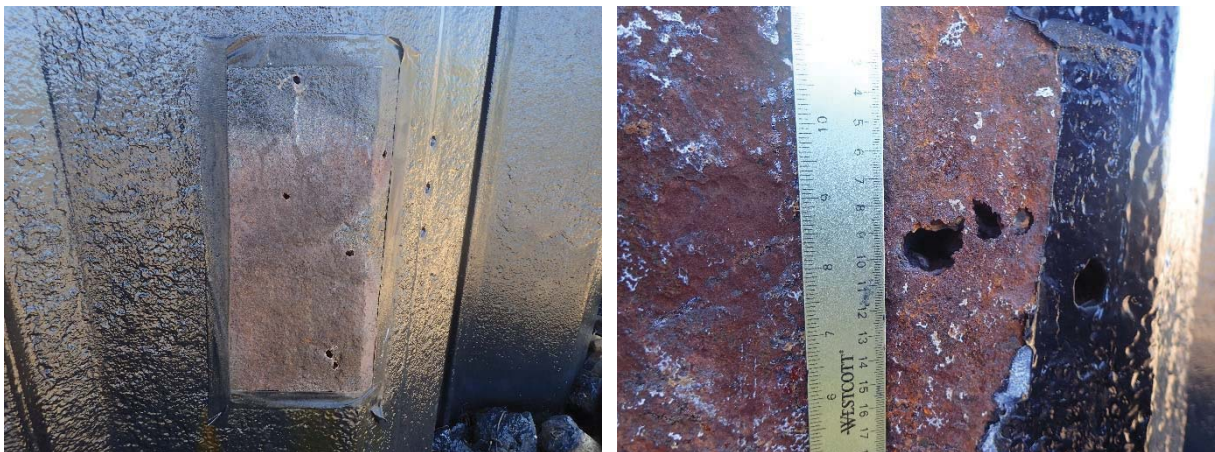
- There were a number of holes through the wall which were taped off to enable future patch repairs. These were generally found at the northern end (Stage 1 section) of the wall, however there were 4 holes found in the Stage 2 section of wall. The paint coating may also have covered over a number of small holes that are now unable to be detected from a visual inspection.

Figure 3.5 Holes in Wall

Corrosion holes through the wall can lead to loss of backfill and subsidence of the pavements behind the wall. During the site inspection a number of holes were found which enabled the washout of backfill through the wall. The inadequate sealing around the drainage pipes is also likely to be contributing to this issue. With no maintenance it is expected that these holes will get larger and more holes will form. This could result in major loss of material potentially in the coming 5 to 10 years.

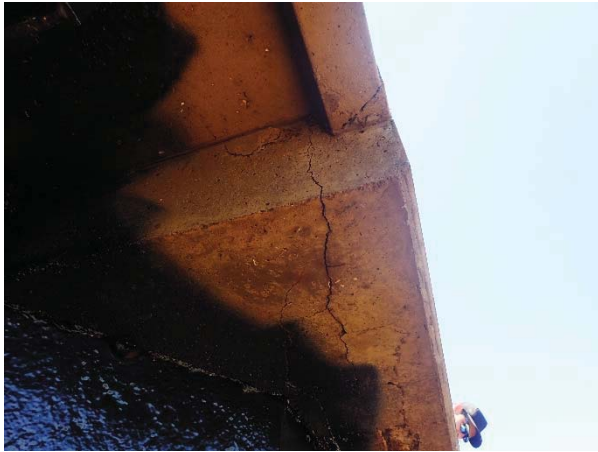
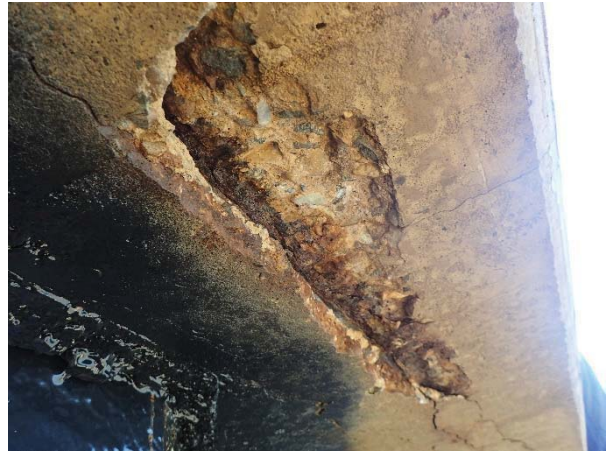
- The concrete capping had extensive cracking due to corrosion of the reinforcing steel and concrete spalling. In some locations it appeared that the concrete cover was less than 10mm, which was much less than the 50mm specified on the design drawings. It is not clear what concrete mix was used, however the design drawings suggest 32MPa concrete. For marine structures the Australian Standard AS4997-2005 recommends structural concrete to have:

The design and installation of the concrete did not meet these requirements.

Figure 3.6 Concrete Capping Failure

Deterioration of the concrete capping beam can result in loss of large sections of concrete, making it unsafe to walk along the top edge of the wall. It is not clear from the design information provided but the concrete capping beam may also be acting as a waling beam to share loads along the sheet pile wall. Therefore, failure of this beam could result in structural failure of the wall.

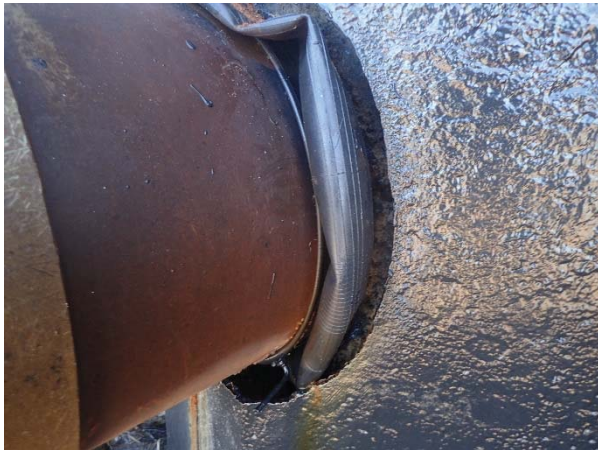
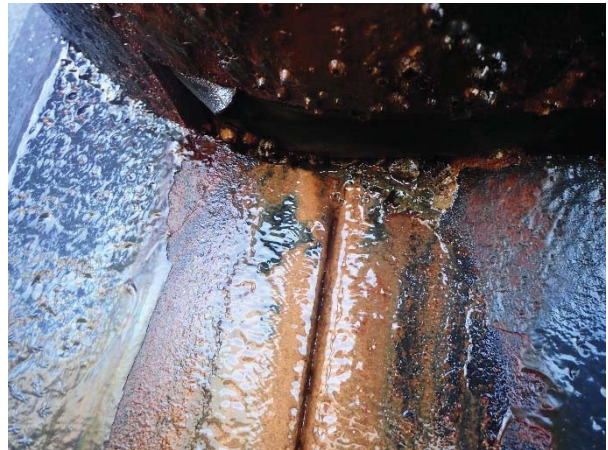
- A number of the drainage outlets were inadequately sealed enabling material to be washed out from behind the wall.

Figure 3.7 Drainage Outlets

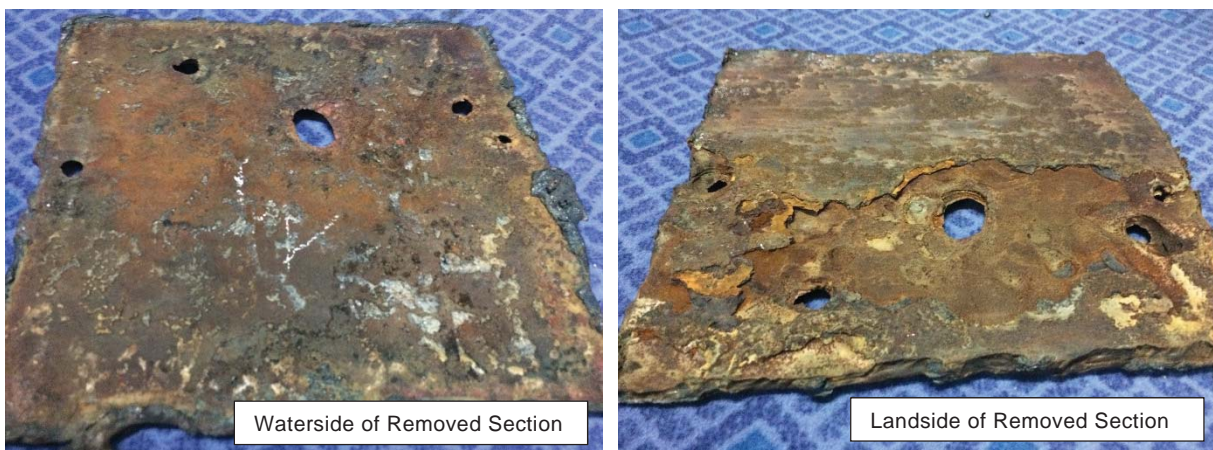
- The section of pile removed from the mid tide level showed severe corrosion on both the front and rear of the sheet pile. Deep pitting corrosion was found on the landward side of the sheet pile as shown in the photograph below.

Figure 3.10 Condition of Removed Steel Section

As shown from the Shire's investigation there appears to be a high level of corrosion on the rear face of the sheet pile. To better understand the cause of this corrosion, testing of the soil is recommended. It is understood that the Shire is currently arranging for this soil testing to be carried out, however the results were not available at the time of writing this report.

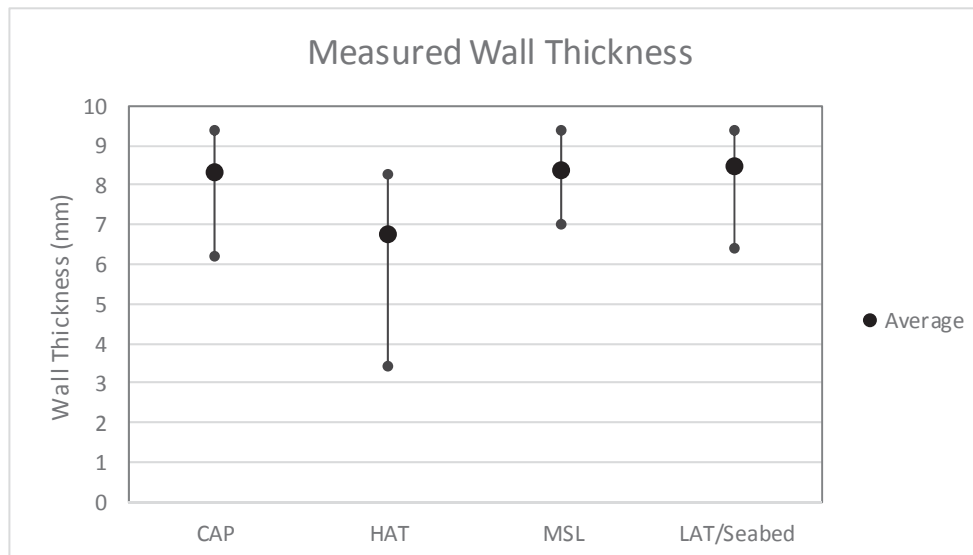
The results from the thickness measurements taken on site are summarised in the following charts. Figure 4.1 shows the wall thickness measurements for different levels on the wall. As shown the thinnest sections of steel were found around the high tide line.

Figure 4.1 Measured Sheet Pile Wall Thickness

The measurements represented in the above chart do not include the isolated holes that were found where the wall thickness had been completely corroded.

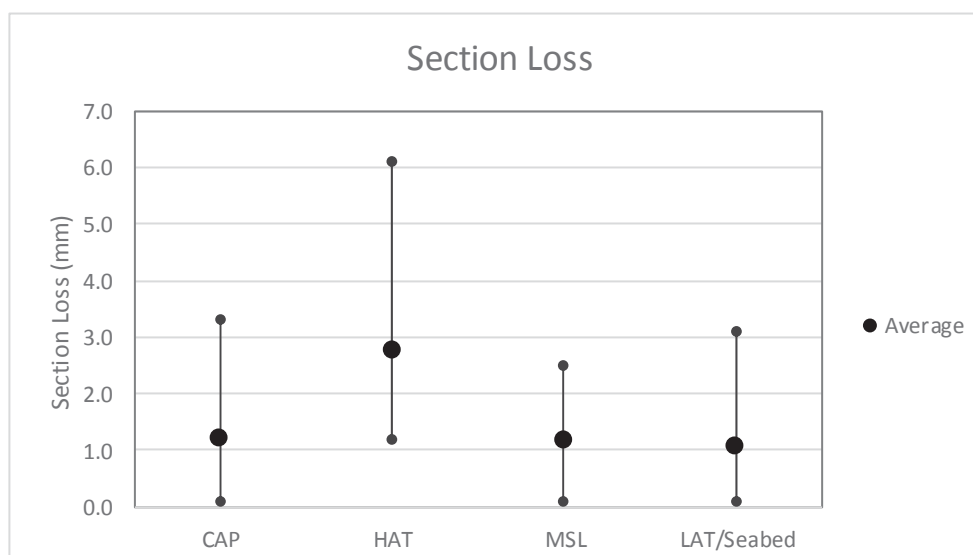
Figure 4.2 Section Loss

Within the splash zone the average section loss varied from about 1 to 3 mm.

Based on the measured section loss the typical corrosion rates were around **0.25 to 0.75 mm/yr**. However for the localised pitting that has resulting in holes in the sheet pile wall the corrosion rates are in the order of 2 to 3 mm/yr.

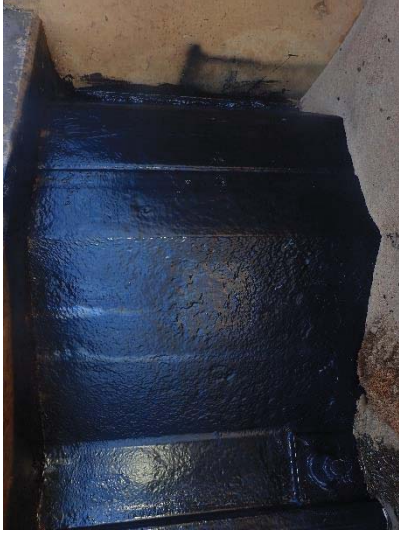
LOCATION 1:

LOCATION #	CONVEX/ CONCAVE/SIDEWALL	CAP LEVEL	HAT	MSL/ INTERTIDAL	LAT OR SEABED	ANODE % WORN	DIVER COMMENTS
1	Convex	8.2	N/A	8.2	8.4	N/A	Recently heavy protective paint coating applied, Pitting observed under paint coating, No exposed unprotected steel.
1	Concave	8.5	N/A	8.2	8.0	N/A	
1	East Sidewall	8.4	N/A	8.2	8.2	N/A

CP Meter	N/A	Depth of paint – CC to DP	800mm	Depth of Unprotected steel – PC to SB	N/A
----------	-----	---------------------------	-------	---------------------------------------	-----

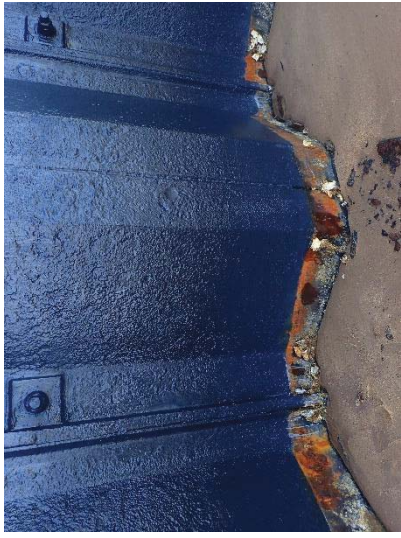
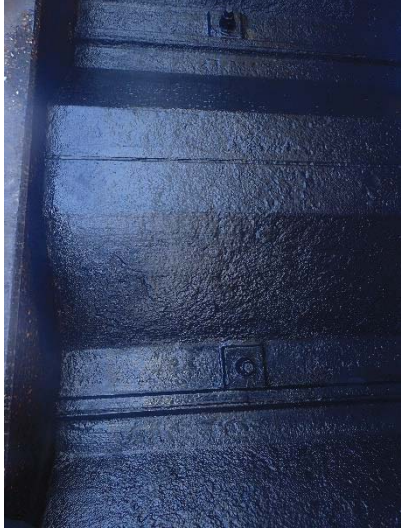
LOCATION 2:

LOCATION #	CONVEX/CONCAVE/SIDEWALL	CAP LEVEL	HAT	MSL/INTERTIDAL	LAT OR SEABED	ANODE % WORN	DIVER COMMENTS
2	Convex	8.3	7.7	N/A	9	N/A	Recently heavy protective paint coating applied, Pitting observed under paint coating, exposed unprotected steel 90mm to seabed.
2	Concave	8.4	7.7	N/A	9.1	N/A	
2	East Sidewall	8.0	7.9	N/A	8.8	N/A

CP Meter	N/A	Depth of paint – CC to DP	1750mm	Depth of Unprotected steel – PC to SB	100mm
----------	-----	---------------------------	--------	---------------------------------------	-------

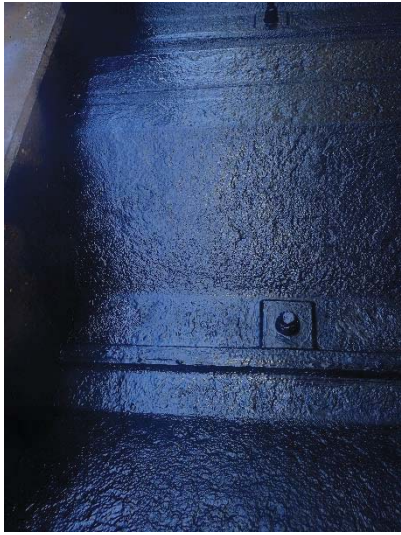
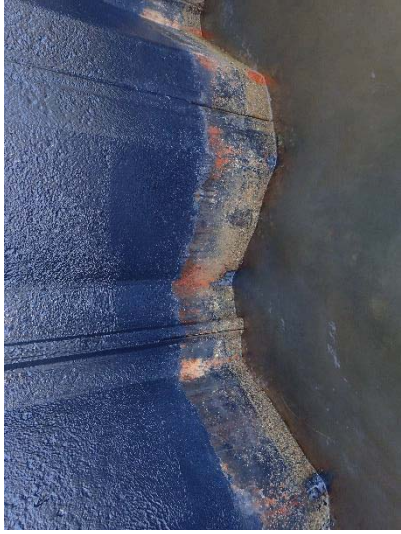
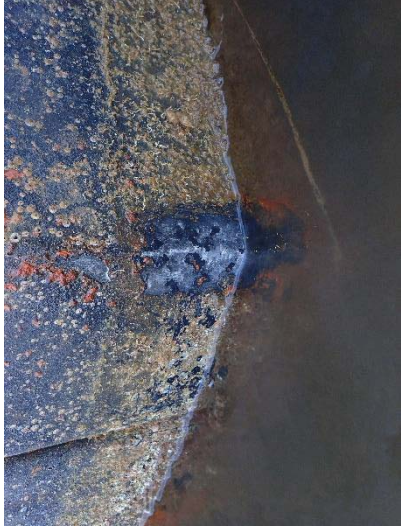
LOCATION 3:

LOCATION #	CONVEX/CONCAVE/SIDEWALL	CAP LEVEL	HAT	MSL/INTERTIDAL	LAT OR SEABED	ANODE% WORN	DIVER COMMENTS
3	Convex	7.8	8.2	9.0	8.2	N/A	Recently heavy protective paint coating applied, Pitting observed under paint coating, Minor Paint loss on corners of sheet wall pile clutches, Surface corrosion on unprotected steel.
3	Concave	7.9	7.0	8.4	8.3	N/A	
3	East Sidewall	7.9	7.7	8.7	8.7	N/A

CP Meter	-665mV	Depth of paint – CC to DP	1770mm	Depth of Unprotected steel – PC to SB	480mm
----------	--------	---------------------------	--------	---------------------------------------	-------

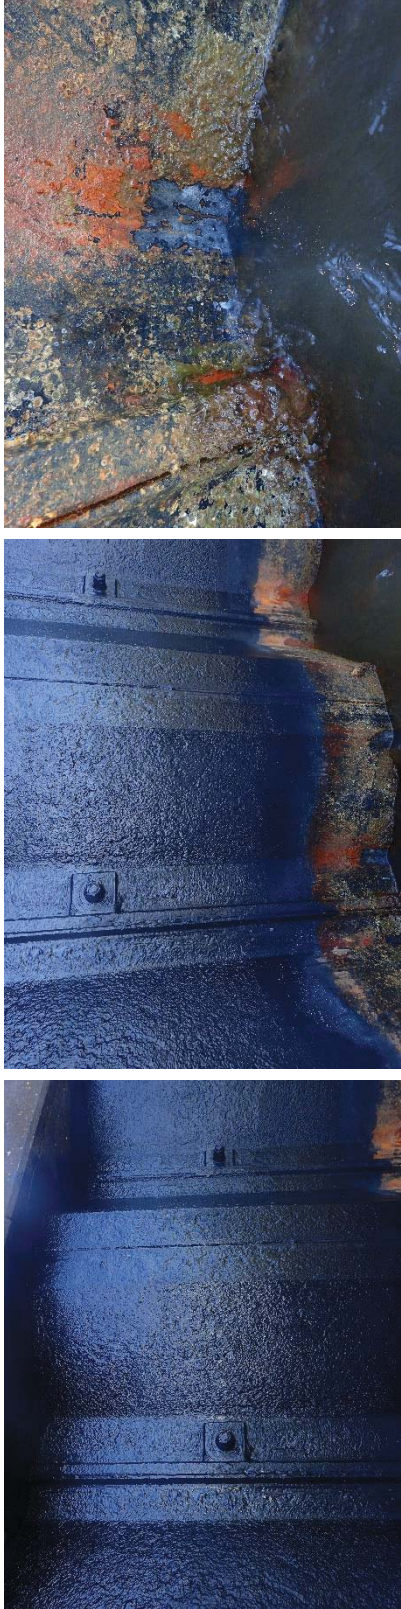
LOCATION 4:

LOCATION #	CONVEX/ CONCAVE/SIDEWALL	CAP LEVEL	HAT	MSL/ INTERTIDAL	LAT OR SEABED	ANODE % WORN	DIVER COMMENTS	
4	Convex	8.0	7.5	7.8	8.9	N/A	Recently heavy protective paint coating applied, Pitting observed under paint coating, Minor Paint loss in intertidal area, Surface corrosion on unprotected steel.	
4	Concave	8.2	7.8	8.4	8.9	N/A		
4	East Sidewall	8.3	7.7	8.7	8.8	N/A		
CP Meter		-665mV	Depth of paint – CC to DP		1650mm	Depth of unprotected steel - PC to SB		550mm

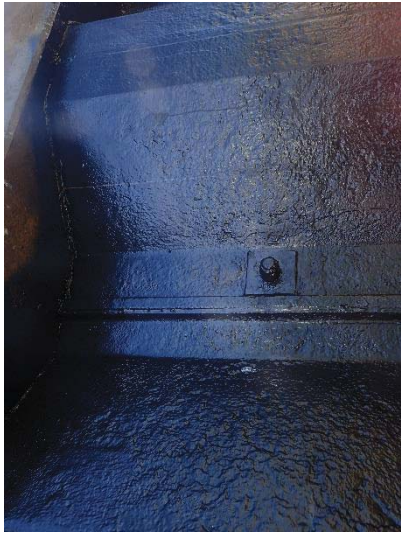
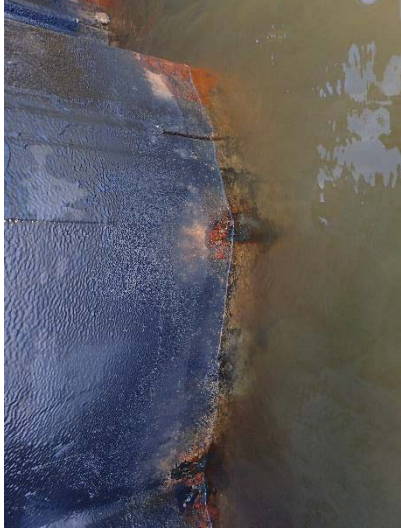
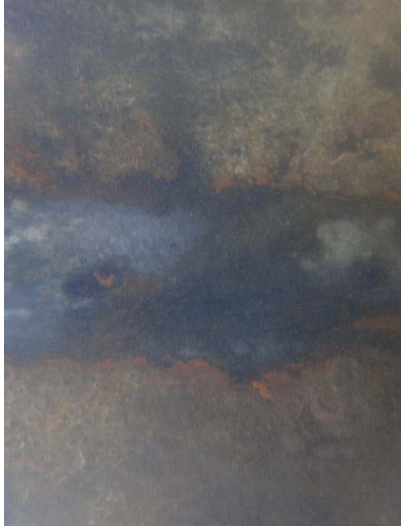
LOCATION 5:

LOCATION #	CONVEX/ CONCAVE/SIDEWALL	CAP LEVEL	HAT	MSL/ INTERTIDAL	LAT OR SEABED	ANODE % WORN	DIVER COMMENTS	
5	Convex	7.9	7.2	8.3	9.0	N/A	Recently heavy protective paint coating applied, Pitting observed under paint coating, Minor Paint loss in intertidal area, Surface corrosion on unprotected steel.	
5	Concave	8.3	4.2	8.4	8.9	N/A		
5	East Sidewall	8.1	5.2	8.2	8.5	N/A

CP Meter	-660mV	Depth of paint – CC to DP	1720mm	Depth of Unprotected steel – PC to SB	680mm
----------	--------	---------------------------	--------	---------------------------------------	-------

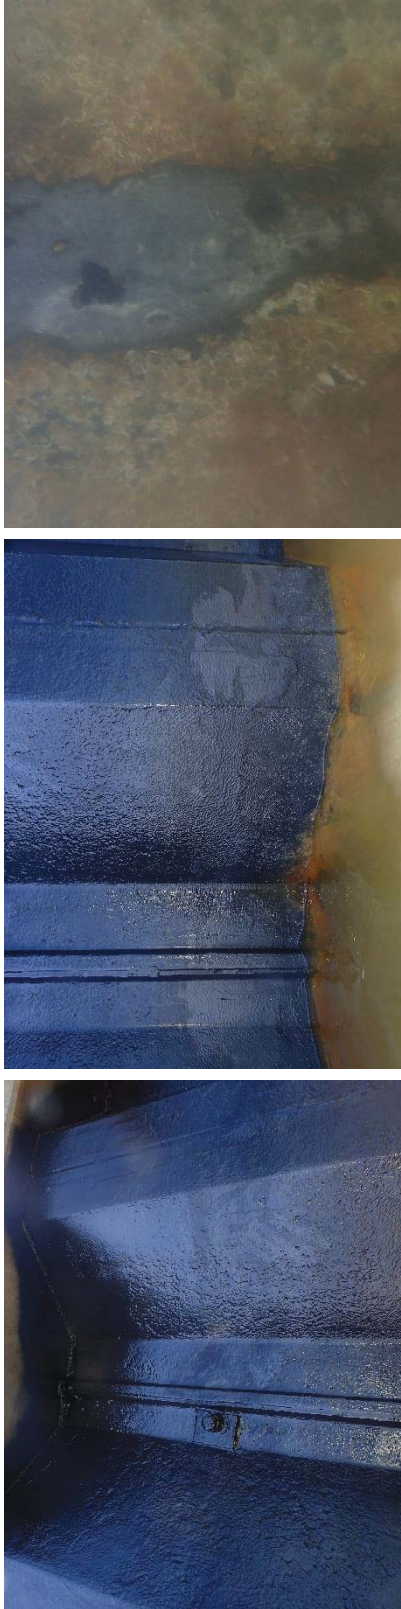
LOCATION 6:

LOCATION #	CONVEX/ CONCAVE/SIDEWALL	CAP LEVEL	HAT	MSL/ INTERTIDAL	LAT OR SEABED	ANODE % WORN	DIVER COMMENTS	
6	Convex	9.0	7.7	8.2	8.6	N/A	Recently heavy protective paint coating applied, Pitting observed under paint coating, Minor Paint loss in intertidal area, Surface corrosion on unprotected steel.	
6	Concave	8.9	7.0	8.1	8.5	N/A		
6	East Sidewall	9.0	8.0	8.3	8.3	N/A		
CP Meter		-610mV	Depth of paint – CC to DP		1800mm	Depth of Unprotected steel - PC to SB		930mm

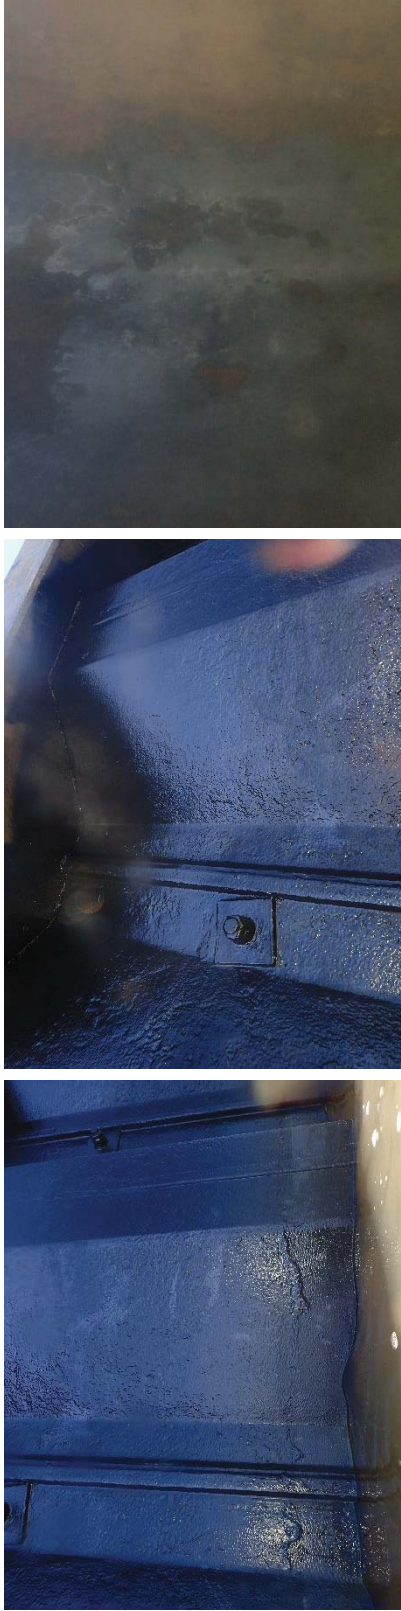
LOCATION 7:

LOCATION #	CONVEX/ CONCAVE/SIDEWALL	CAP LEVEL	HAT	MSL/ INTERTIDAL	LATOR SEABED	ANODE % WORN	DIVER COMMENTS
7	Convex	9.1	8.1	8.3	7.2	N/A	Recently heavy protective paint coating applied, Pitting observed under paint coating, Minor Paint loss in intertidal area, Surface corrosion on unprotected steel.
7	Concave	9.2	8.2	8.4	7.3	N/A	
7	East Sidewall	8.7	8.0	8.2	7.8	N/A	
7	West Sidewall	9.0	8.3	8.6	7.8	N/A

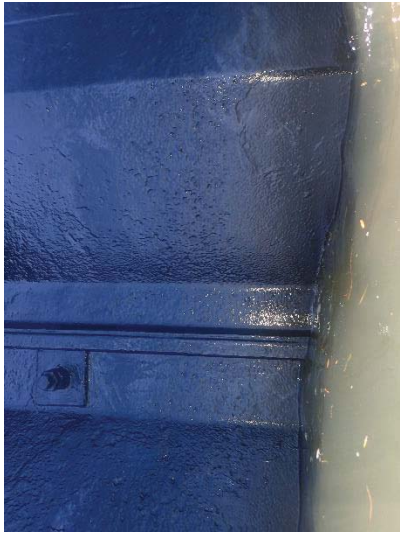
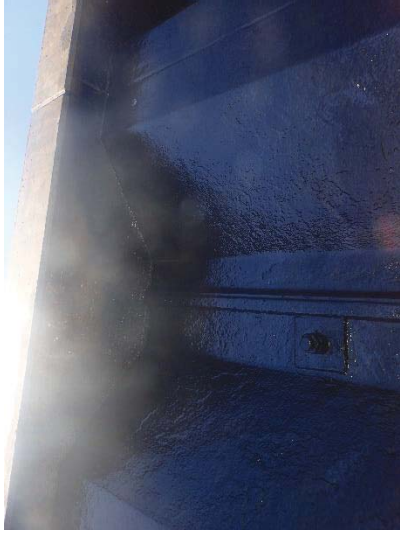
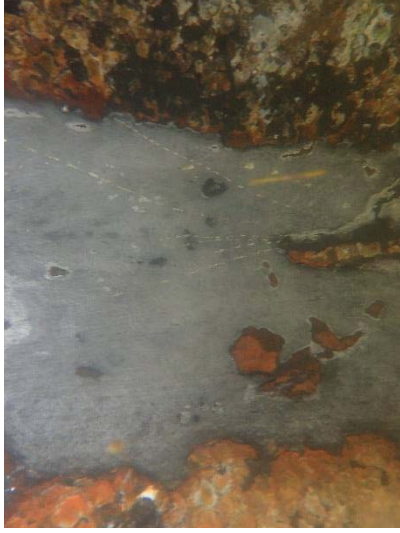
LOCATION 8:

LOCATION #	CONVEX/ CONCAVE/SIDEWALL	CAP LEVEL	HAT	MSL/ INTERTIDAL	LAT OR SEABED	ANODE % WORN	DIVER COMMENTS
8	Convex	8.8	7.9	7.9	8.1	N/A	Recently heavy protective paint coating applied, Pitting observed under paint coating, Paint loss in intertidal area, Surface corrosion on unprotected steel. (Paint may have been affected by incoming tide at time of application)
8	Concave	8.1	8.0	8.2	8.3	N/A	
8	East Sidewall	8.7	6.9	8.3	8.1	N/A	
8	West Sidewall	8.4	5.6	8.4	8.2	N/A

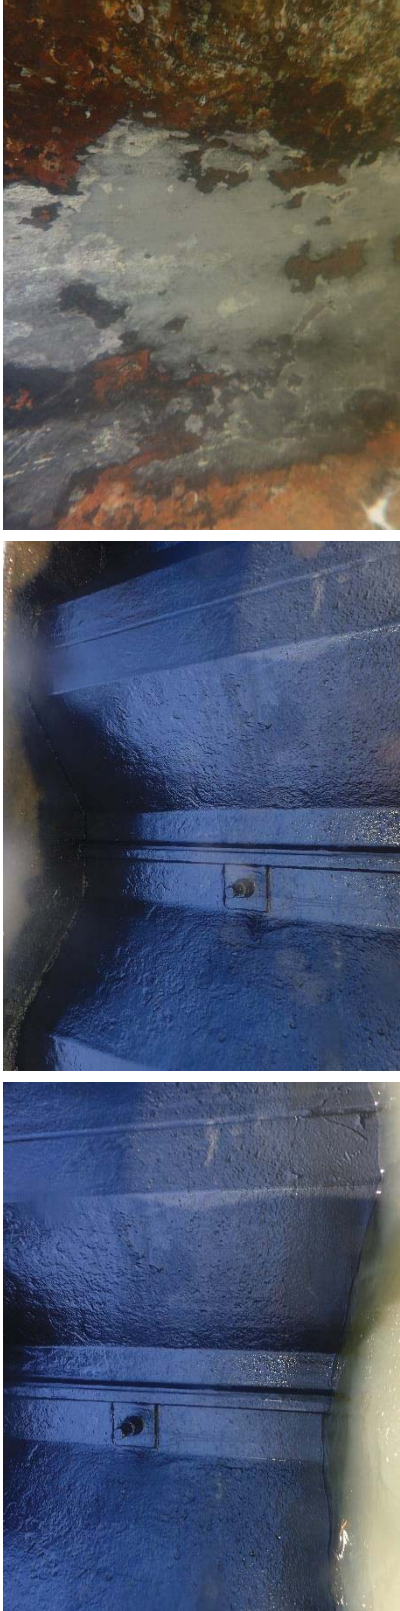
LOCATION 9:

LOCATION #	CONVEX/ CONCAVE/SIDEWALL	CAP LEVEL	HAT	MSL/ INTERTIDAL	LATOR SEABED	ANODE % WORN	DIVER COMMENTS	
9	Convex	9.1	7.6	8.8	8.3	N/A	Recently heavy protective paint coating applied, Pitting observed under paint coating, Paint loss in intertidal area, Surface corrosion on unprotected steel. (Paint may have been affected by incoming tide at time of application)	
9	Concave	9.1	7.9	8.5	8.2	N/A		
9	East Sidewall	9.3	7.4	8.5	8.6	N/A		
9	West Sidewall	8.3	7.2	8.3	8.8	N/A		
CP Meter		-680mV	Depth of paint – CC to DP		1830mm	Depth of Unprotected steel - PC to SB		1630mm

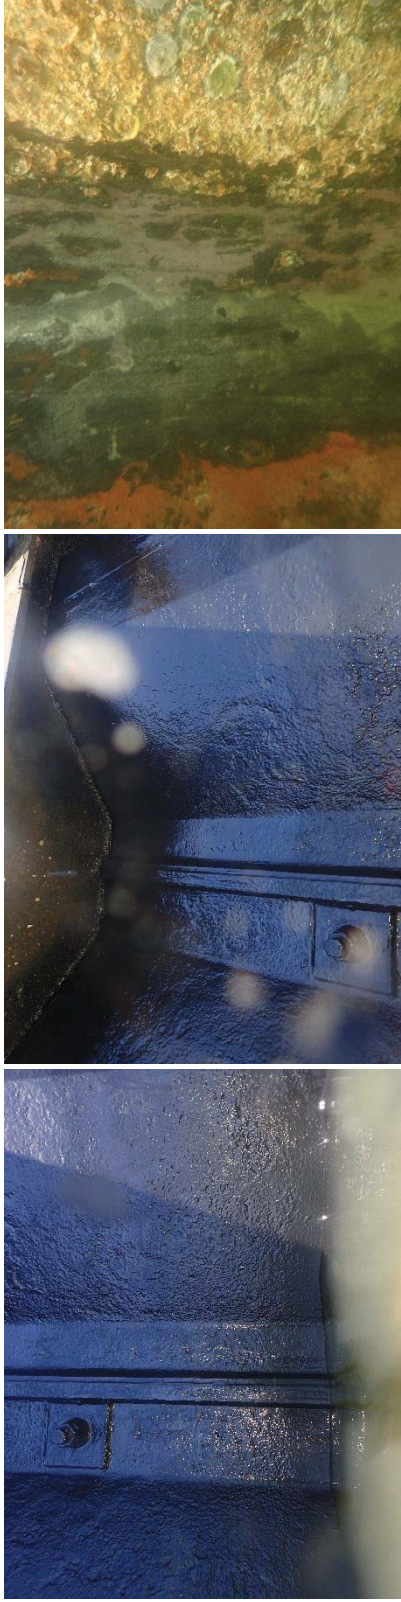
LOCATION 10:

LOCATION #	CONVEX/ CONCAVE/SIDEWALL	CAP LEVEL	HAT	MSL/ INTERTIDAL	LATOR SEABED	ANODE % WORN	DIVER COMMENTS
10	Convex	9.4	6.3	8.2	8.9	N/A	Recently heavy protective paint coating applied, Pitting observed under paint coating, Paint loss in intertidal area, Surface corrosion on unprotected steel. (Paint may have been affected by incoming tide at time of application)
10	Concave	9.1	7.6	8.7	8.2	N/A	
10	East Sidewall	9.4	6.5	8.3	8.5	N/A	
10	West Sidewall	9.0	7.0	8.6	7.8	N/A

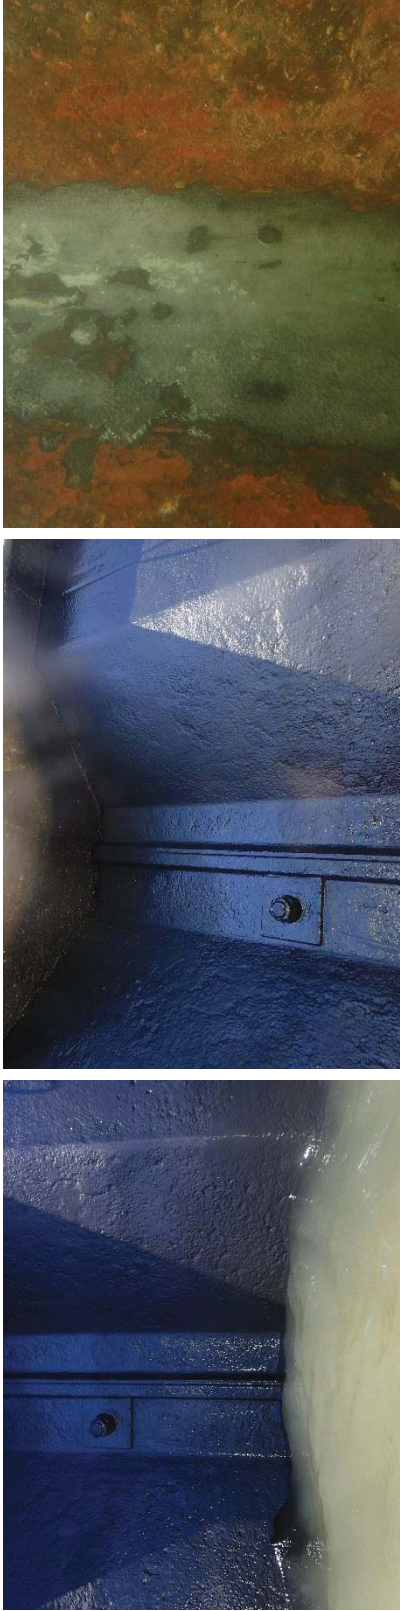
LOCATION 11:

LOCATION #	CONVEX/ CONCAVE/SIDEWALL	CAP LEVEL	HAT	MSL/ INTERTIDAL	LATOR SEABED	ANODE % WORN	DIVER COMMENTS
11	Convex	9.0	7.0	8.4	7.3	N/A	Recently heavy protective paint coating applied, Pitting observed under paint coating, Paint loss in intertidal area, Surface corrosion on unprotected steel. (Paint may have been affected by incoming tide at time of application)
11	Concave	8.9	5.8	8.3	7.1	N/A	
11	East Sidewall	8.5	4.9	8.2	6.4	N/A	
11	West Sidewall	8.3	5.0	8.7	8.3	N/A	
CP Meter		-655mV	Depth of paint – CC to DP		1880mm	Depth of Unprotected steel - PC to SB	
							1420mm

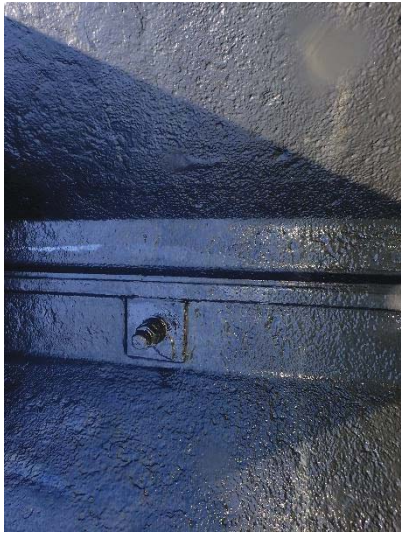
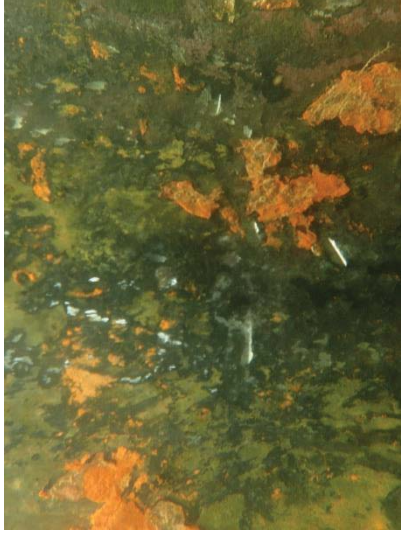
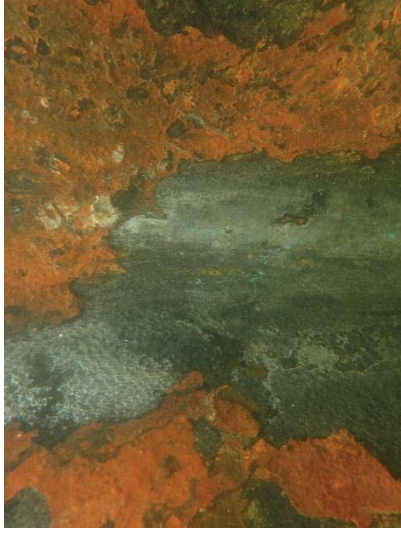
LOCATION 12:

LOCATION #	CONVEX/ CONCAVE/SIDEWALL	CAP LEVEL	HAT	MSL/ INTERTIDAL	LAT OR SEABED	ANODE % WORN	DIVER COMMENTS
12	Convex	9.2	7.0	8.1	8.5	N/A	Recently heavy protective paint coating applied, Pitting observed under paint coating, Paint loss in intertidal area. (Paint may have been affected by incoming tide at time of application) Surface corrosion on unprotected steel below water line was more evident within this Location
12	Concave	9.2	7.5	8.4	7.9	N/A	
12	East Sidewall	8.4	6.8	8.5	8.1	N/A	
12	West Sidewall	7.9	5.7	8.3	7.4	N/A

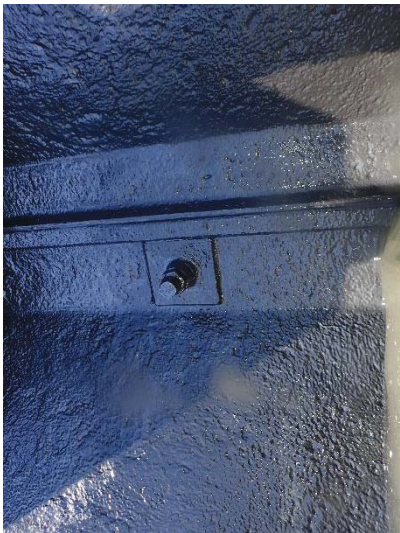
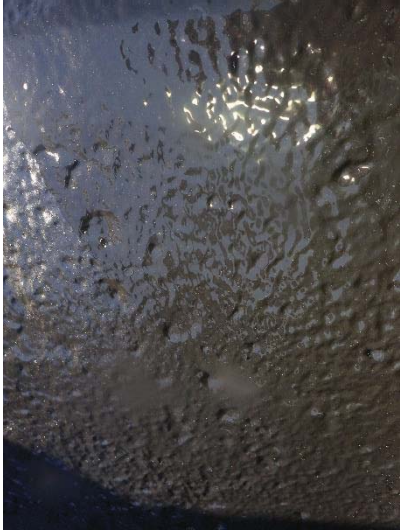
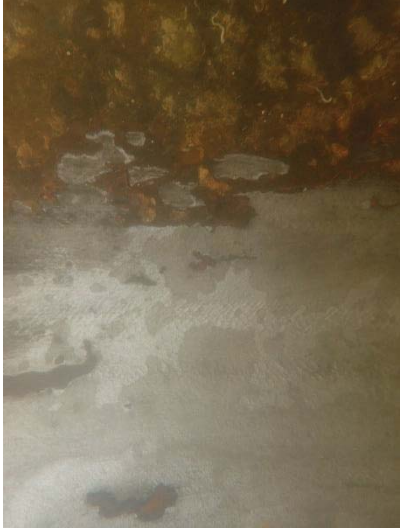
LOCATION 13:

LOCATION #	CONVEX/ CONCAVE/SIDEWALL	CAP LEVEL	HAT	MSL/ INTERTIDAL	LATOR SEABED	ANODE % WORN	DIVER COMMENTS	
13	Convex	7.9	6.4	9.4	8.6	N/A	Recently heavy protective paint coating applied, Pitting observed under paint coating, Paint loss in intertidal area, Surface corrosion on unprotected steel. (Paint may have been affected by incoming tide at time of application)	
13	Concave	8.3	6.5	8.8	8.7	N/A		
13	East Sidewall	7.1	7.8	9.0	8.6	N/A		
13	West Sidewall	8.5	7.2	8.5	6.8	N/A		
CP Meter		-680mV	Depth of paint – CC to DP		1800mm	Depth of Unprotected steel - PC to SB		1850mm

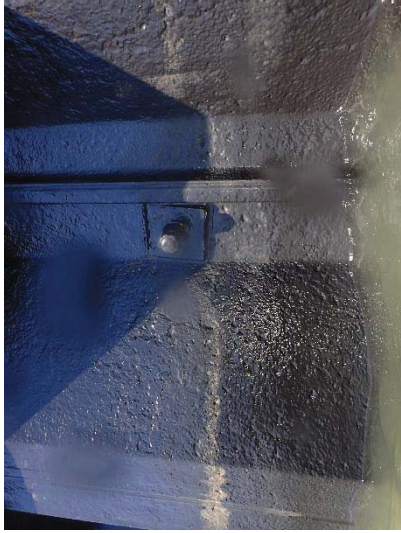
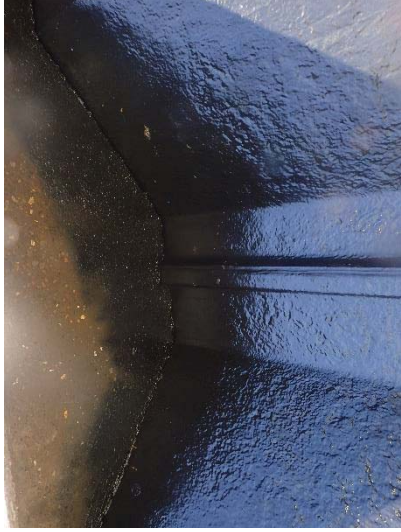
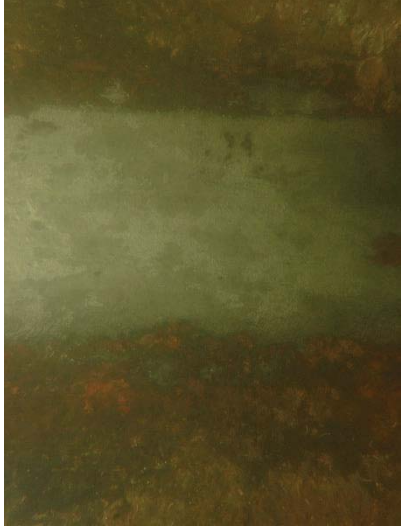
LOCATION 14:

LOCATION #	CONVEX/ CONCAVE/SIDEWALL	CAP LEVEL	HAT	MSL/ INTERTIDAL	LATOR SEABED	ANODE % WORN	DIVER COMMENTS
14	Convex	9.1	7.1	7.9	8.2	N/A	Recently heavy protective paint coating applied, Pitting observed under paint coating, Paint loss in intertidal area, Surface corrosion on unprotected steel. (Paint may have been affected by incoming tide at time of application)
14	Concave	8.7	6.7	8.5	8.4	N/A	
14	East Sidewall	8.7	6.1	8.1	8.5	N/A	
14	West Sidewall	8.4	7.0	7.6	8.7	N/A

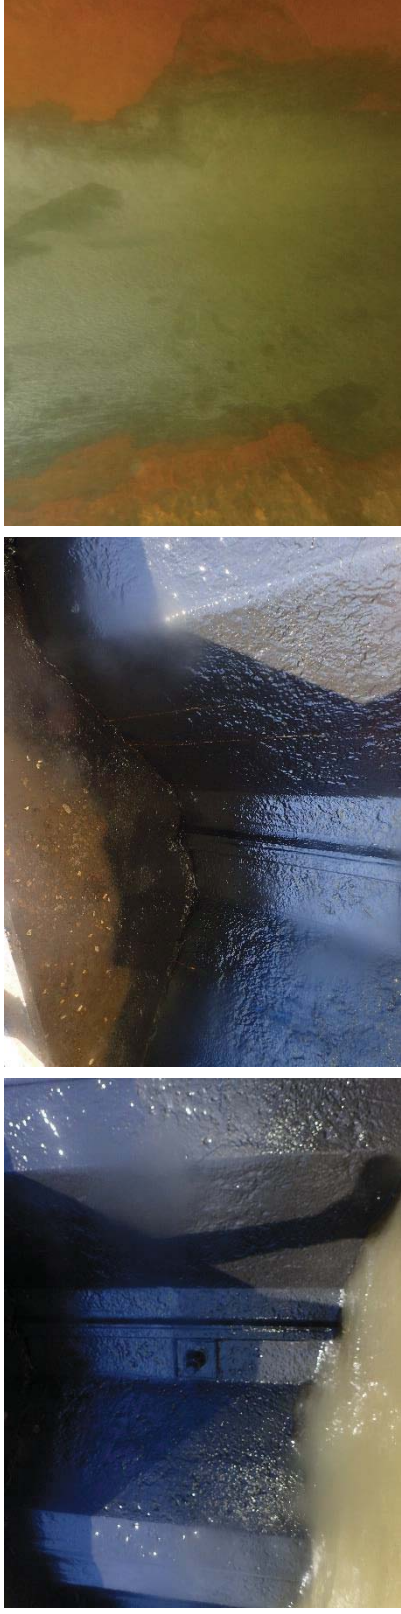
LOCATION 15:

LOCATION #	CONVEX/ CONCAVE/SIDEWALL	CAP LEVEL	HAT	MSL/ INTERTIDAL	LATOR SEABED	ANODE % WORN	DIVER COMMENTS
15	Convex	8.3	6.9	7.0	8.4	N/A	Recently heavy protective paint coating applied, Pitting observed under paint coating, Paint loss in intertidal area, Surface corrosion on unprotected steel. (Paint may have been affected by incoming tide at time of application)
15	Concave	8.0	8.0	8.2	8.0	N/A	
15	East Sidewall	6.5	6.7	7.8	7.8	N/A	
15	West Sidewall	6.5	6.6	7.8	8.8	N/A

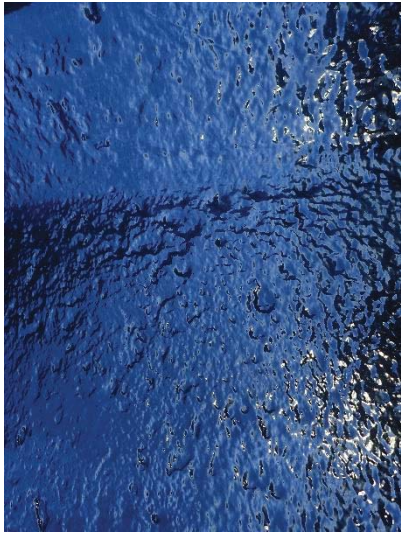
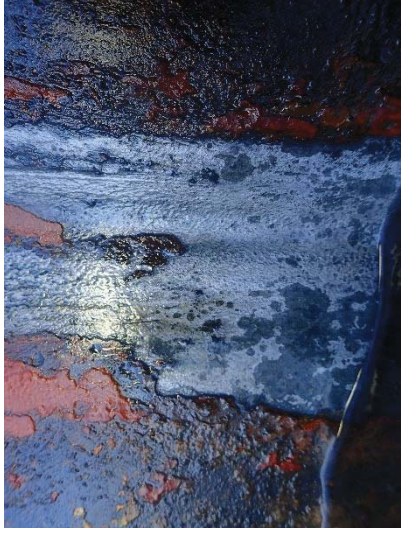
LOCATION 16:

LOCATION #	CONVEX/CONCAVE/SIDEWALL	CAP LEVEL	HAT	MSL/INTERTIDAL	LAT OR SEABED	ANODE % WORN	DIVER COMMENTS
16	Convex	7.9	6.6	8.3	9.0	N/A	Recently heavy protective paint coating applied, Pitting observed under paint coating, Paint loss in intertidal area. (Paint may have been affected by incoming tide at time of application). Surface corrosion on unprotected steel below and above water line was more evident within this Location
16	Concave	7.6	6.2	8.2	9.2	N/A	
16	East Sidewall	7.5	6.0	8.4	9.0	N/A	
16	West Sidewall	7.7	6.3	8.2	8.9	N/A

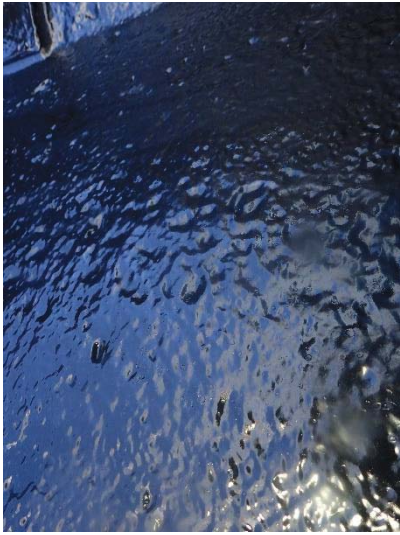
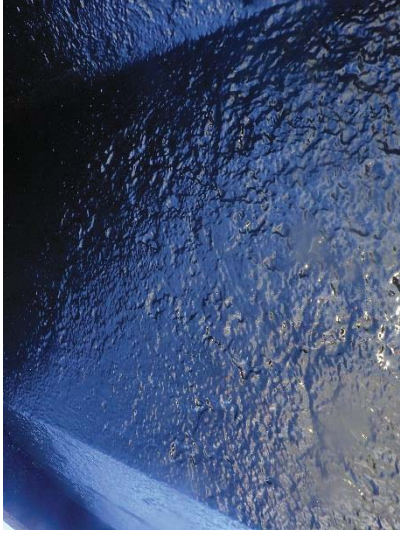
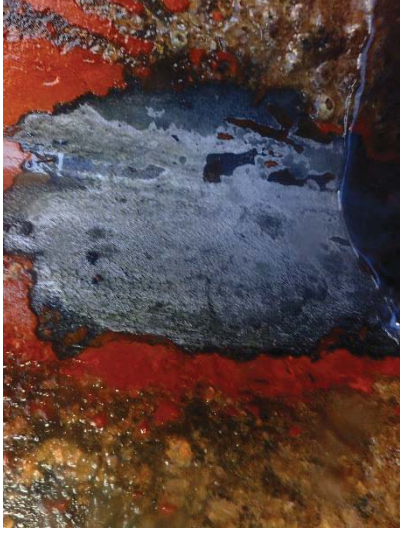
LOCATION 17:

LOCATION #	CONVEX/ CONCAVE/SIDEWALL	CAP LEVEL	HAT	MSL/ INTERTIDAL	LATOR SEABED	ANODE % WORN	DIVER COMMENTS
17	Convex	7.7	5.5	9.1	9.3	N/A	Recently heavy protective paint coating applied, heavier pitting observed under paint coating within this location, Paint loss in intertidal area. Surface corrosion on unprotected steel below water line was more evident within this Location
17	Concave	6.4	6.3	8.6	8.8	N/A	
17	East Sidewall	8.2	6.6	8.5	9.0	N/A	
17	West Sidewall	7.0	6.5	8.2	8.8	N/A

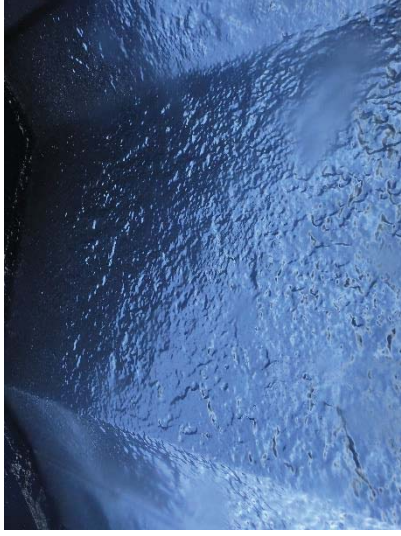
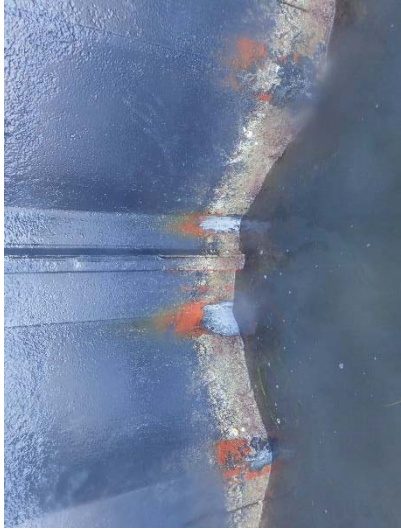
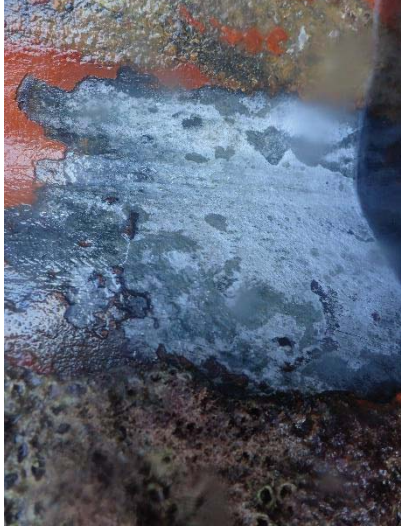
LOCATION 18:

LOCATION #	CONVEX/ CONCAVE/SIDEWALL	CAP LEVEL	HAT	MSL/ INTERTIDAL	LAT OR SEABED	ANODE % WORN	DIVER COMMENTS
18	Convex	7.6	5.4	8.2	8.6	N/A	Recently heavy protective paint coating applied, Pitting observed under paint coating, Paint loss in intertidal area. (Paint may have been affected by incoming tide at time of application) Surface corrosion on unprotected steel below water line was more evident within this Location
18	Concave	6.4	5.7	8.3	8.5	N/A	
18	East Sidewall	6.2	5.5	7.9	8.6	N/A	
18	West Sidewall	6.5	3.4	8.2	8.2	N/A

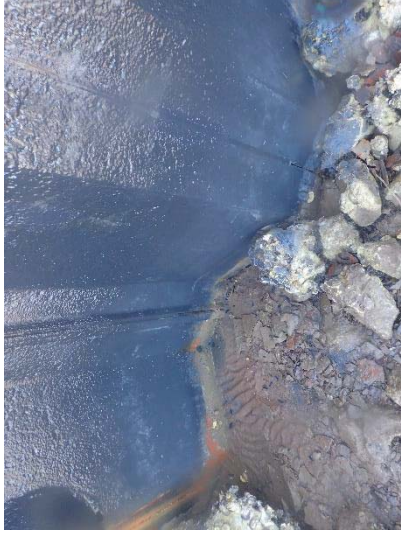
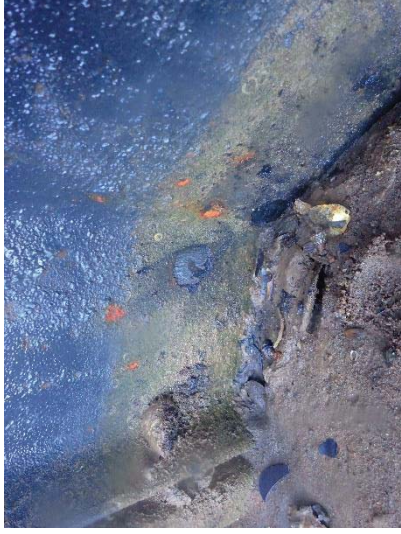
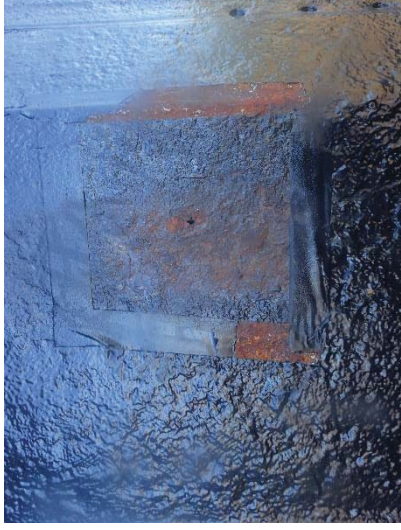
LOCATION 19:

LOCATION #	CONVEX/ CONCAVE/SIDEWALL	CAP LEVEL	HAT	MSL/ INTERTIDAL	LATOR SEABED	ANODE % WORN	DIVER COMMENTS
19	Convex	9.0	3.7	N/A	9.2	N/A	Recently heavy protective paint coating applied, Pitting observed under paint coating, Holes within sheet piling observed, Paint loss in intertidal area. Surface corrosion on unprotected.
19	Concave	8.5	6.2	N/A	8.8	N/A	
19	East Sidewall	7.7	6.6	N/A	9.0	N/A	
19	West Sidewall	7.6	6.4	N/A	8.7	N/A

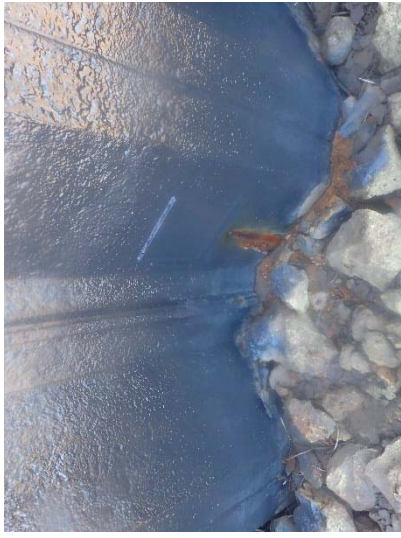
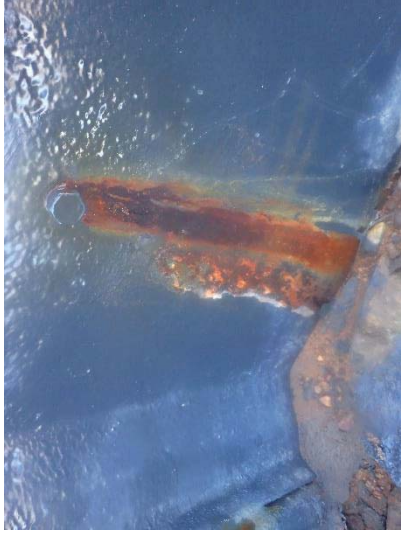
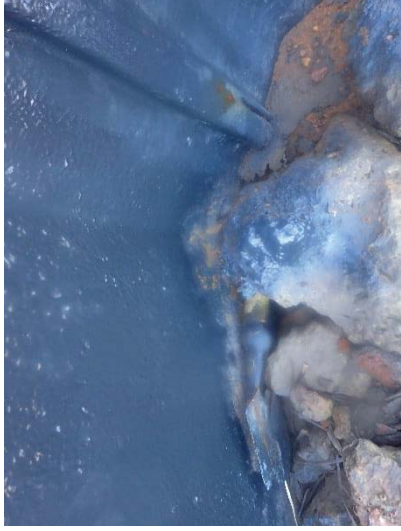
LOCATION 20:

LOCATION #	CONVEX/ CONCAVE/SIDEWALL	CAP LEVEL	HAT	MSL/ INTERTIDAL	LATOR SEABED	ANODE % WORN	DIVER COMMENTS
20	Convex	9.0	6.6	N/A	9.3	N/A	Recently heavy protective paint coating applied, Pitting observed under paint coating. Holes have been patch welded in this location, Bolt threaded into sheet wall piling is causing paint failure.
20	Concave	8.9	6.4	N/A	9.4	N/A	
20	East Sidewall	8.8	6.2	N/A	9.3	N/A	
20	West Sidewall	8.0	5.8	N/A	9.2	N/A

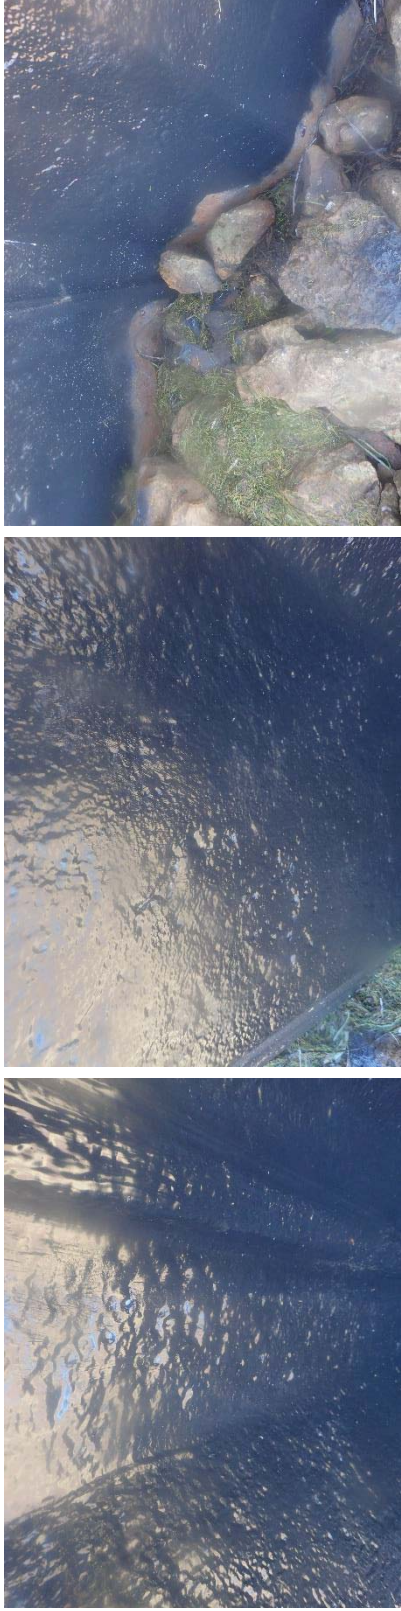
LOCATION 21:

LOCATION #	CONVEX/ CONCAVE/SIDEWALL	CAP LEVEL	HAT	MSL/ INTERTIDAL	LATOR SEABED	ANODE % WORN	DIVER COMMENTS
21	Convex	9.0	7.2	N/A	8.2	N/A	Recently heavy protective paint coating applied, Pitting observed under paint coating, paint coating not applied around rocks and base of sheet wall.
21	Concave	8.8	5.5	N/A	8.8	N/A	
21	East Sidewall	8.8	7.0	N/A	8.5	N/A	
21	West Sidewall	8.6	7.0	N/A	9.3	N/A

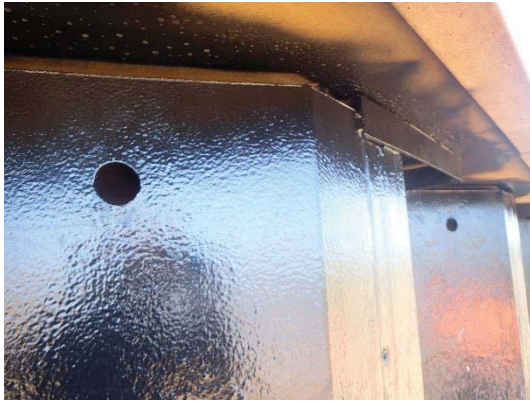
5.1

Within chainage areas 710 to 800 sheet wall piles have open holes, presumed lifting points during fabrication, that may lead to corrosion or back full material subsidence. As seen in the below photos.
