In-water hull cleaning and filtration system: In-water cleaning trials

26-28 November 2012

IN-WATER HULL CLEANING AND FILTRATION SYSTEM: IN-WATER CLEANING TRIALS – 26-28 NOVEMBER 2012

July 2013
Version 3.3

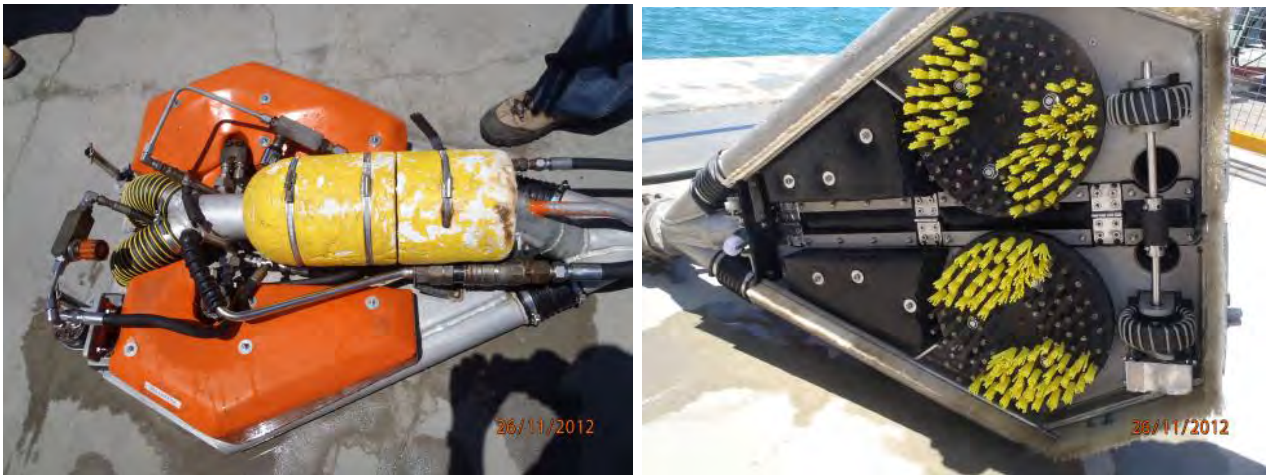
Figure 2.1 Upper and lower views of the *MkII Envirocart*

The *MkII Envirocart* has two counter-rotating discs to which 300 mm diameter brushes or bladed discs are attached (Figure 2.1). The discs are hydraulically driven, and the total width of clean in one pass is 700 mm. The chassis and drive systems both have scissor actions that enable the cart to clean flat and curved surfaces including, for example, the turn of the bilge. The lower rim of the cart body is fringed by a shroud of dense, flexible bristles that act to contain debris within the area of suction, and there are two forward wheels and a rear jockey wheel for movement and manoeuvrability across the surface to be cleaned. Suction of debris is generated by the submersible trash pump and hydrodynamic vortices generated by the brushes, and water and material is drawn through ports to a central and two lateral suction lines which lead into the 4” hose to the trash pump (Figures 2.2, 2.3). A foam float is fitted to the upper side of the cart to provide neutral buoyancy of the unit underwater (Figure 2.3).

- Combination steel and nylon bristle brushes for heavy fouling removal on scrubbable, biocide-free coatings or other hard substrates (Figure 2.1);
- All nylon bristles for biocidal conventional or copolymer antifouling coatings; and
- 45° nylon blades for contactless cleaning (Figure 2.4).

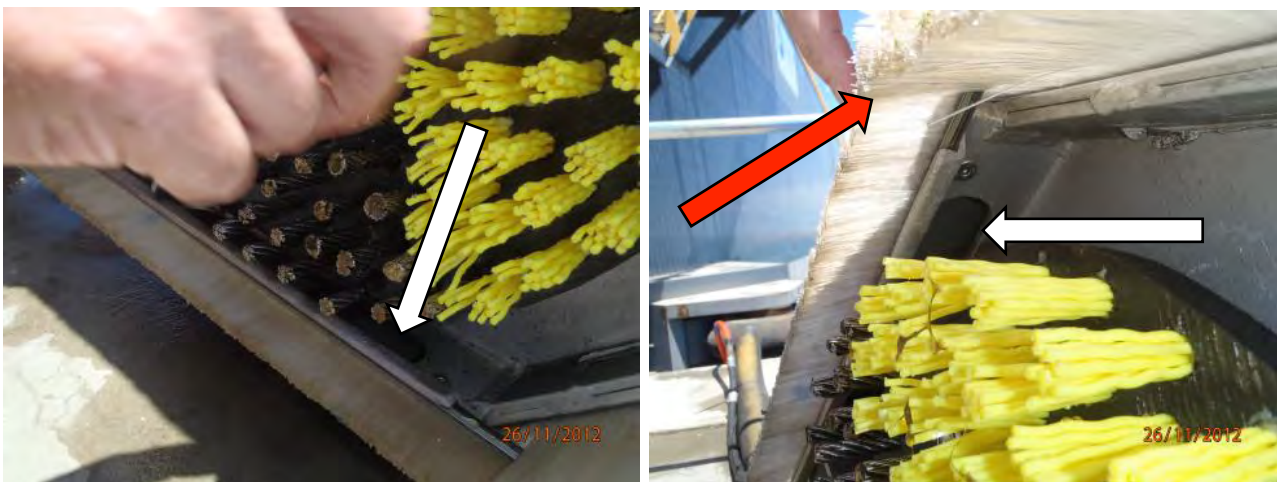
Figure 2.2 Under surface of cart showing suction ports (white arrows) and shroud (red arrow).

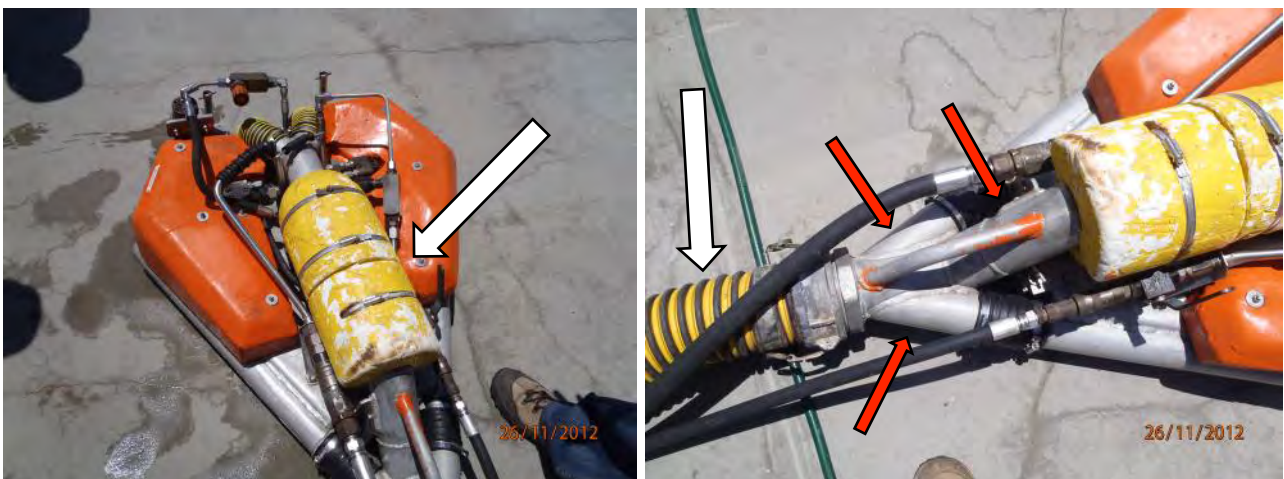
Figure 2.3 Upper surface of cart showing, left, buoyancy float and, right, suction outlets (red arrows) and hose (white arrow).

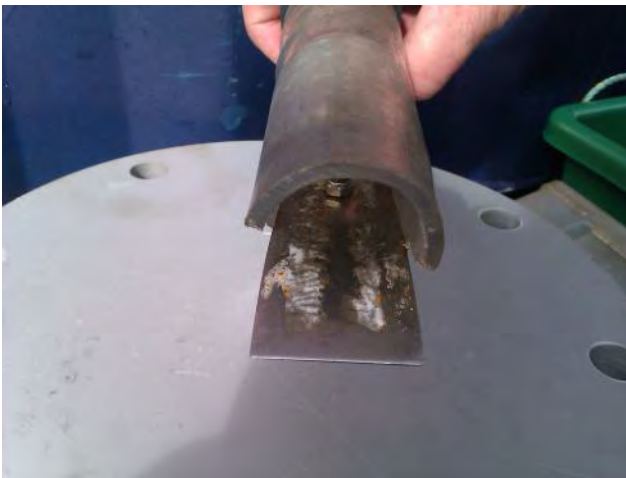
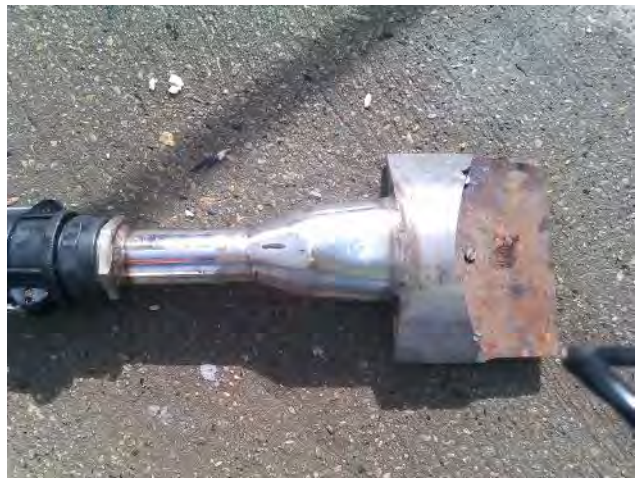
Figure 2.5 40 mm (left) and 100 mm (right) shrouded hand-cleaning blades.

For small areas, such as along weld lines and bilge keels, shrouded hand scrapers have been designed. Two sizes, 40 mm and 100 mm blade width scrapers are currently available (Figure 2.5).

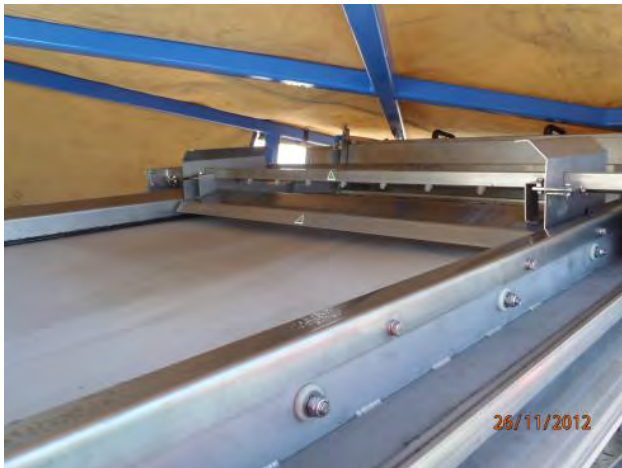
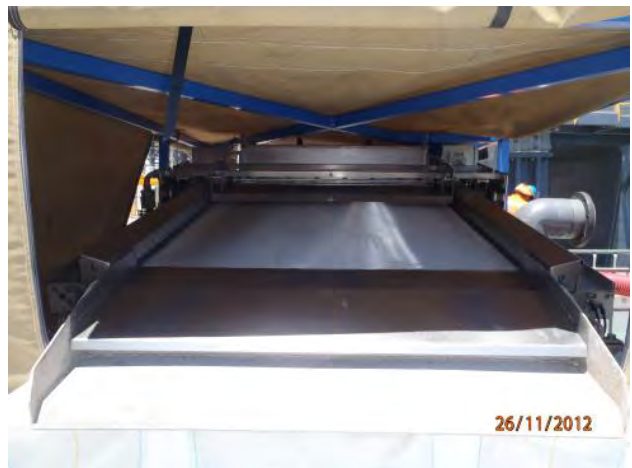
Figure 2.6 First stage filtration: filter screen

The trash pump lifts water and debris through a 4" hose to the first stage filtration system. This unit comprises a feed box which allows a consistent flow of feed slurry onto an inclined, static woven mesh screen (the *Baleen Filter*®) (Figure 2.6). Mesh size on the prototype unit is 50 µm, although finer mesh could potentially be used. Any oversize or near-size particles (including viscous emulsion, if present) are retained on the screen surface and the slurry filtrate passes through the mesh screen by gravity. The oversize material is fluidised from the screen surface by a low volume, high pressure water spray bar located below the surface of the screen and perpendicular to it (Figure 2.7). Concurrently, a similar spray bar located above the screen surface, and at a slightly forward orientation, flushes the fluidised bed of oversize material to the discharge end of the screen for collection in a disposable bin bag.

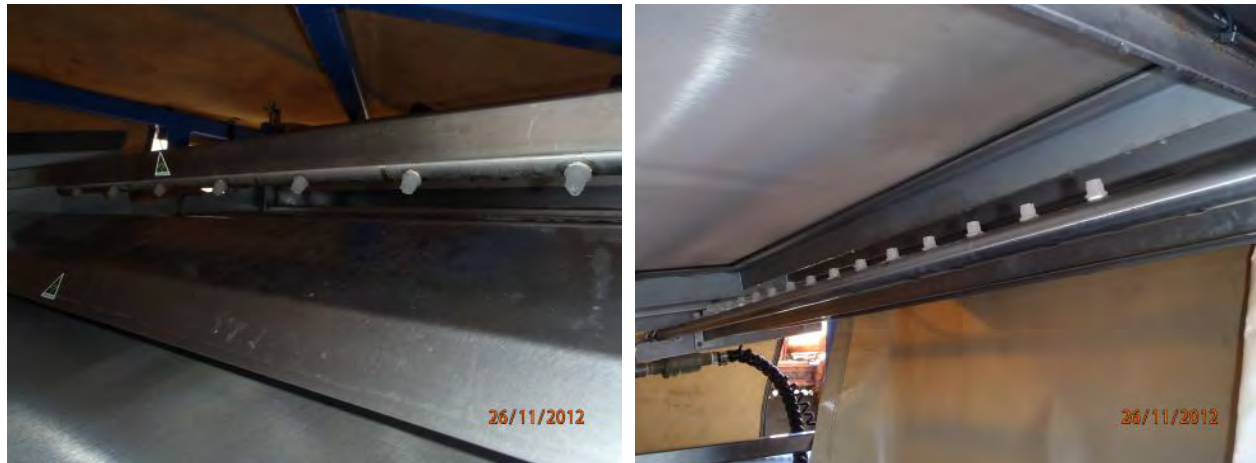
Figure 2.7 First stage filtration: upper and lower spray bars

The connected top and bottom spray bars travel down the screen in a pneumatically-driven carriage system. When the carriage reaches the lower limit of travel at the lower end of the screen, the spray water is cut off and the carriage returns to the feed end of the screen for the next cleaning cycle.

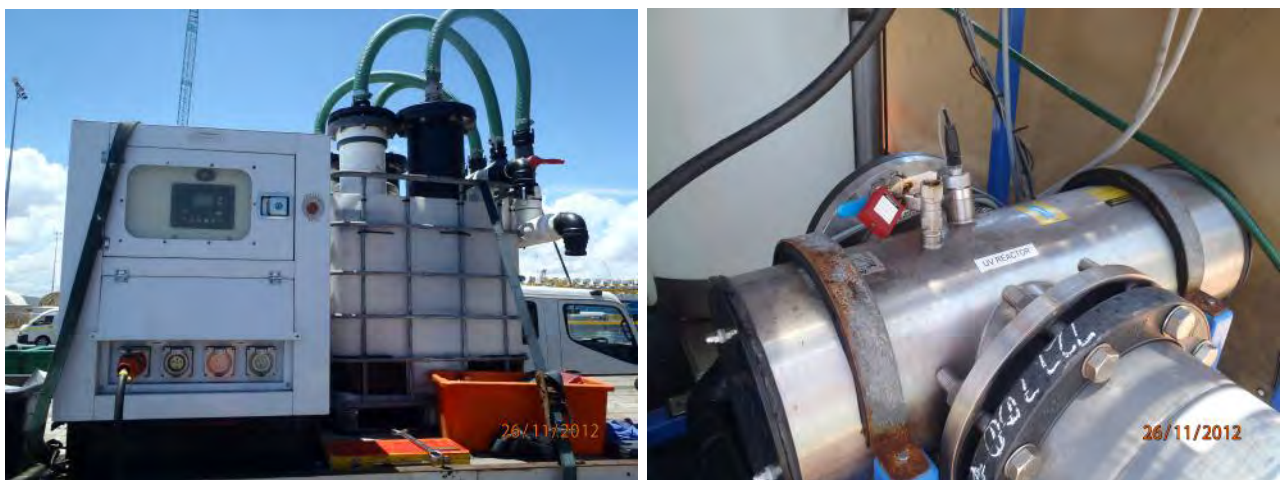
Figure 2.8 Second stage filtration assembly (left) and UV treatment unit (right).

Filtrate from the first stage filtration is further filtered by pumping it through a series of four back-flushable filter units that contain high volume, interchangeable, cartridge filters (3M™ High Flow 40" filter cartridges, 25 µm media grade) capable of removing particulate material greater in size than 2 – 5 µm (Figure 2.8). 3M™ internal laboratory testing determined the removal efficiency of these cartridges to be 98.93% for 3-5 µm particles (A Ng, 3M Purification Pty Ltd, personal communication 13 March 2012). The filters are regularly back-flushed when resistance increases (in practice about every 25 min), with the back-flushed water discharged back into the solids bin, drained, then recycled back through the filtration process. Back-flushing and cleaning re-generates 60% of a filter's efficiency, but ultimately the cartridges reach a maximum operating back pressure and need to be replaced. Filter units in the series

After filtration through both first and second stage filtration, the filtrate is disinfected by passing through an automated UV chamber (Figure 2.8). Filtered and treated water is then released for discharge, or can be contained and pumped into tankers for onshore disposal.

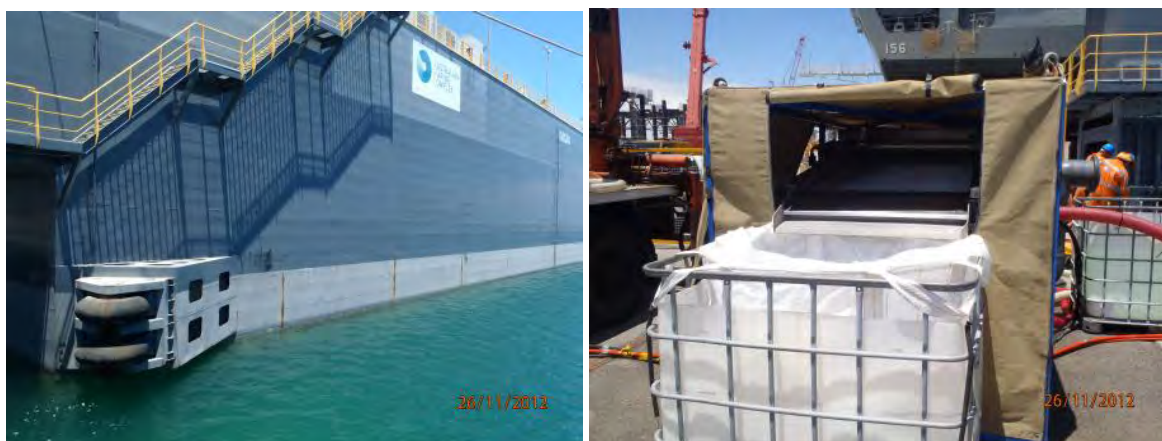
Figure 4.1 Dry-dock *Yargan* (left), and first stage filtration unit (right).

Trial 1 was undertaken on floating dry-dock *Yargan*, located at the Australian Marine Complex, Henderson, WA (Figure 4.1). *Yargan* is constructed of steel and underwater surfaces are painted with a high performance anti-corrosive marine paint system. The current top coat, applied in November 2007, is a two component epoxy coating, *PPG Sigmashield 420*. No antifouling coating, either biocidal or biocide-free, was applied.

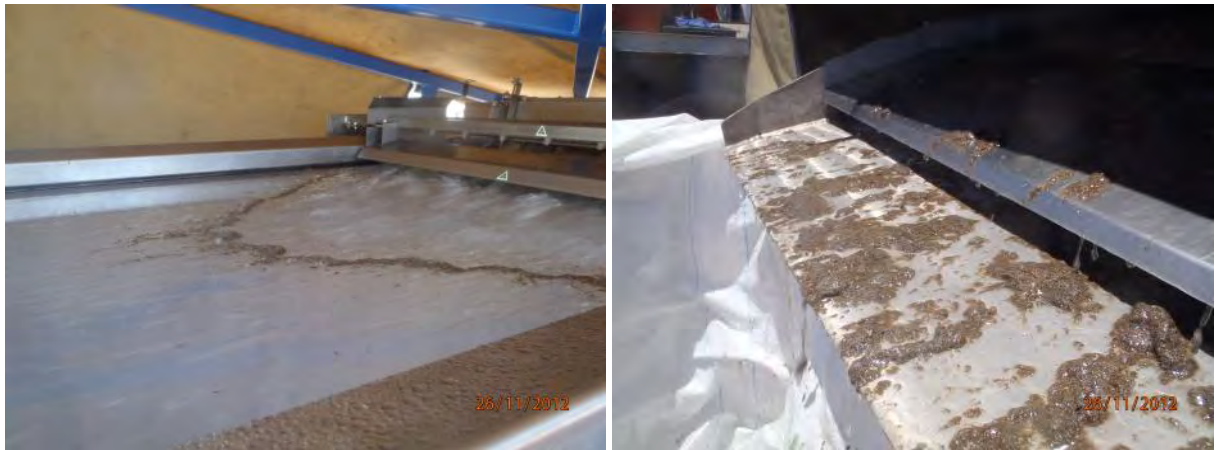
Figure 4.4 Debris greater than 50 μm accumulating on the baleen screen (left) and washed into the waste bag (right).

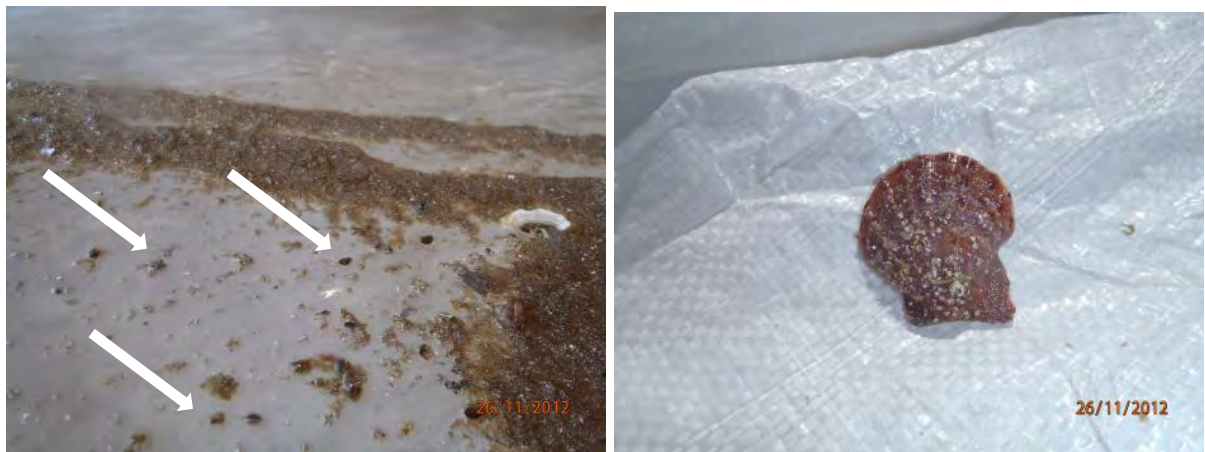
Figure 4.5 Captured debris, including juvenile mytilid mussels (arrowed) and an intact scallop (right).

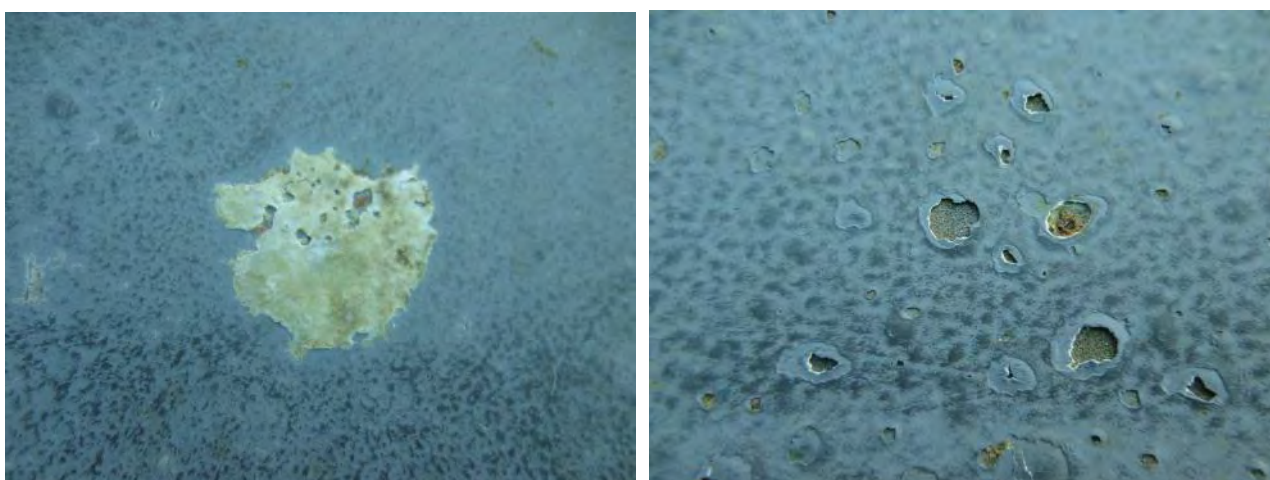
Figure 4.8 Residual oyster base (left) and paint blistering defects (right) on the vertical side.

After cleaning, smooth areas of hull plate were mostly visibly free of biofouling on both the vertical sides (Figure 4.7) and flat bottom (Figure 4.8). Biofouling encrustation did persist alongside hull irregularities, such as weld-lines, but on the flat hull plate only some scattered and isolated calcareous baseplate scars of oysters and tubeworms remained (Figure 4.9). The only mechanical damage to the coating from the cleaning was light scuffing from contact of the brushes. These would not compromise coating life or performance.

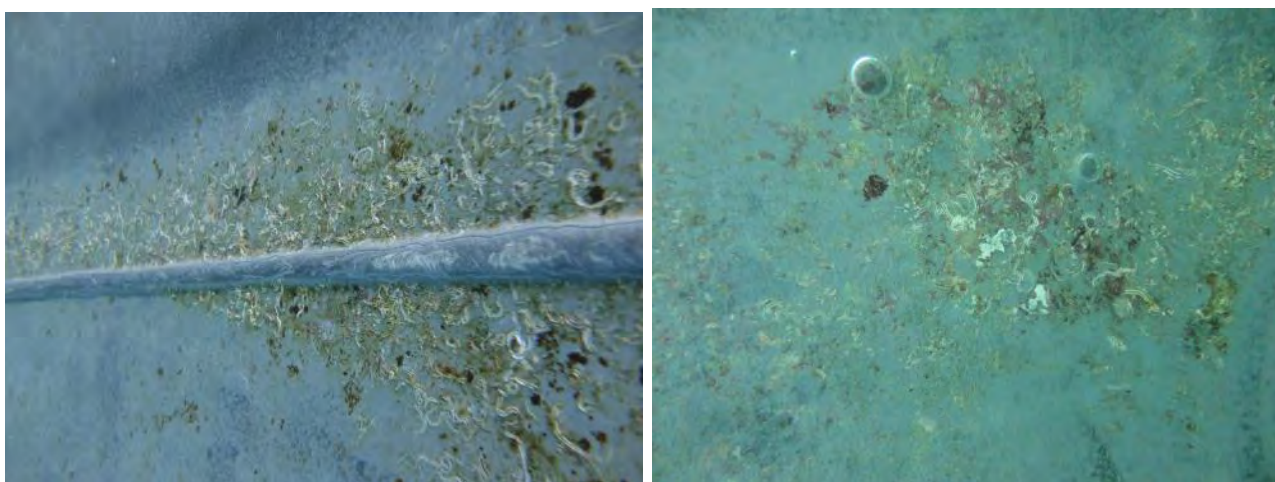
Figure 4.9 Fouling along weld-line after *Envirocart* cleaning (left) of the flat bottom, and some residual calcareous bases (right)

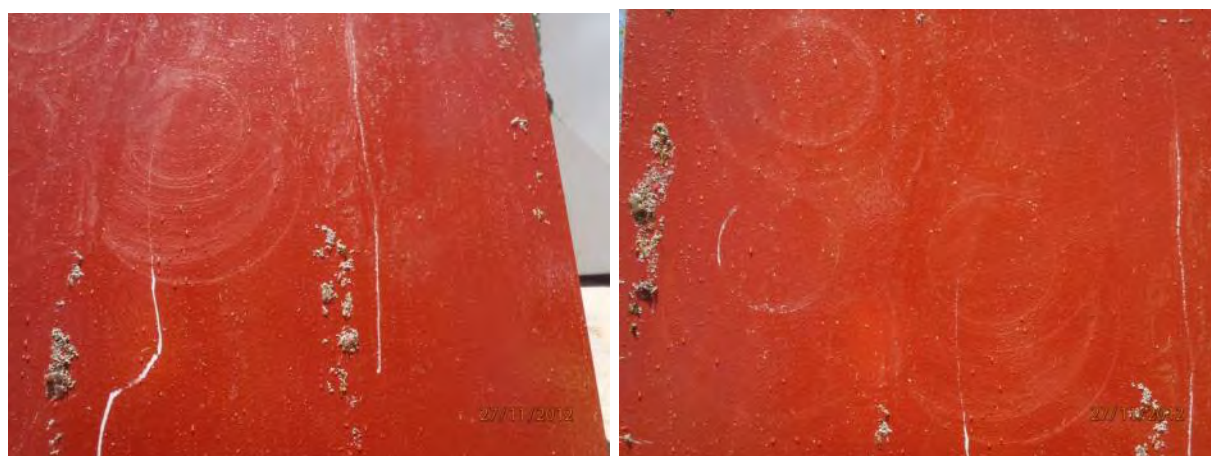
Figure 5.4 Scuffing of the coating surface caused by the blades touching the surface.

The cart passes in this trial caused two types of damage to the FR coating: elongate scratching of the silicone coating under the mid-line of the chassis (Figure 5.4), and light radial scratching and scuffing of the surface by the left-hand disc (Figure 5.5). The former was determined to be due to the hard plastic jockey wheel either jamming or dragging across the coating surface as the cart moved forward or, less likely, shell-growth being caught on around the jockey wheel and scoured across the paint.

The second type of damage was due to the blades on the left hand disc touching the coating surface. Although the blades had been set to ensure they did not do this, it was found that the bolts holding the left-hand blade disc had loosened causing the disc to wobble and touch the surface. On inspection, blades on this disc had traces of paint on their inner edge. The track under the right-hand disc showed no sign of scratching or scuffing, and the surface was completely free of any visible micro- or macro-fouling.

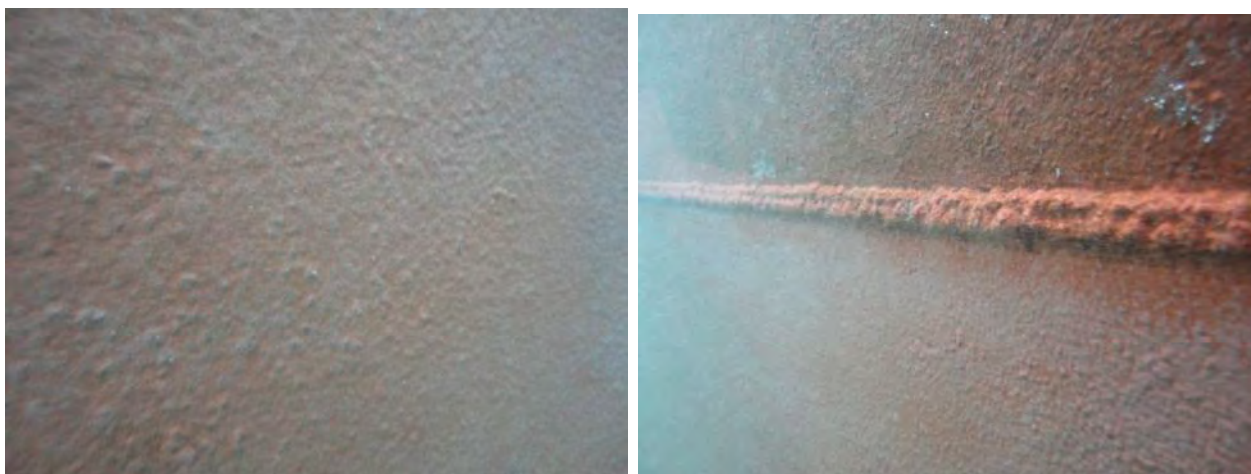
Figure 6.4 Hull surface after cleaning with the *Envirocart* fitted with bladed discs.

Cart cleaning with both the bladed disc and brushes completely removed the biofilm, and caused no visible damage to the underlying coating (Figures 6.4, 6.5). No plume of either paint or organic debris was visible around the cart during the clean. Removal of the biofilm and leached surface layer of the paint would not cause accelerated deterioration or aging of the antifouling system but, rather, regenerates the antifouling mechanism by restoring the biocide leach rate to, or close to the design rate for the system

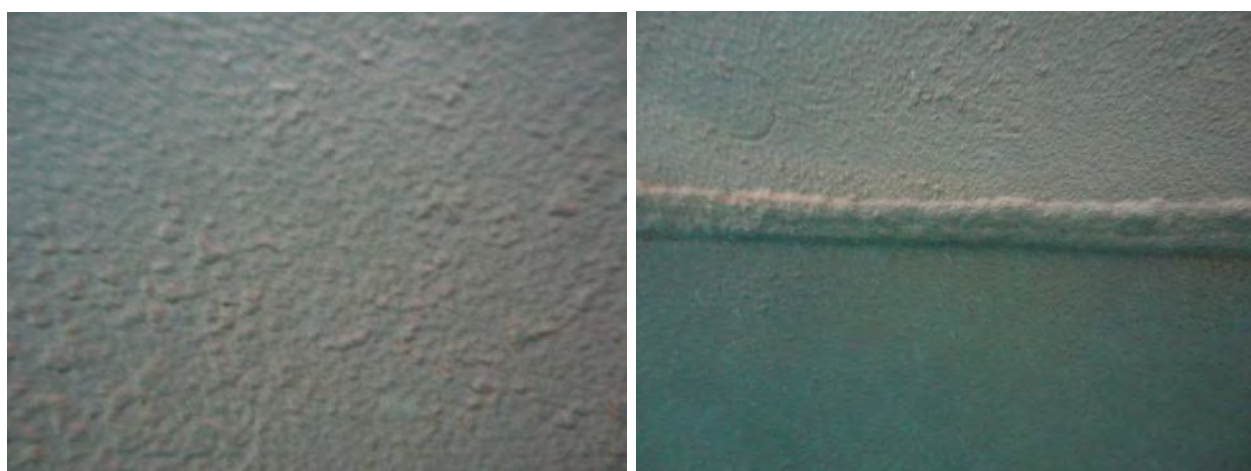
Figure 6.5 Hull surface after cleaning with the *Envirocart* fitted with brushes.

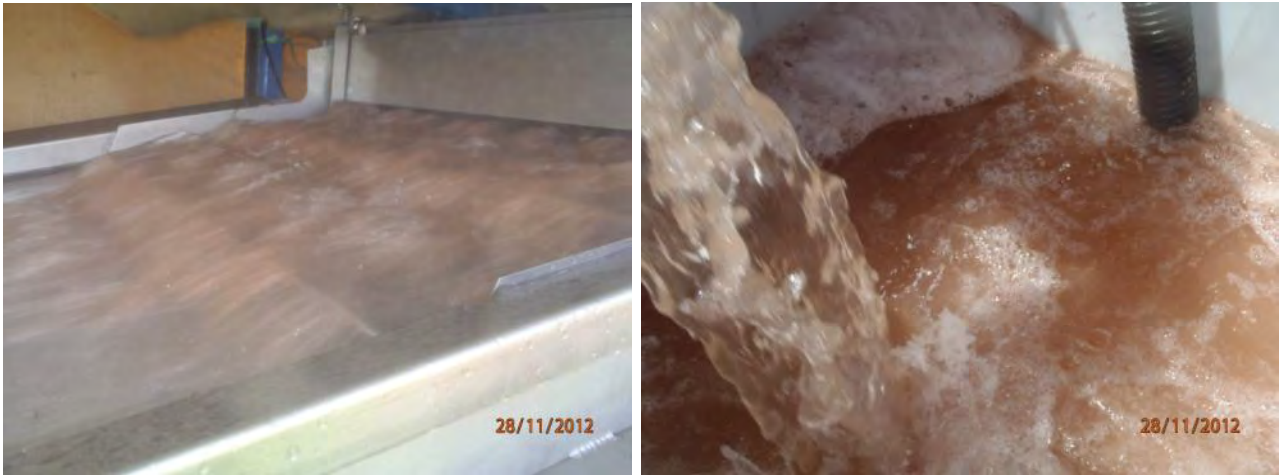
Figure 6.7 Red (copper) tinted water flowing over the first stage filter (left), filtrate in the tank below the filter tray (right), during the *Wambiri* hull clean.

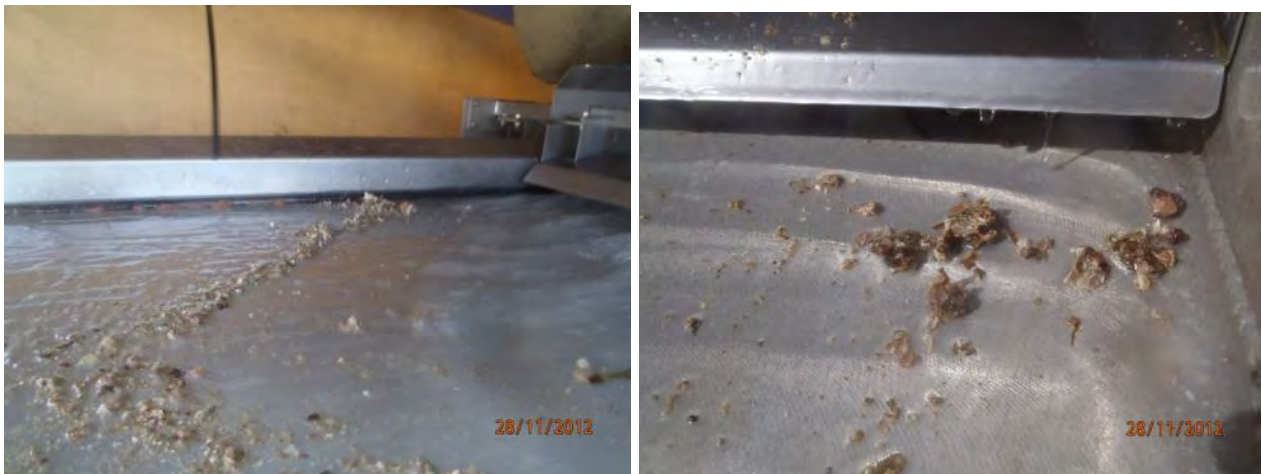
Figure 6.8 First stage filtration debris from the box clean of the *Wambiri* anode (left), and scraper clean of the jetty pile (right).

Removal of biofouling growth from the wharf pile with the shrouded blade was effective and growth scraped from the surface was drawn into the suction pipe. The observed limitation of the technique related to the severity and thickness of the fouling on the surface. The depth of the fouling exceeded the height of the shroud, and the diver was required to hold clumps of fouling as they were scraped from the surface, and direct them into the suction shroud to ensure they did not fall away from the scraper.
