technical bulletin

No. 53

AN ASSESSMENT OF RECOVERY AND LAND CAPABILITY OF PART OF THE ORD RIVER CATCHMENT REGENERATION PROJECT

by W. J. Ryan

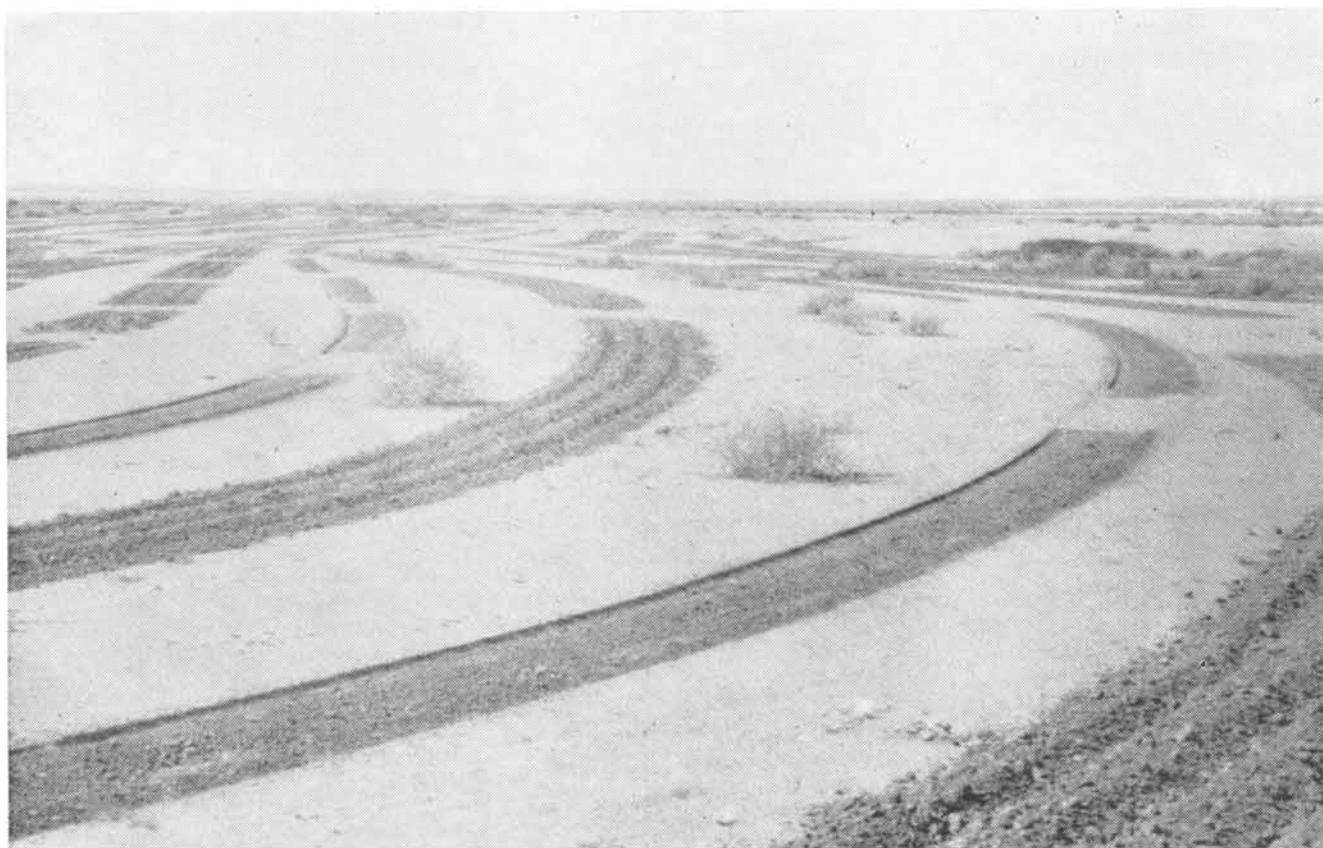
Plate 1. Strip cultivation used for regeneration.

The opposed disc unit was a three point linkage implement and threw up a small bank about 30 to 40 cm high and about one metre wide at the base. The discs generally cut to a depth of

10 to 14 cm. The chisel plough was either five or seven tyned and was also three point linkage mounted. It worked to a depth of about 10 to 15 cm and was approximately two metres wide.

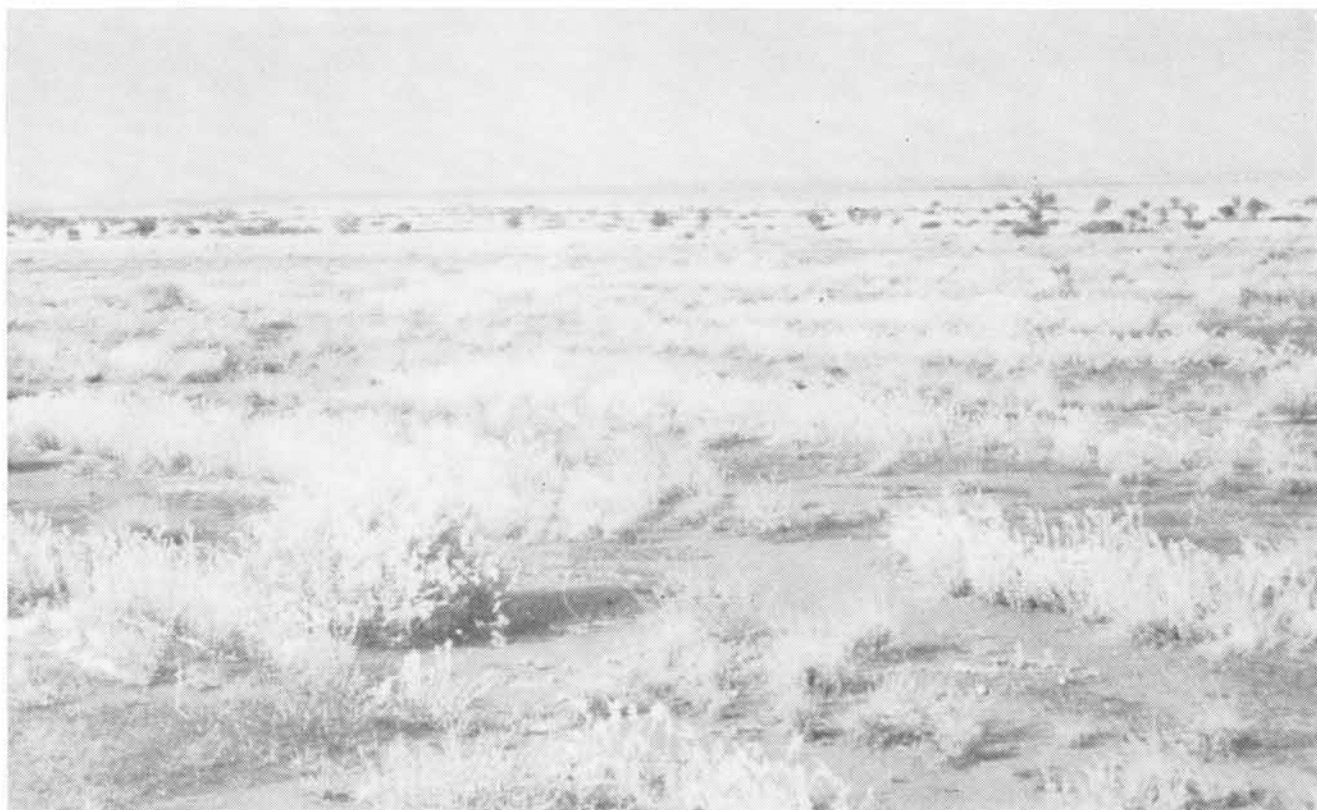
Plate 2. Initial establishment of kapok bush along chisel plough workings.

Seed boxes were mounted either on the implement or on the back of the tractor and were chain driven from a sprocket on the rear wheel of the tractor. The seeding rate was about 0.5 kg per km of furrow.

The distance between the furrows varied according to the severity of degradation of the area being treated. It was as little as five or six metres on very bare areas, and up to 20 metres apart on less degraded areas.

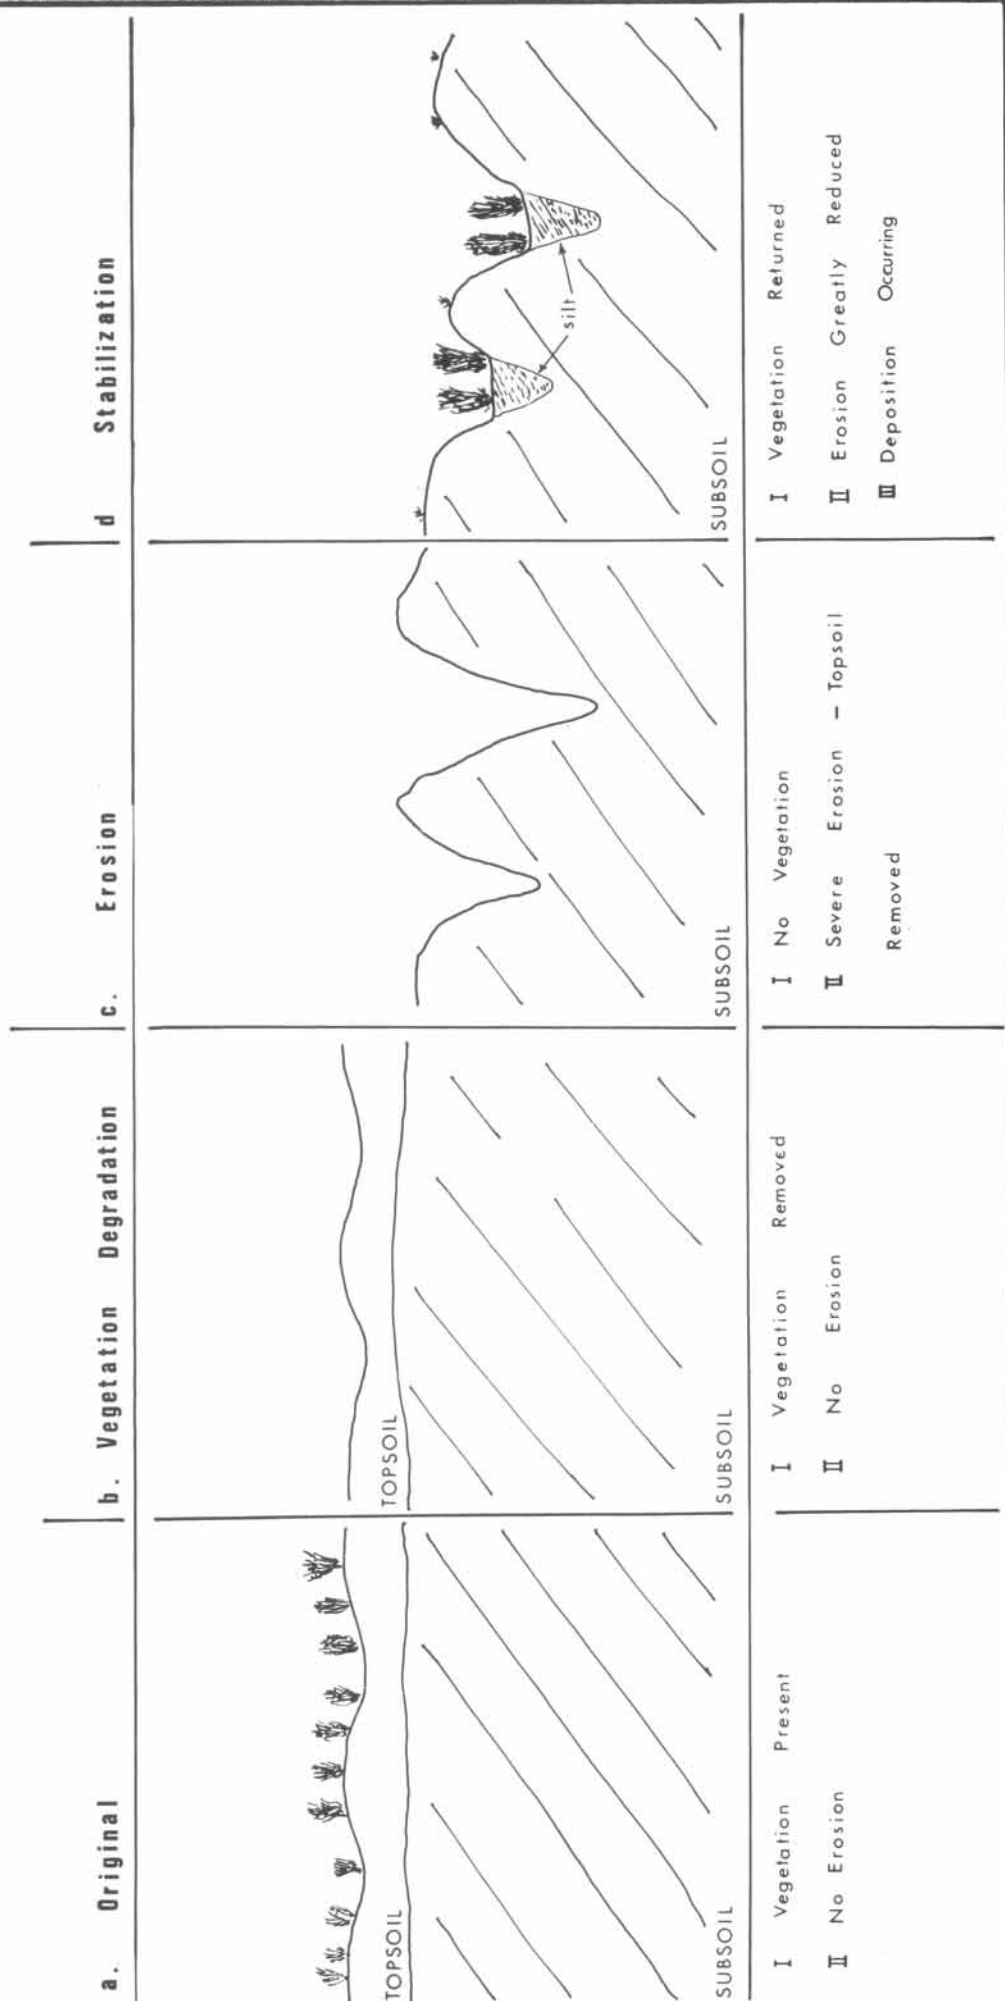
Figure 4 : Diagram of the Erosional Cycle

This levelling effect will continue until overall stabilisation has been achieved. With every deposition of silt the gradient between the active erosional site and the depositional site is reduced and hence the speed of succeeding water flows will be reduced and their ability to transport material will be reduced. This will cause further deposition and hence the cycle will start again with the gradient being further reduced.

In smaller rills it is not unusual to find dense vegetation right down the rill line or gully path while the surrounding area may have sparse vegetation. Trapped silt in the rill is apparently more fertile and has more favourable moisture relationships than the surrounding subsoil and thus supports more growth (Figure 4).
