Evaluation of deep, open drains in the North Stirling area

Evaluation of Deep, Open Drains in the North Stirling Area

Resource Management Technical Report 161

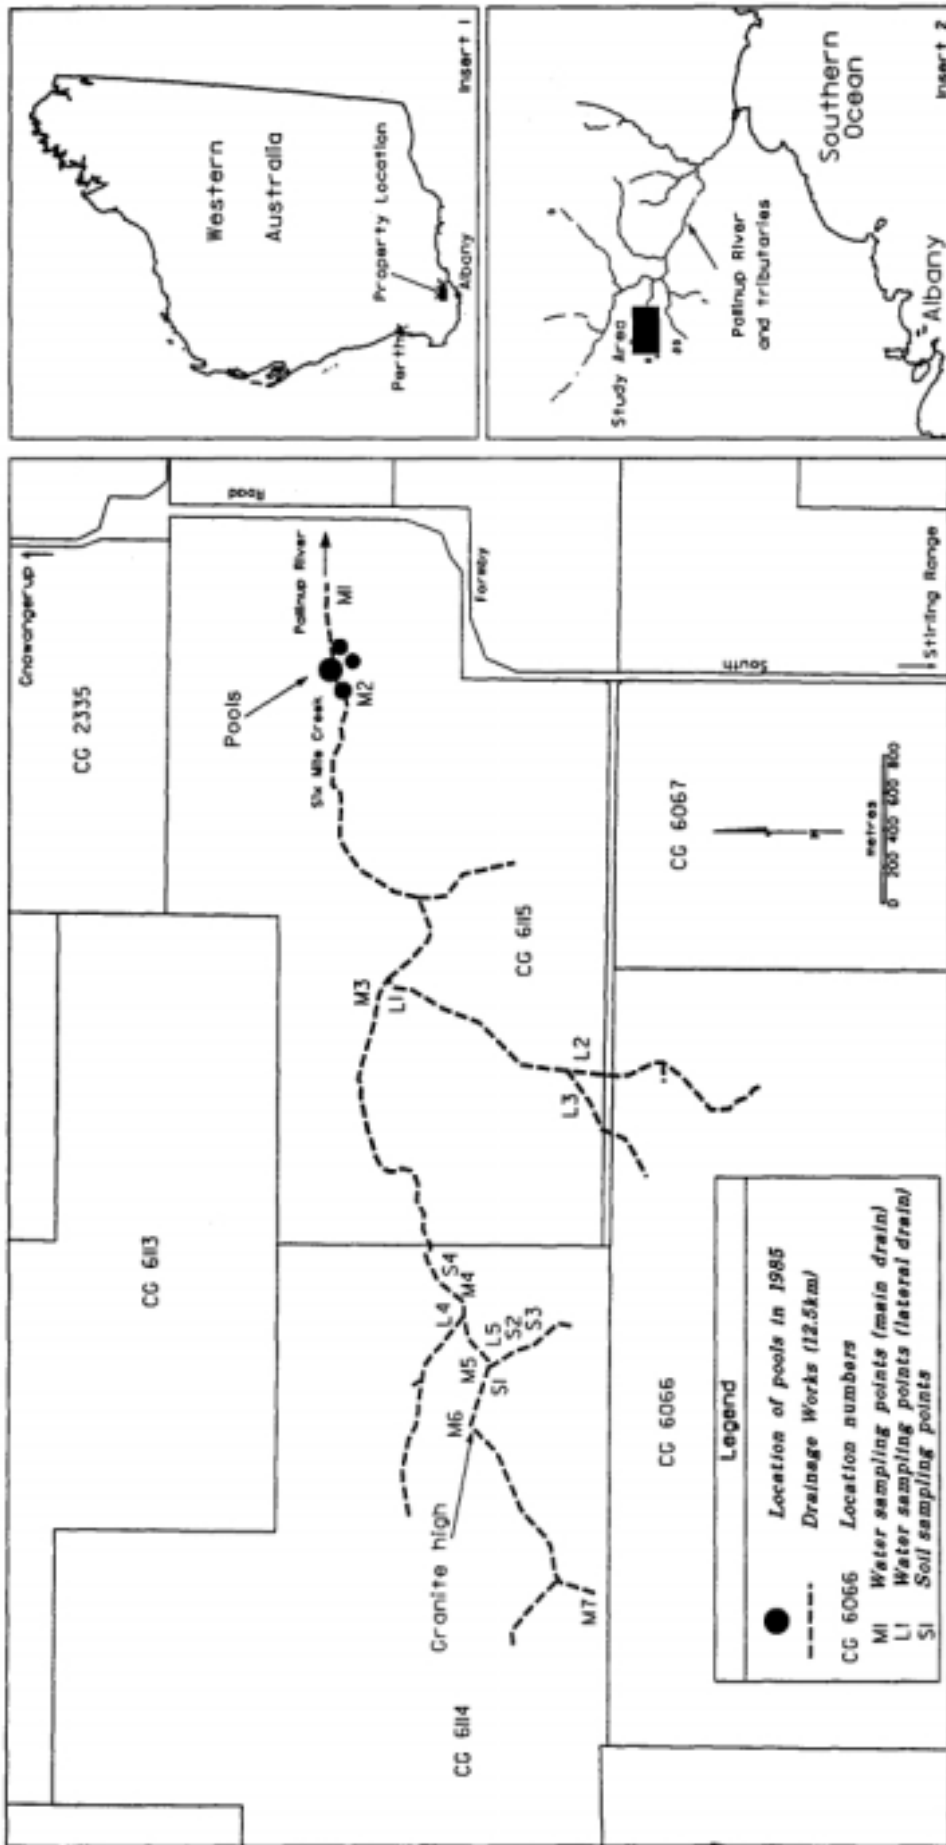
Figure 1: Location boundaries, numbers and sampling points in relation to drainage works on Ken Pech's property, Gnowangerup

All drains have a trapezoidal cross-section. The bed of the main drain is 3 m wide and its sideslopes 1:1 (vertical : horizontal). The beds of lateral drains are 1.2 m wide and their sideslopes 2:1. With the exception of approximately 100 m (Figure 1; the granite high near M6), the drains are entirely in the Pallinup Formation.

The flow rate along the main drain (December 1996) varied between 0.2 L/sec (site M7; Figure 1) and 2 L/sec (M1; at the outlet of the property). A few of the lateral drains had no or little flow (Table 2 and Figure 1).

The flowing water was baseflow which was groundwater seeping into the drain. Baseflow salinity varied between 5600 and 8400 mS/m (Table 2). The lowest salinity reading (5600 mS/m) was at site L5 which is close to a seepage zone (S2; Figure 1). This salinity is probably similar to the salinity of the groundwater. The salinity of the baseflow at the outlet of the property was 8300mS/m (M1; Table 2). The increase in salinity is probably due to evaporation.

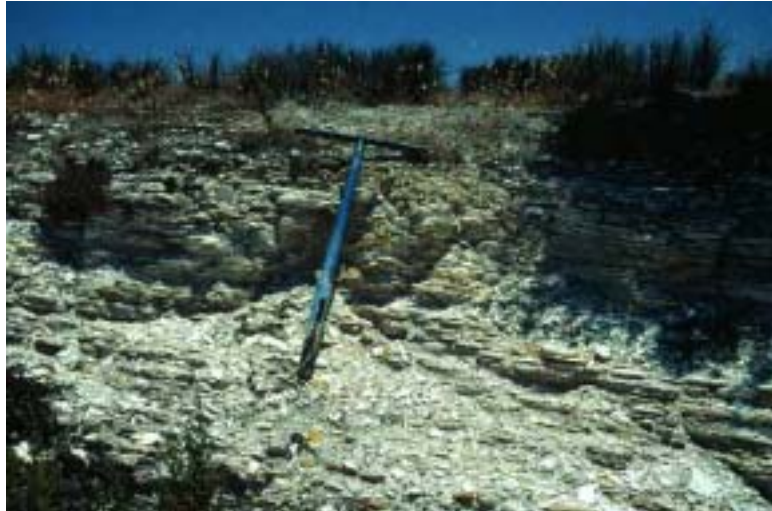
Photo 1: Sedimentary layers of the Pallinup silty clay in the study area.

The area is covered by Pallinup Siltstone which is a Tertiary Formation. The Pallinup sediments in this area, are mainly composed of fine silt, clay (Photograph 1) and occasionally fine to medium sand (Table 1). The siltstone, in some areas, contains pink and white spongolite (a siltstone full of sponge spicules). The Pallinup Siltstone overlays the basement rock which is of Precambrian origin and part of the Yilgarn Craton. There are basement (granite and gneiss) highs in the area that are covered by sediments. Weathered granite can be seen along the bed of the main drain (Figure 1).

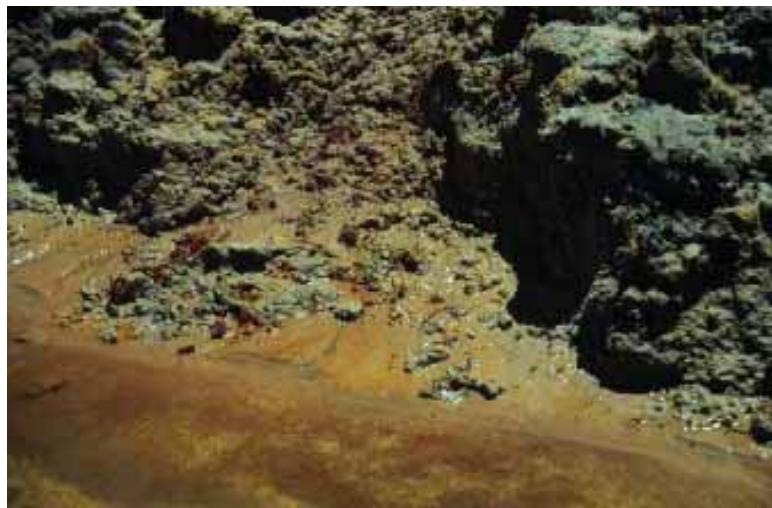
Photo 2: One of the few major seepage zones. Note: the collapse of material at the seepage zone which is in the centre of the photograph.

We recorded the position of major seepage zones (Figure 1 and Photograph 2) which were along the mid section of the drain.

The bed of the drain was wet throughout its entire length but only a few seepage areas which had sandy profiles (Table 1) contributed to the baseflow. Seepage zones included sections of the drain which had been cut into the floor of salt lakes.

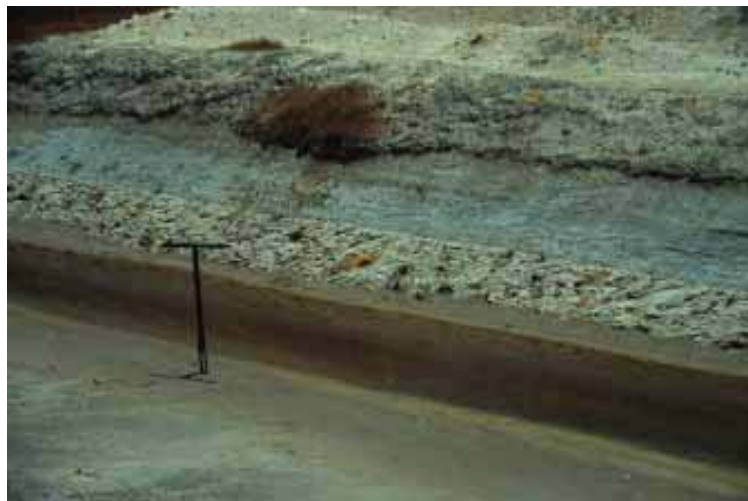
Photo 3: With the exception of a few sites, the soil profile along the main drain is very tight silty clay. Note: The bed of the drain is filled with silt.

Some sections of the main drain were badly eroded. Gullies, 1 m apart and up to 0.5 m deep, had formed along the sideslopes in some sections of the main drain (Photograph 4). Part of the eroded material had filled the base of the main drain (Photograph 3) and part was transported out of the area. There were also indications of sedimentation further downstream. A typical site where this silting may be seen is 500 m before the creek crosses the South Formby Road (Figure 1). On the 1985 aerial photographs there are four pools in this area. These pools are absent on the 1993 aerial photographs. It is likely that these pools have been filled with silt between 1985 and 1993. Silting of the creek bed can also be seen further downstream, east of the South Formby Road.

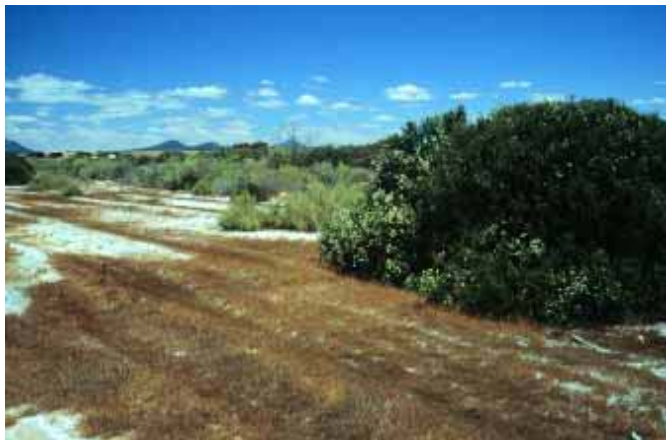
Improvement of creek beds and flood plains (eg. Area 2; Figure 3) could be partly attributed to them being fenced off and revegetated with salt-tolerant species. These areas had been mounded and planted with salt-tolerant species. *Melaleuca thyoides*, *Acacia saligna* and *Atriplex spp.* were among the surviving plants. *Melaleuca thyoides* was very impressive (Photograph 5) with a large canopy (5m in diameters) and healthy growth.

Photo 5: Melaleuca thuyoides (foreground) had more impressive growth than Atriplex spp. (saltbush).

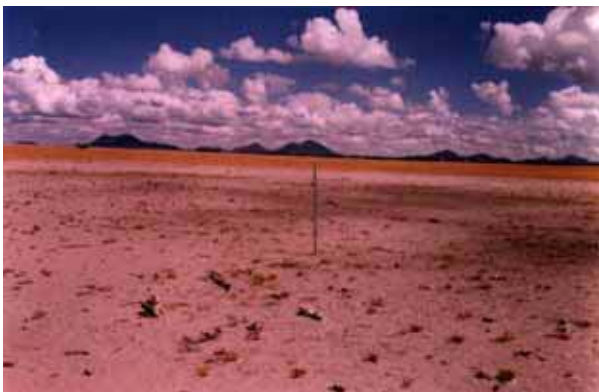
The improved area, furthest from the drain which was cropped in 1996 was a 3 ha patch of land (Area 3; Figure 3) up to 200 m away from the main drain. Improvement of this land is entirely due to the effects of the drain since there is no treatment other than the drain. The area was bare in 1985 (Photograph 6a). At the time of our second visit (December 1996), this area had been cropped but not harvested because the crop (barley) looked patchy. The Geonic EM38 readings on this area were between 80 and 120mS/m. These reading showed that the area was still moderately salt-affected. Photograph 6b shows lupins grown in the area in 1995. This land is probably on a sandy lens that crosses the deep drain (Site S1; Figure 1). By having a high hydraulic conductivity, this sandy lens has extended the effect of the drain far beyond the expected distance. We observed one section (Site S1; Figure 1) of the deep drain that had higher seepage rates than other areas and found that the sandy lens crossed the drain here.

Photo 6a : This area was extremely salt-affected and bare in April 1985.

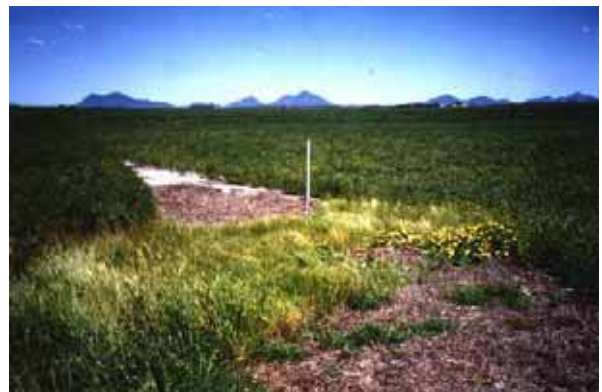
Photo 6b: The same area in September 1995 growing a crop of lupins.

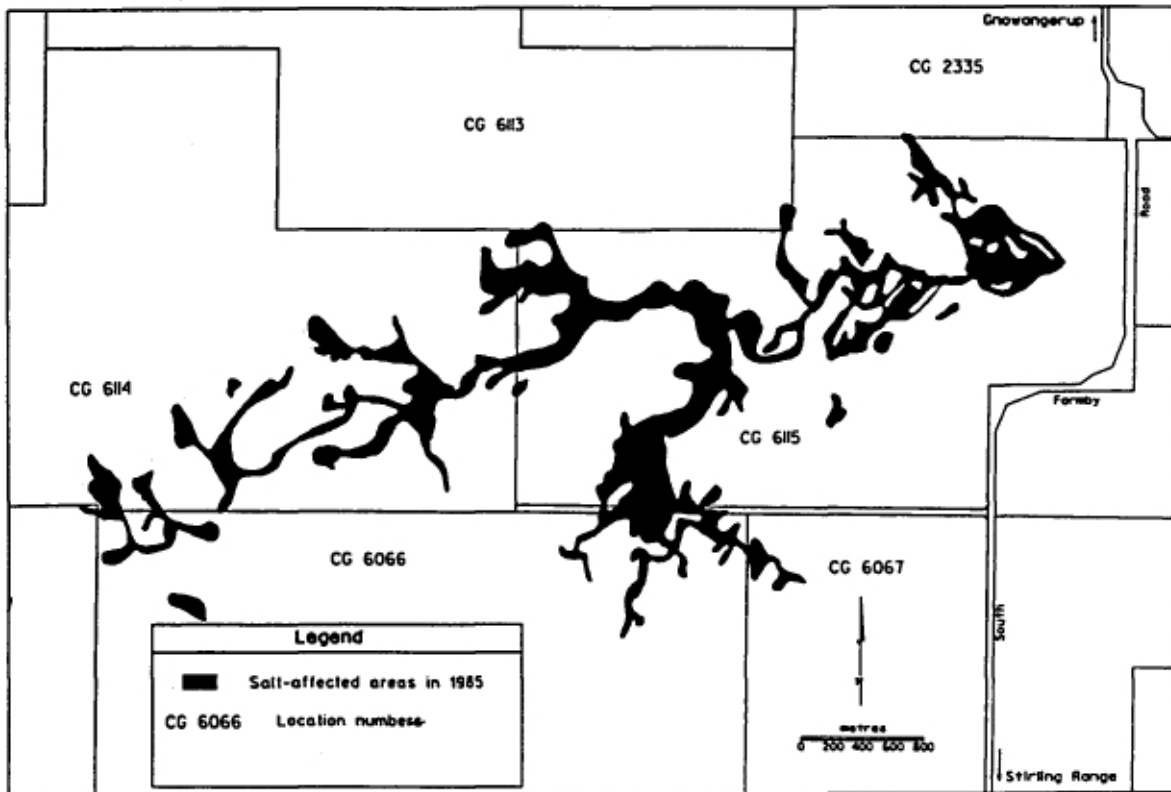
About 251 ha of land was strongly salt-affected on the 1985 aerial photographs. These areas looked continuous and spread out (Figure 2). Most of the affected areas were in the natural drainage beds.

Figure 2: Extent of strongly salt-affected areas in 1985 (251 ha).

- salt-affected areas close to the deep drains had been reduced, and in some places had become isolated (Figures 2, 3 and 4);
- during the same period, salinity had encroached into other areas that were further away from the drain (Figures 2 and 3).

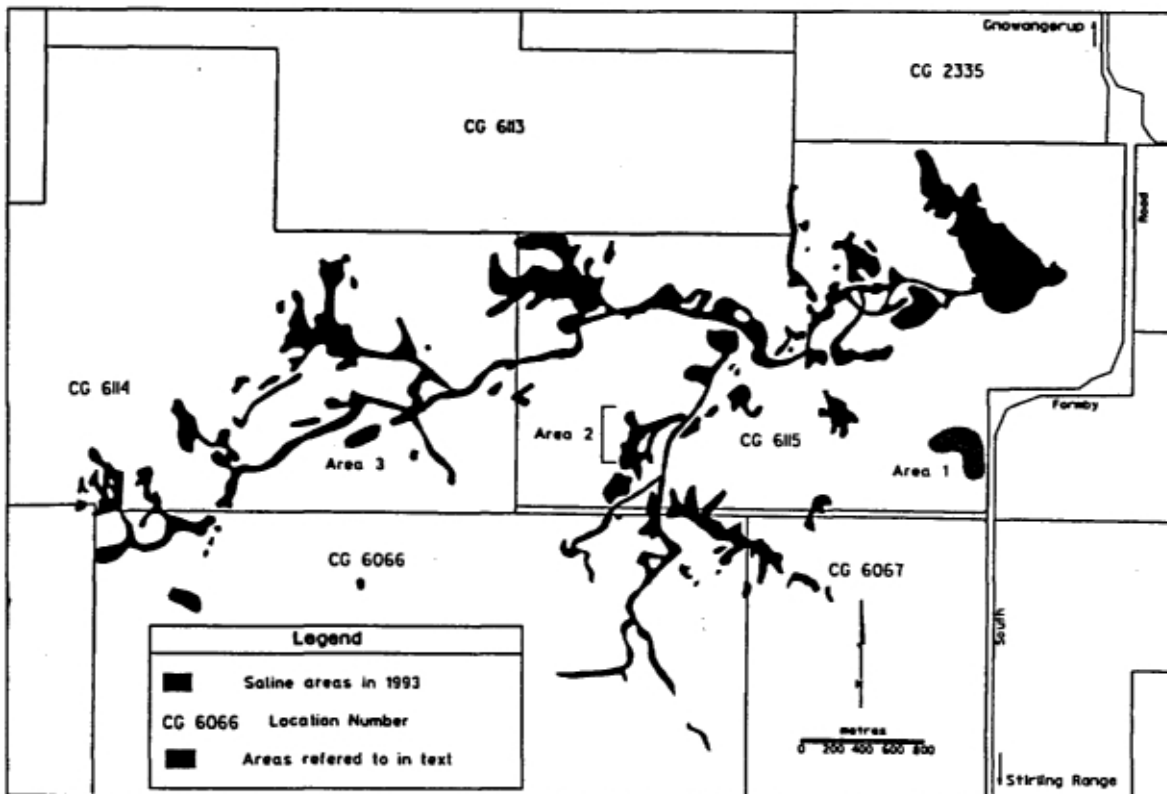
The total salt-affected area based on 1993 aerial photographs was about 224 ha (Figure 3). By comparing the 1985 and 1993 aerial photographs, we could see that:

Figure 3: Extent of strongly salt-affected areas in 1993 (224 ha).

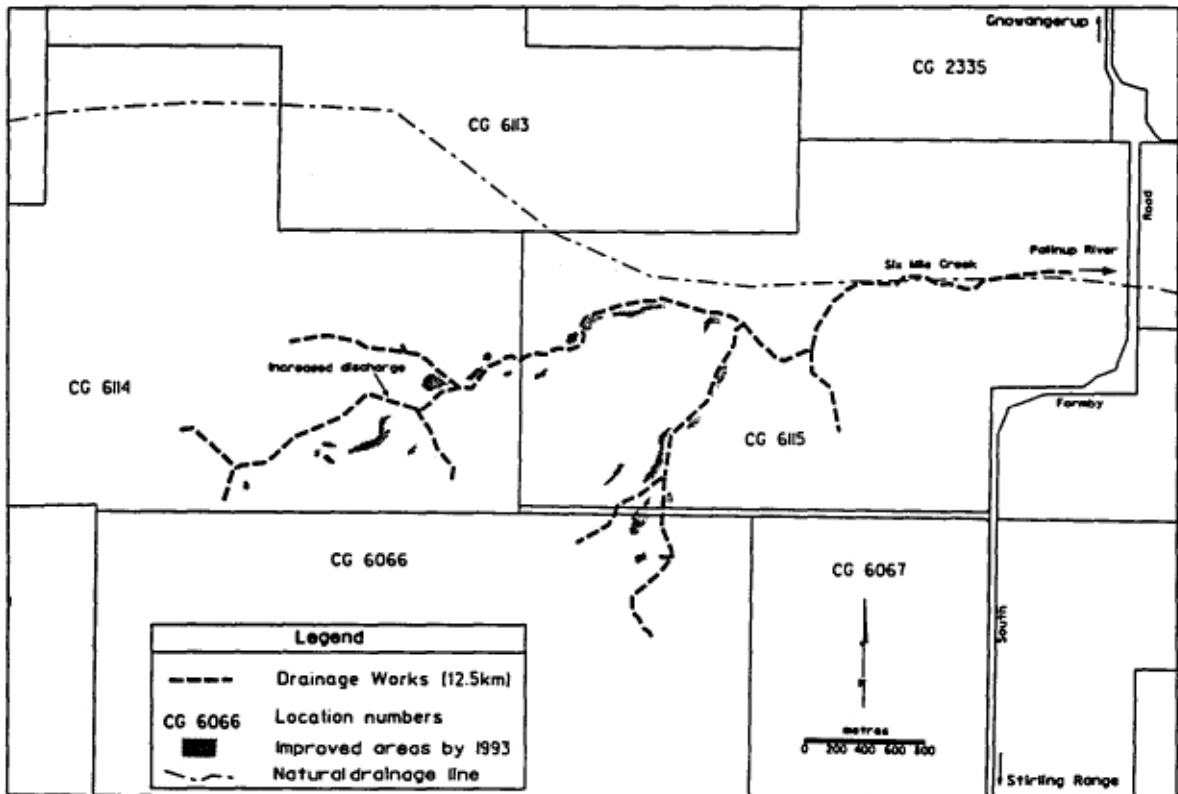
We found that the salt-affected land in the study area had reduced by 27 ha between 1985 and 1993. Out of the 27 ha which showed signs of improvement, about 8 ha was cropped in 1996 and the balance (19 ha) was within the natural creek beds and flood plains.

Figure 4: Areas where salinity improved (27 ha) between 1985 and 1993 and a major discharge site.

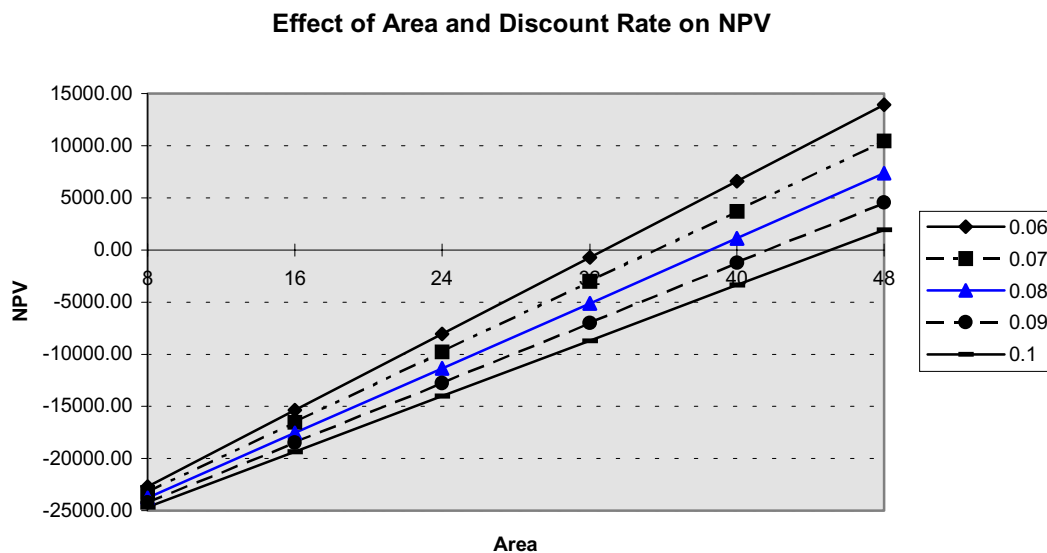
The analysis indicated that at a discount rate of 8% the investment cost would be recovered if 40 ha of land was reclaimed. The actual reclaimed area (8 ha) will not recover costs over the life of the project. The area required to break even varies with the level of discount rate (Figure 5).

Figure 5: Effect of discount rates and reclaimed area (ha) on the Net Present Value (NPV) of Pech's drain.

Note: The area required to break even, with the lowest level of discount rate (6%), is 32 ha (four times the reclaimed land).

The valleys in this area have sandy lenses in their Tertiary sediments. The existence of sand has made this area one of the most suitable areas for constructing deep drains in the district. The drain has therefore reduced the extent of salt-affected land in some nearby areas but it has not been a cost-effective exercise. The area required to break even, with the lowest level of discount rate (6%), is four times the reclaimed land.

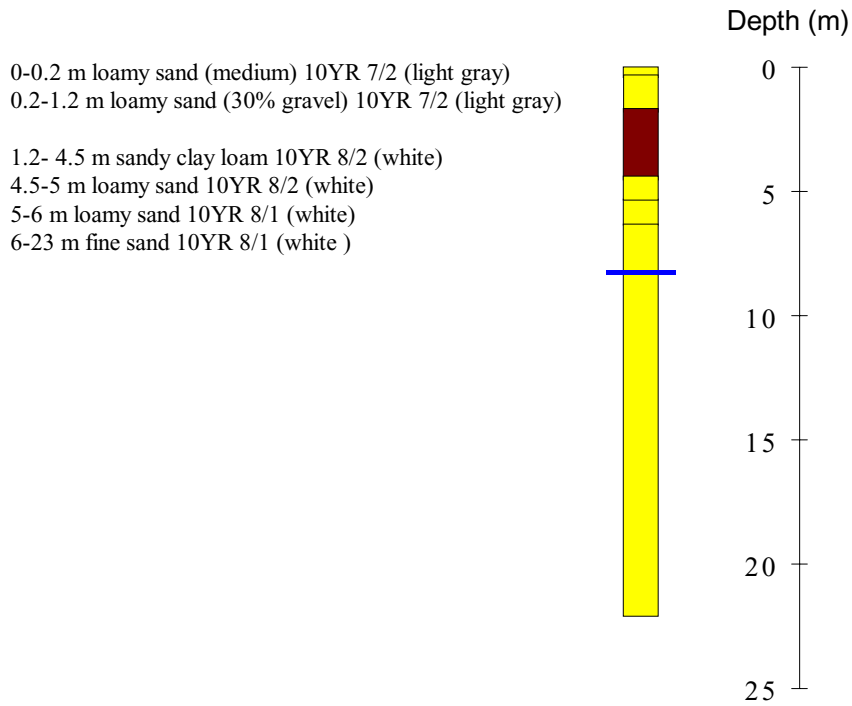
KP1/95

Easting: 592550 **Northing:** 6222928

Groundwater salinity (mS/m): 1075 **Water level below ground (m):** -8.7

Landform Pattern: Lunette Fields

Interpreted Lithology: Tertiary Pallinup Formation

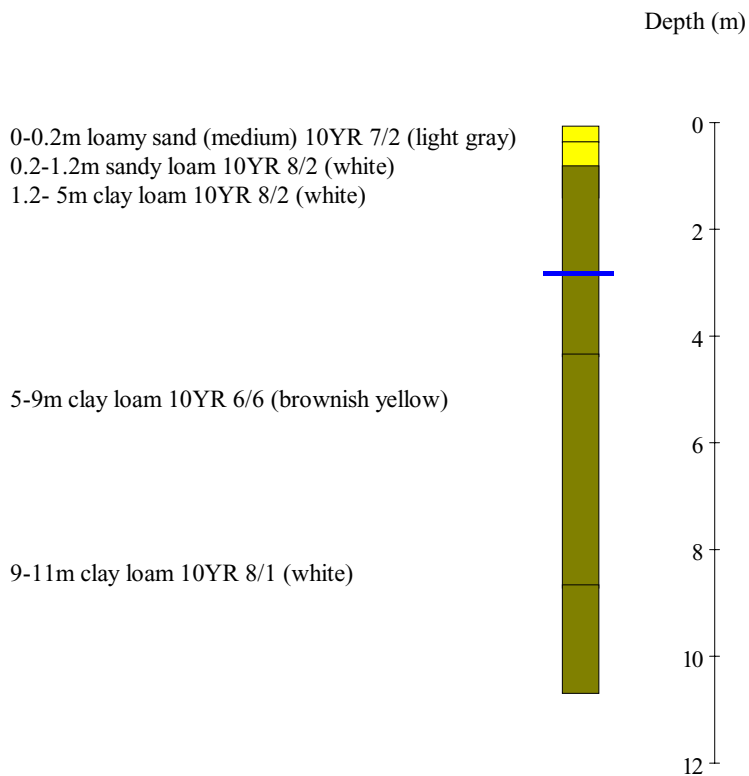
KP4/95

Easting: 589720 **Northing:** 622114

Groundwater salinity (mS/m): 5870 **Water level below ground (m):** -2.8

Landform Pattern: Stagnant Flats

Interpreted Lithology: Tertiary Pallinup Formation
