Groundwater study of the Narrogin townsite

Crossley, E K. (2004), *Groundwater study of the Narrogin townsite*. Department of Primary Industries and Regional Development, Western Australia, Perth. Report 256.

GROUNDWATER STUDY OF THE NARROGIN TOWNSITE

**RESOURCE MANAGEMENT
TECHNICAL REPORT 256**

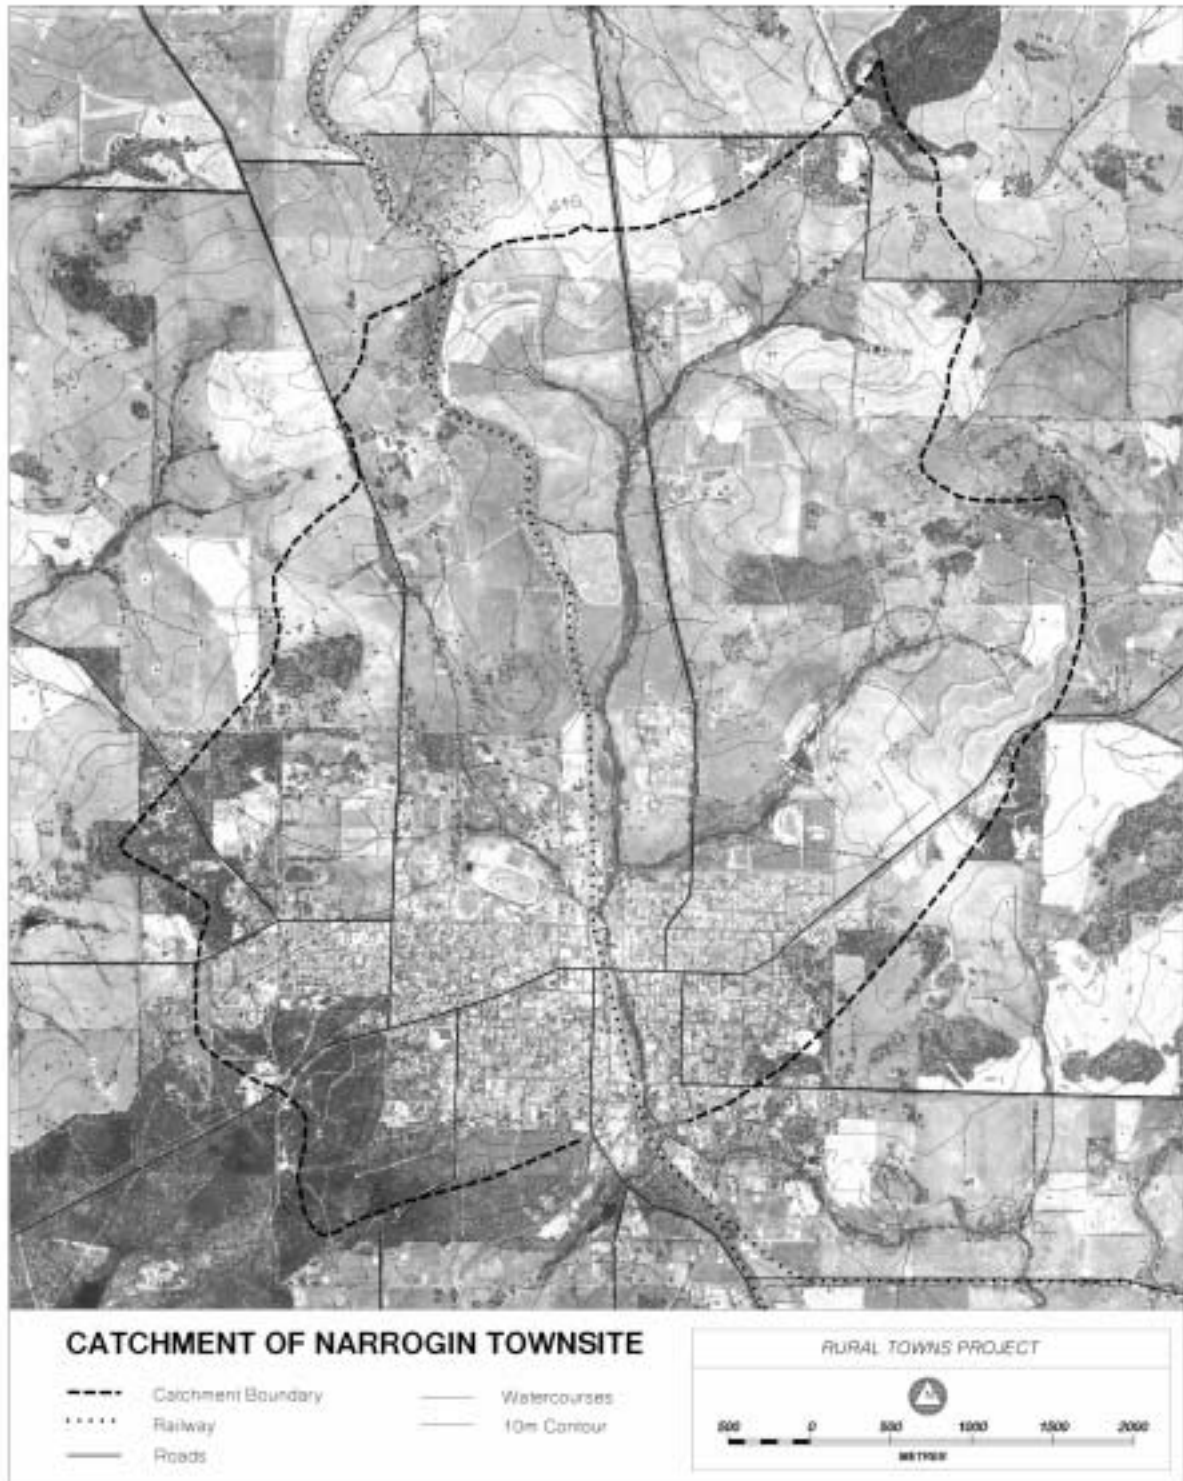
Figure 1-2. Location of Narrogin townsite within its catchment

Narrogin lies in the upper portion of the Narrogin Brook Catchment. The area of catchment upslope is 2430 hectares. The town straddles Narrogin Brook just below the confluence of its three tributaries. The catchment is at its narrowest within the town, with a distinct narrowing of the valley adjacent to Fortune Street and again at the southern edge of town where the brook has cut through a ridge associated with the Binneringie dyke (see Section 1.3). Downstream, the brook is a meandering and often braided stream within the much broader and flatter Narrogin Valley. Figure 1-2 illustrates the catchment area for Narrogin.

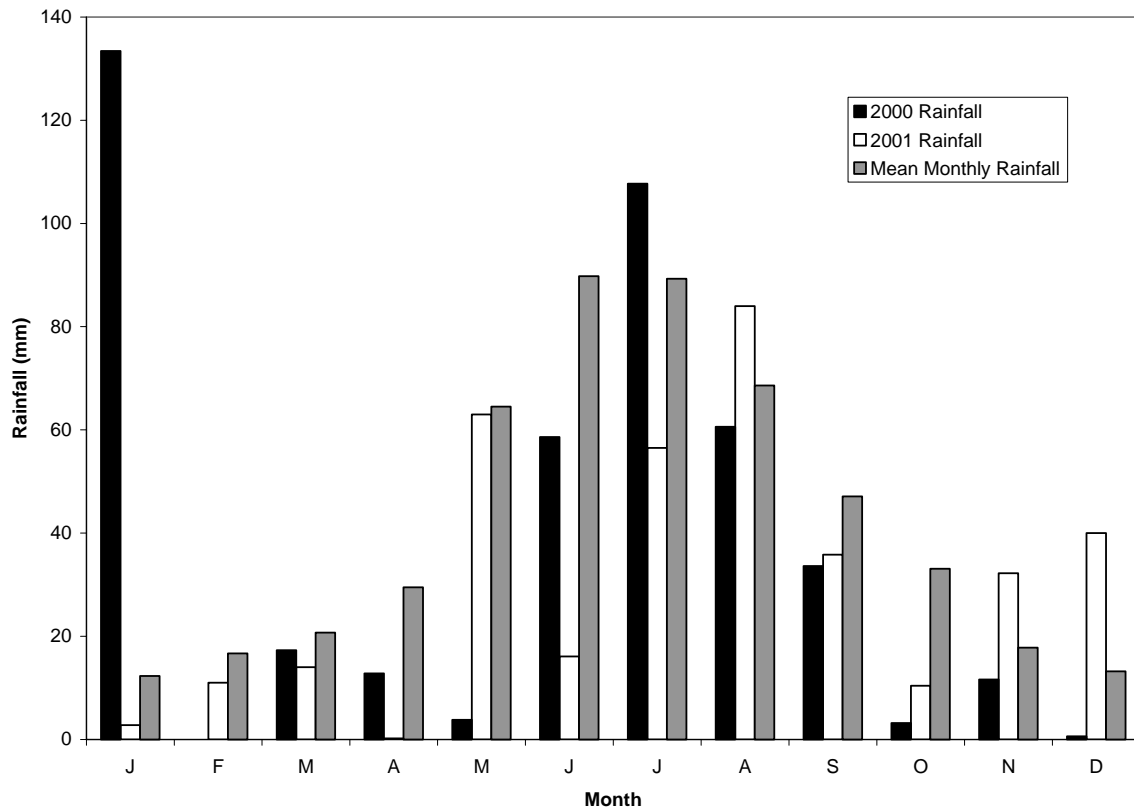
Figure 1-3. Mean monthly rainfall data for Narrogin

Narrogin receives an average of 503 mm of rainfall each year of which 396 mm falls between May and November (Bureau of Meteorology 2001). Rainfall recorded in 2000 was less than could be expected in 50% of years and in 2001 rain received was lower than in 90% of years. June 2001 rainfall was the lowest on record since 1893. Annual evaporation estimates range from 1646 mm to 1896 mm (Luke *et al.* 1988). Mean daily monthly and annual evaporation rates and rainfall statistics are shown in Table 1-1. Figure 1-3 illustrates the differences between 2000, 2001 and average monthly rainfall.

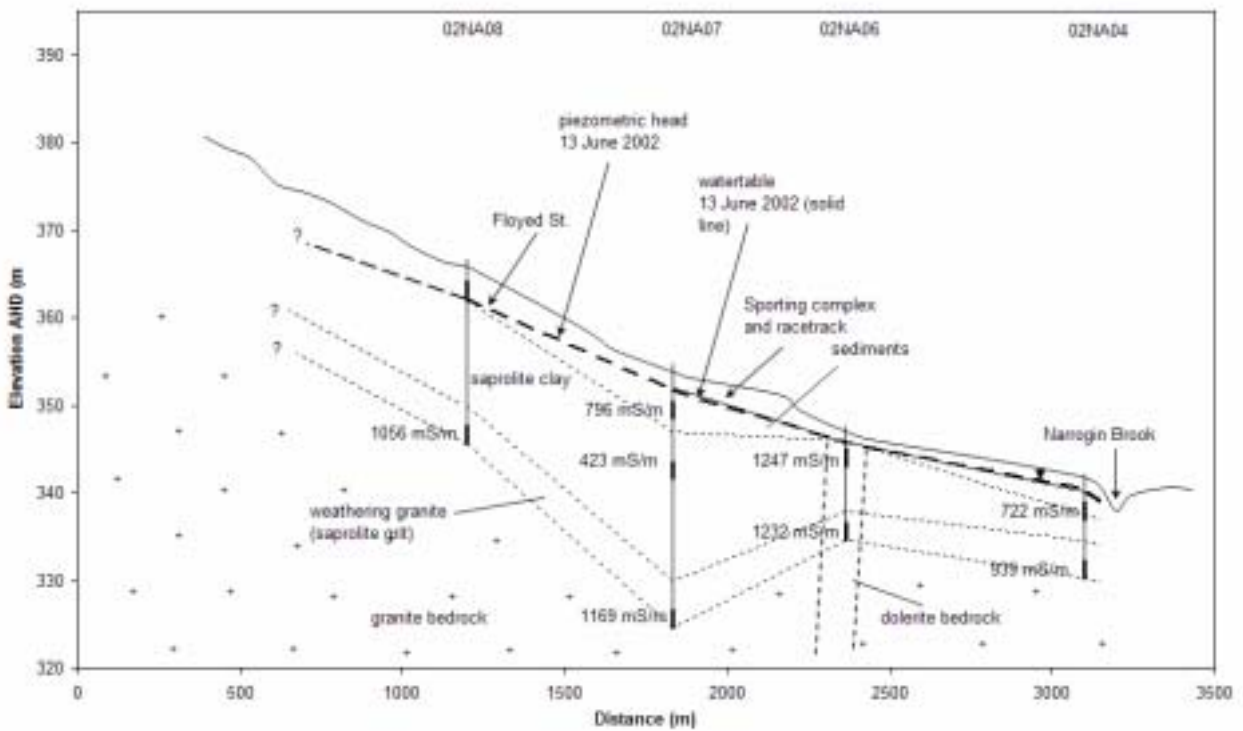
Figure 2-2. Section along Clayton Rd transect to Narrogin Brook

Median thickness of the saprolite aquifer (permeable saprolite clay and saprock) was 5 m and ranged from less than 0.5 to 13 m at St Matthews School, suggesting that this aquifer has a relatively high transmissivity in places. Quartz and feldspar particles formed 40-60 % of this layer and ranged in diameter up to 10 mm, averaging 3-4 mm. At many sites weathering of saprolite overlying bedrock was well advanced and comprised coarse to gritty clays, rich in mica and consequently the saprolite at these sites was assumed to have a lower permeability. The cross-sections shown in Figures 2-3 to 2-6 illustrate the key elements of the drill logs and watertable position along four transects within Narrogin town.

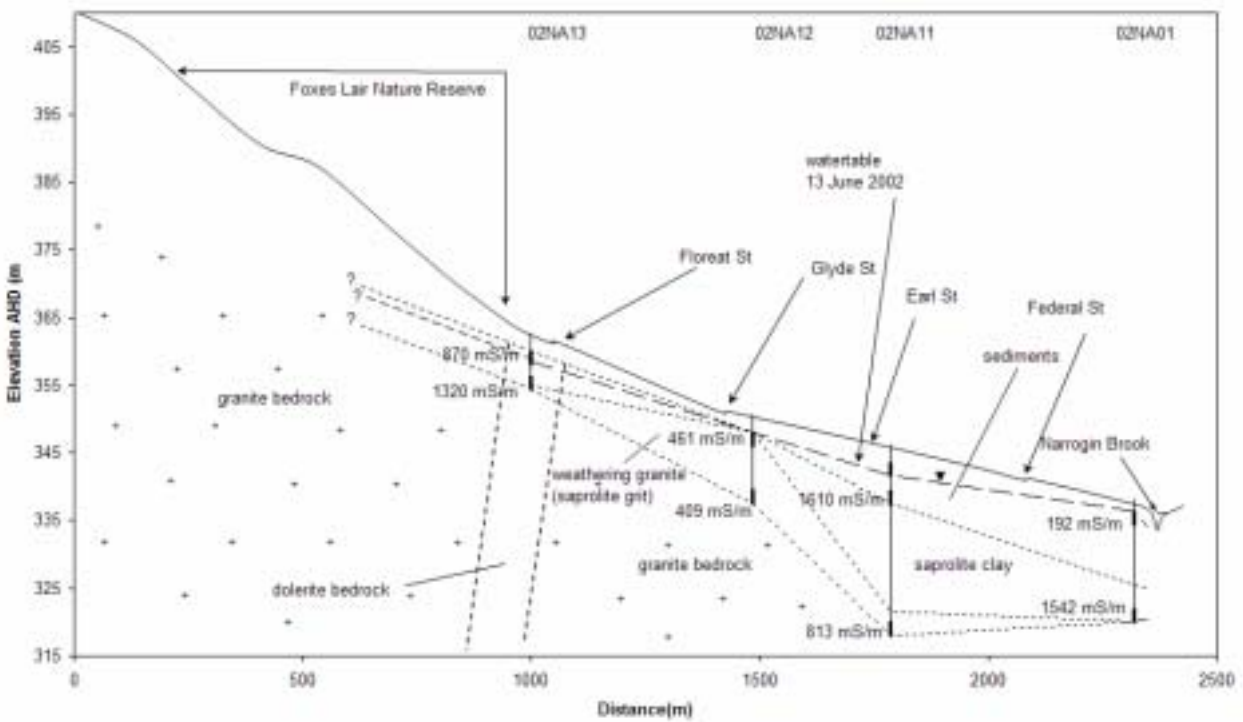
Figure 2-3. Section along Foxes Lair transect to Narrogin Brook

Some of the piezometer and groundwater details are listed in Table 2-1. Figures 2-3 to 2-6 illustrate variations in groundwater levels and EC across the townsite.

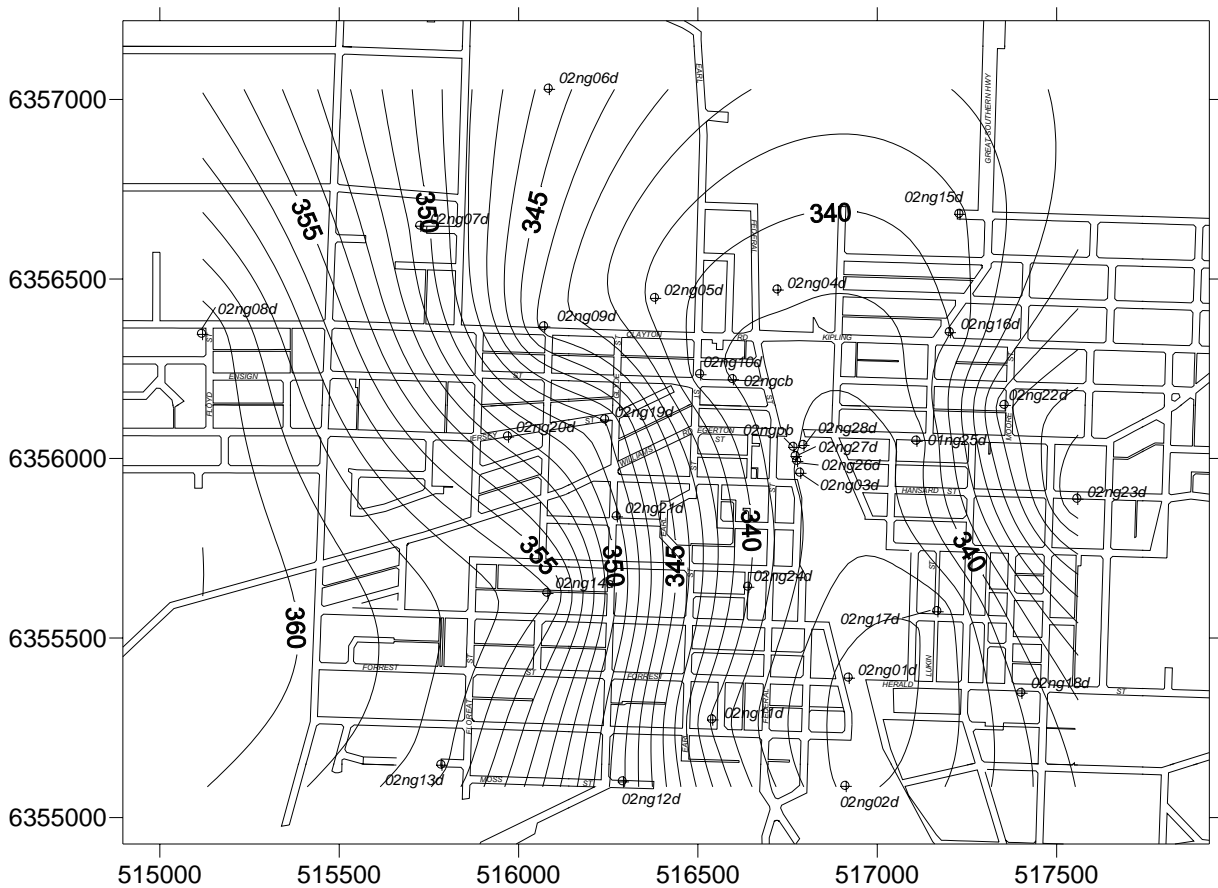
Figure 3-1. Potentiometric surface of deep bores (contours at 1 m intervals; heights in m AHD)

The potentiometric surface, as illustrated in Figure 3-1 is a subdued reflection of the landscape topography and, despite the local influence of lineaments and irregular bedrock topography, general flow direction is orthogonal to the lines of equal pressure shown in the figure. (The lines on the periphery of Figure 3-1 are artefacts associated with the limited number of data sites, edge effects and the contouring package.)
