Managing storm water flow in the Neridup Creek catchment

**RESOURCE MANAGEMENT
TECHNICAL REPORT 365**

Angela Massenbauer and Austin Rogerson

August 2010

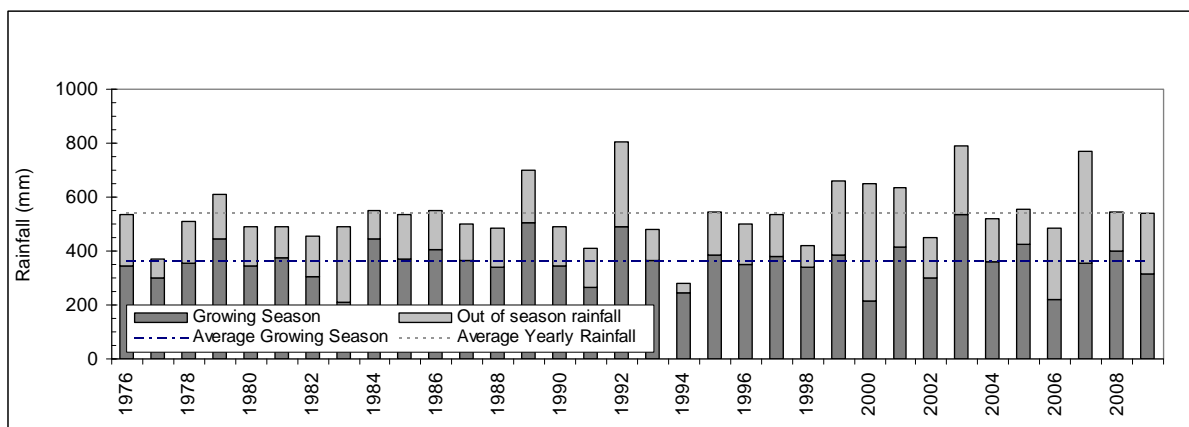
Figure 2 Average yearly rainfall 1976–2009

Annual rainfall averages 540 mm and two-thirds of the rain falls during the May–October growing season (Figures 1 and 2) (Patched Point Dataset 2010).⁴ Figure 2 also shows the frequency and amount of out of season rainfall, which has often caused problems such as erosion and sedimentation. The driest year since 1976 was 1994, when the area received only half of the average annual rainfall. The highest annual rainfall occurred in 1992 with 260 mm more than average (Table 1). There is a 20 per cent chance (one in five years) that the area will receive annual rainfall above 610 mm (wet year) or below 450 mm (dry year). July is the wettest month averaging 76 mm and the driest month, December, averages only about 20 mm (Figure 3).

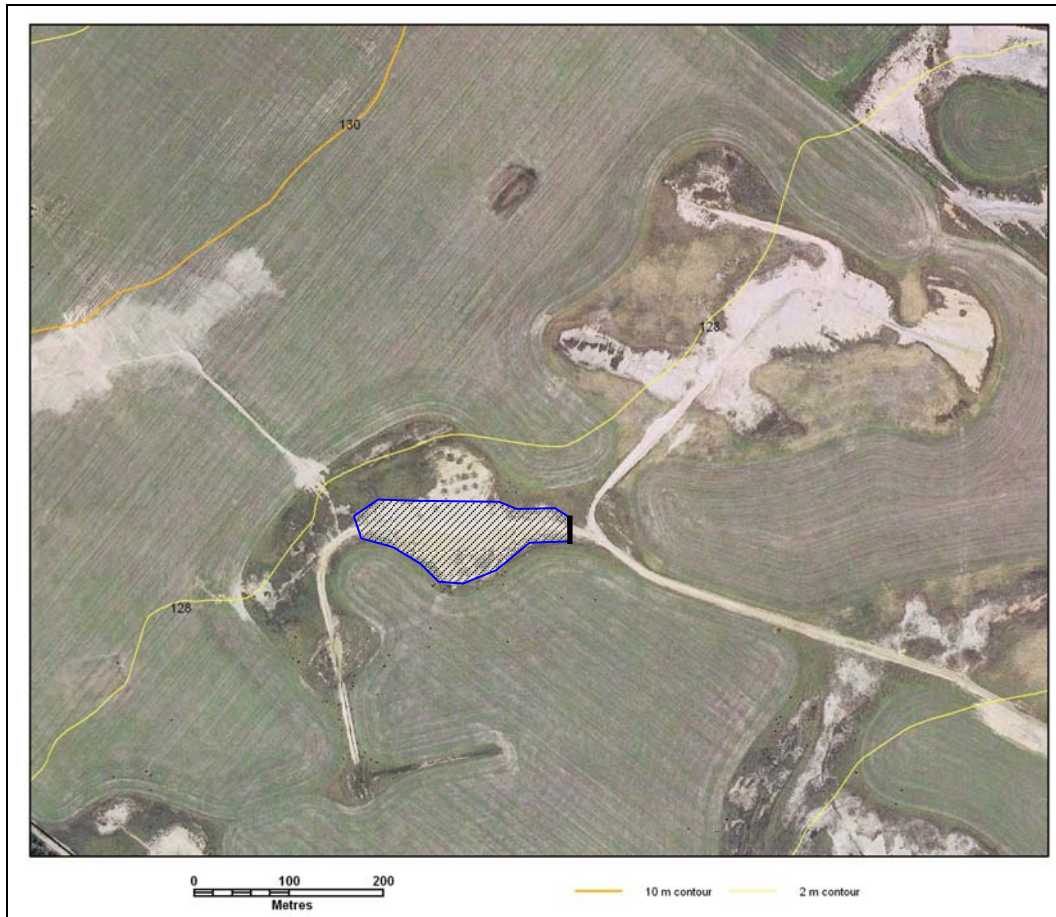
Figure 13 Aerial view of the location of a possible sump detention wall (thick black line) and the extent of water detained behind the wall when full (blue hashed area)

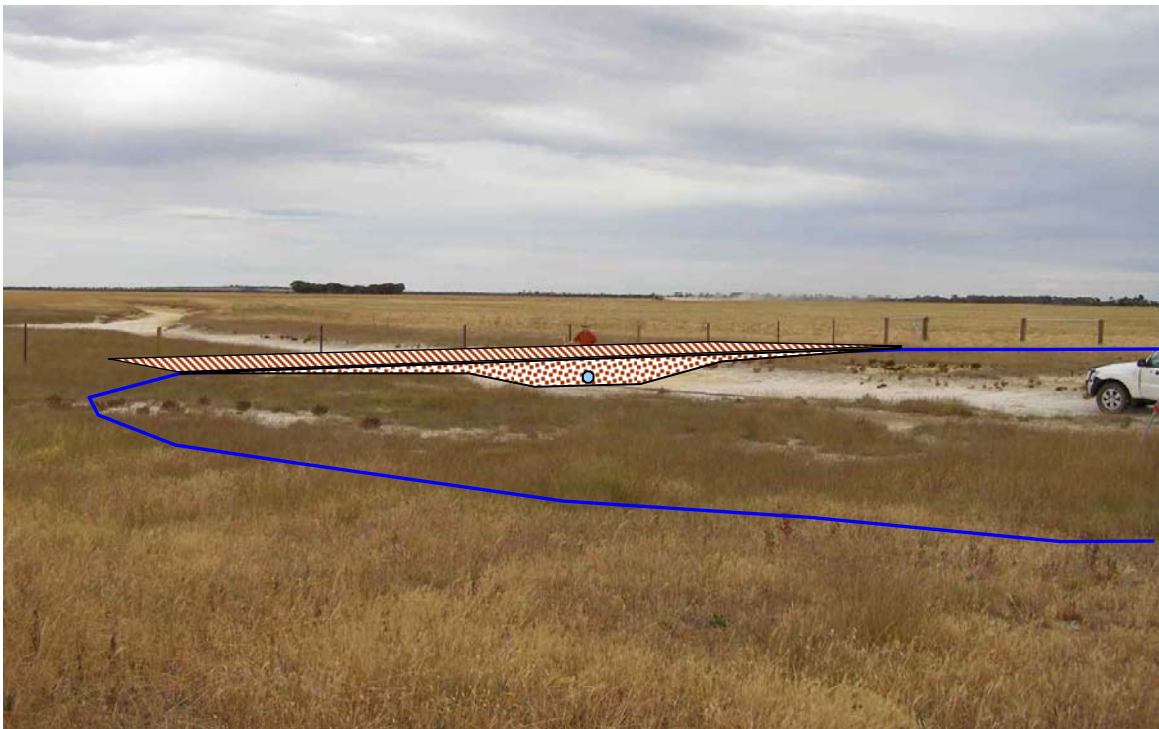
Figure 14 Possible detention area for controlling water flow. The hatched area represents the wall constructed across the drain with a pipe in the base; the blue line represents the extent of water detained behind the wall when full.

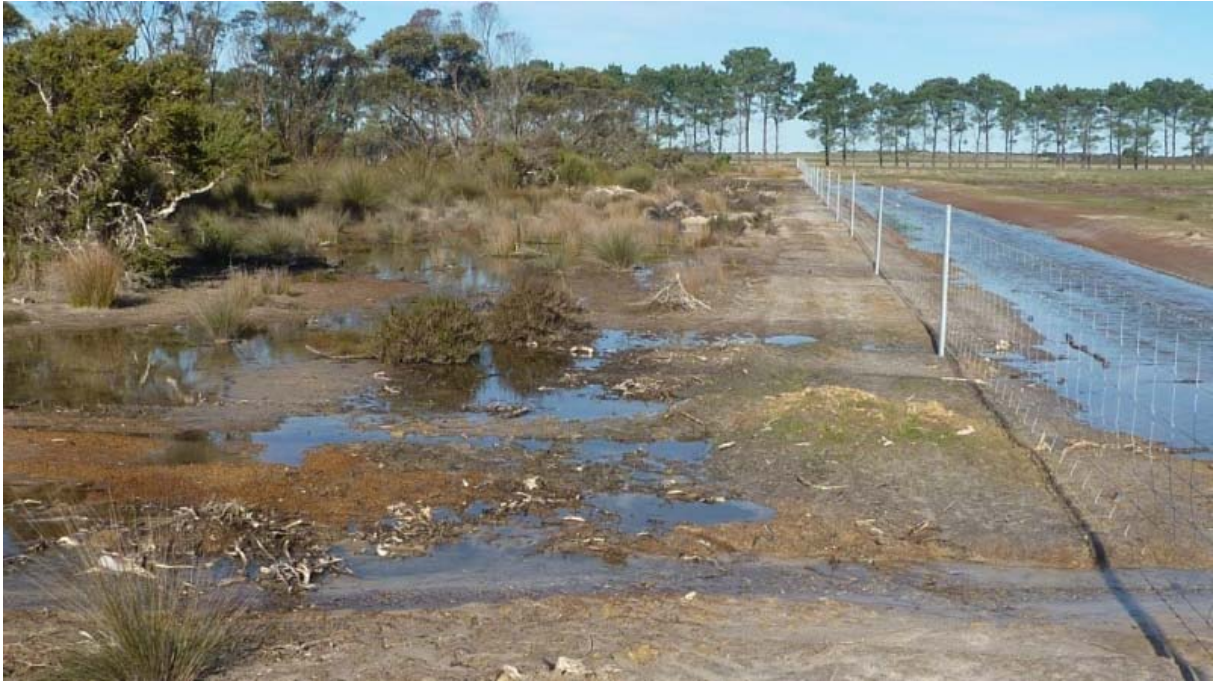
Plate 3 Neridup Creek spreading through remnant vegetation on Property ID 1194330 and entering a relief drain on the adjoining property (ID 1194320) to continue its way south (taken 31/07/2009)

- There is an 80 ha block of remnant vegetation on Property ID 1194330 that provides an important attenuation and slow down point for the Neridup Creek. The creek spreads undefined through the vegetation and from our site visits, it appears to withhold or use water as well.

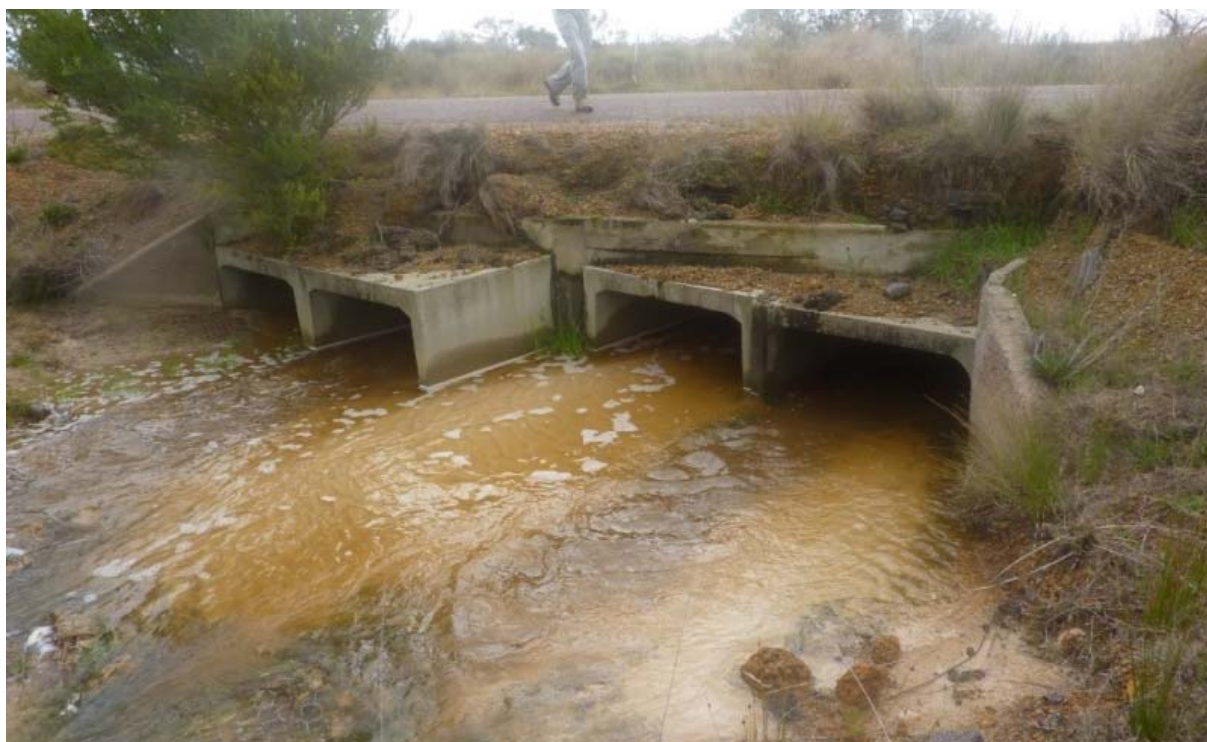
Plate 14 **Neridup Creek flowing through box culverts under Fisheries Road (taken 29/07/2009)**
