Carnarvon Fascine Wall Independent Review

R972 Rev 1

December 2017

**Carnarvon Fascine Wall
Independent Review**

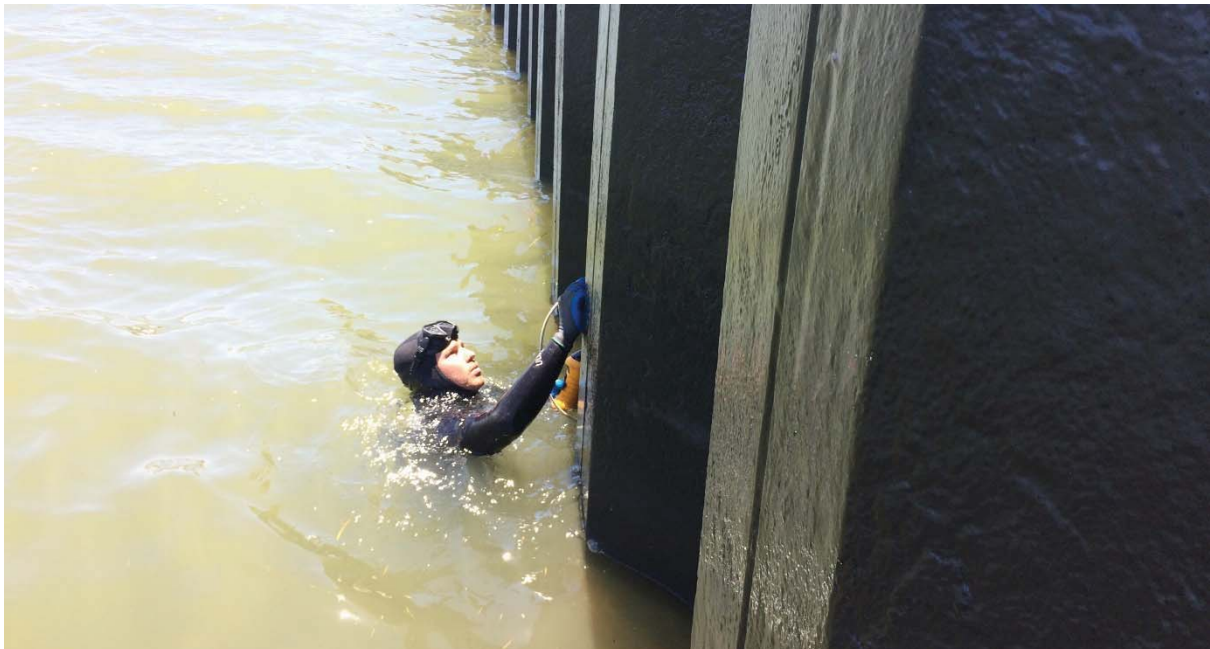
Figure 3.1 Thickness Testing by Shorewater Marine

To assess the current condition of the steel sheet pile system a detailed inspection and testing of the wall was completed. The inspection was undertaken by Senior Coastal Engineer, Peter Doust, together with divers from Shorewater Marine who were engaged as a subcontractor to MRA. The inspection was completed on the 24th and 25th October 2017 during low tides.

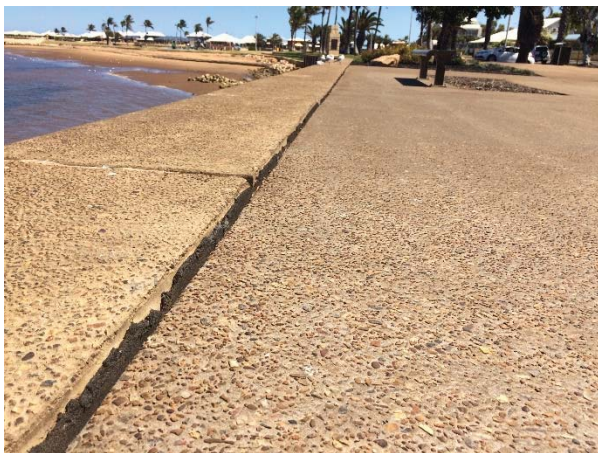
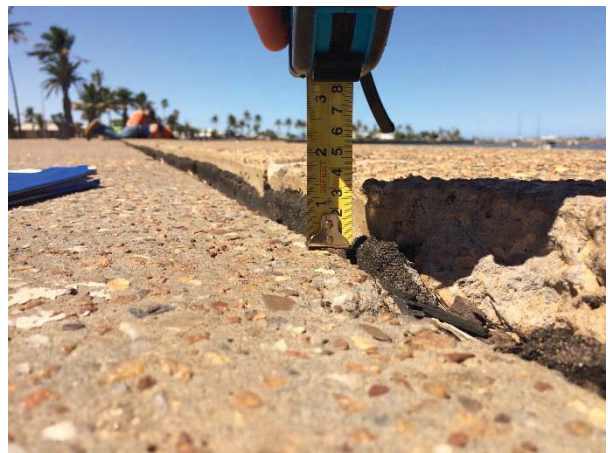
Figure 3.8 Paving Subsidence

- At the northern end of the wall (Stage 1 section) there appeared to be some subsidence of the pavement behind the wall. This may be due to loss of backfill material through the wall. The pavement behind the wall was approximately 30mm lower than the capping beam.

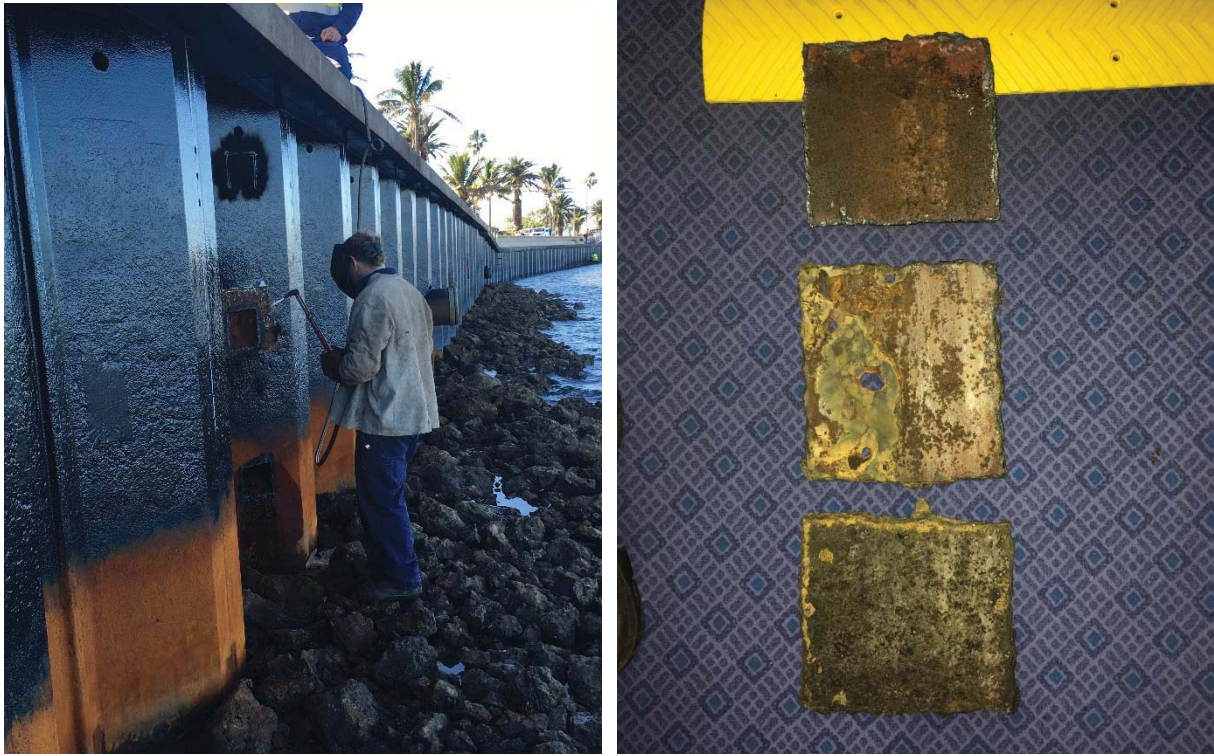
Figure 3.9 Removal of Sections by Shire

In addition to the inspection undertaken by MRA and its subcontractors, the Shire of Carnarvon has also carried out their own investigations on the wall including extracting sections of the wall for more detailed assessment. This is shown in the following photographs provided by the Shire.

The following points summarise the findings from the sections removed from the wall:

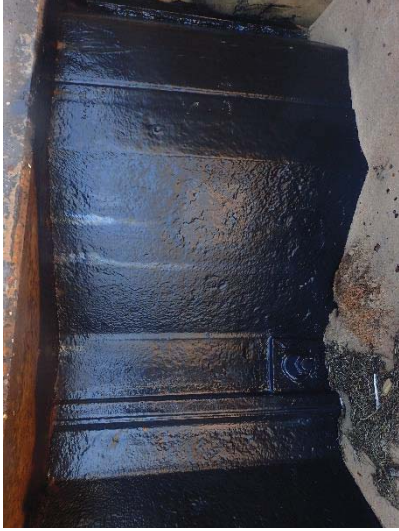
LOCATION 1:

LOCATION #	CONVEX/ CONCAVE/SIDEWALL	CAP LEVEL	HAT	MSL/ INTERTIDAL	LAT OR SEABED	ANODE % WORN	DIVER COMMENTS
1	Convex	8.2	N/A	8.2	8.4	N/A	Recently heavy protective paint coating applied, Pitting observed under paint coating, No exposed unprotected steel.
1	Concave	8.5	N/A	8.2	8.0	N/A	
1	East Sidewall	8.4	N/A	8.2	8.2	N/A

CP Meter	N/A	Depth of paint – CC to DP	800mm	Depth of Unprotected steel – PC to SB	N/A
----------	-----	---------------------------	-------	---------------------------------------	-----

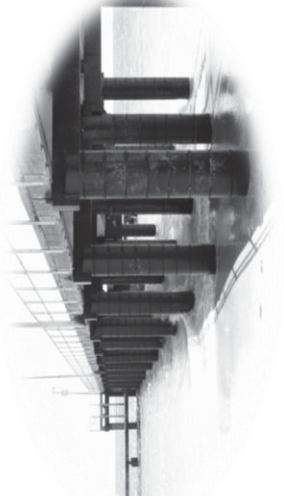
LOCATION #	CONVEX/ CONCAVE/SIDEWALL	CAP LEVEL	HAT	MSL/ INTERTIDAL	LAT OR SEABED	ANODE % WORN	DIVER COMMENTS
8	Convex	8.8	7.9	7.9	8.1	N/A	Recently heavy protective paint coating applied, Pitting observed under paint coating, Paint loss in intertidal area, Surface corrosion on unprotected steel. (Paint may have been affected by incoming tide at time of application)
8	Concave	8.1	8.0	8.2	8.3	N/A	
8	East Sidewall	8.7	6.9	8.3	8.1	N/A	
8	West Sidewall	8.4	5.6	8.4	8.2	N/A

CP Meter	-678mV	Depth of paint – CC to DP	1810mm	Depth of Unprotected steel – PC to SB	1140mm
----------	--------	---------------------------	--------	---------------------------------------	--------

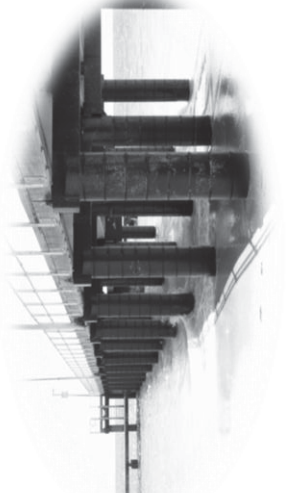
LOCATION #	CONVEX/ CONCAVE/SIDEWALL	CAP LEVEL	HAT	MSL/ INTERTIDAL	LATOR SEABED	ANODE % WORN	DIVER COMMENTS
10	Convex	9.4	6.3	8.2	8.9	N/A	Recently heavy protective paint coating applied, Pitting observed under paint coating, Paint loss in intertidal area, Surface corrosion on unprotected steel. (Paint may have been affected by incoming tide at time of application)
10	Concave	9.1	7.6	8.7	8.2	N/A	
10	East Sidewall	9.4	6.5	8.3	8.5	N/A	
10	West Sidewall	9.0	7.0	8.6	7.8	N/A

CP Meter	-678mV	Depth of paint – CC to DP	1810mm	Depth of Unprotected steel - PC to SB	1590mm
----------	--------	---------------------------	--------	---------------------------------------	--------

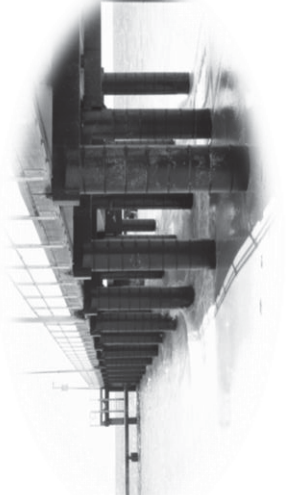
LOCATION 13:

LOCATION #	CONVEX/ CONCAVE/SIDEWALL	CAP LEVEL	HAT	MSL/ INTERTIDAL	LATOR SEABED	ANODE % WORN	DIVER COMMENTS	
13	Convex	7.9	6.4	9.4	8.6	N/A	Recently heavy protective paint coating applied, Pitting observed under paint coating, Paint loss in intertidal area, Surface corrosion on unprotected steel. (Paint may have been affected by incoming tide at time of application)	
13	Concave	8.3	6.5	8.8	8.7	N/A		
13	East Sidewall	7.1	7.8	9.0	8.6	N/A		
13	West Sidewall	8.5	7.2	8.5	6.8	N/A		
CP Meter		-680mV	Depth of paint – CC to DP		1800mm	Depth of Unprotected steel - PC to SB		1850mm

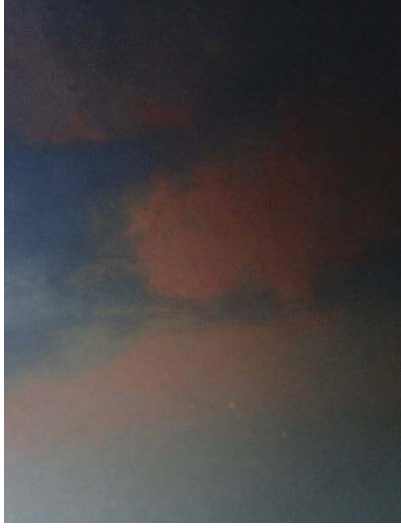
LOCATION 16:

LOCATION #	CONVEX/CONCAVE/SIDEWALL	CAP LEVEL	HAT	MSL/INTERTIDAL	LAT OR SEABED	ANODE % WORN	DIVER COMMENTS
16	Convex	7.9	6.6	8.3	9.0	N/A	Recently heavy protective paint coating applied, Pitting observed under paint coating, Paint loss in intertidal area. (Paint may have been affected by incoming tide at time of application). Surface corrosion on unprotected steel below and above water line was more evident within this Location
16	Concave	7.6	6.2	8.2	9.2	N/A	
16	East Sidewall	7.5	6.0	8.4	9.0	N/A	
16	West Sidewall	7.7	6.3	8.2	8.9	N/A

CP Meter	-687mV	Depth of paint – CC to DP	1910mm	Depth of Unprotected steel – PC to SB	930mm
----------	--------	---------------------------	--------	---------------------------------------	-------

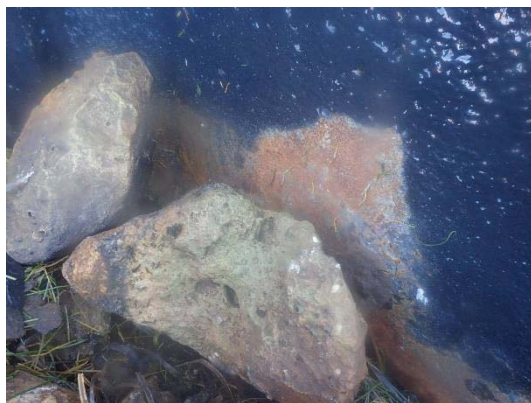
- 1.1 – Example of paint coating not applied due to the presence of rocks on the seabed.
- 1.2 – Example of corrosion holes observed that had not been painted or prepared for repair.
- 1.3 – Example of corrosion holes observed that had been patched, presumably in preparation for repair.
- 1.4 – Example of corrosion holes observed that had been painted over.
- 1.5 – Example of corrosion holes observed that had been painted over.
- 1.6 – Typical corrosion observed on the bare steel in subsea areas.

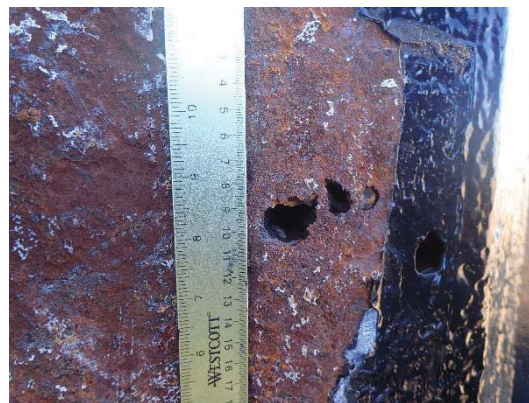
1.2

- Chainage - 710 to 800 number of corrosion holes ranging from 5 - 30mm in dia. In addition to those noted above that had been covered for later repair.
- Chainage - 590 at 450mm below capping level 15mm in dia.
- Chainage - 590 at 200mm below capping level 10mm in dia.
- Chainage - 160 at 420mm below capping level 20mm in dia.
- Chainage - 161 at 410mm below capping level 25mm in dia.

Patch welding of corrosion holes, lifting points and retainment rod holes is recommended to prevent possible subsidence of back fill materials, and assist with the longevity of the structure.

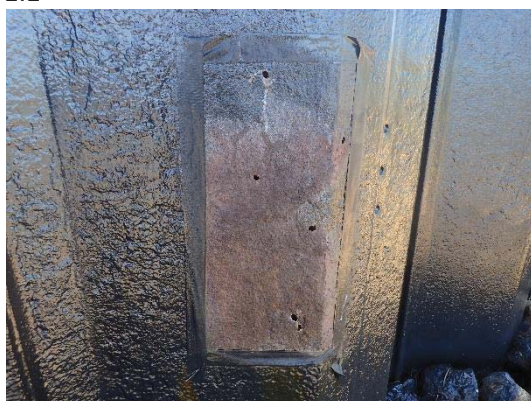
1.3

During the painting process localised corrosion holes had been identified by the painting contractor and covered over with duct tape, presumably for future patch welding repairs, these patches were most prominent between chainage areas 710 - 800.

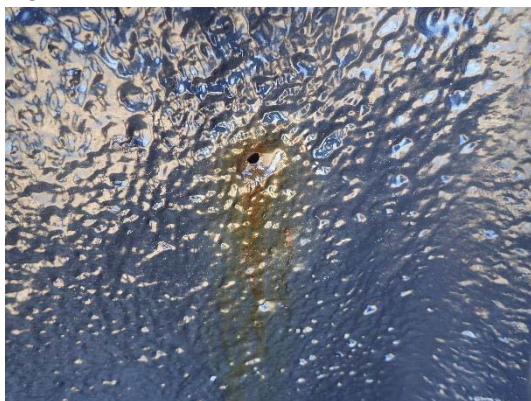
1.5

SWM divers also noted additional corrosion holes that were not patched over, but had received application of a new paint coating in the following chainage areas:

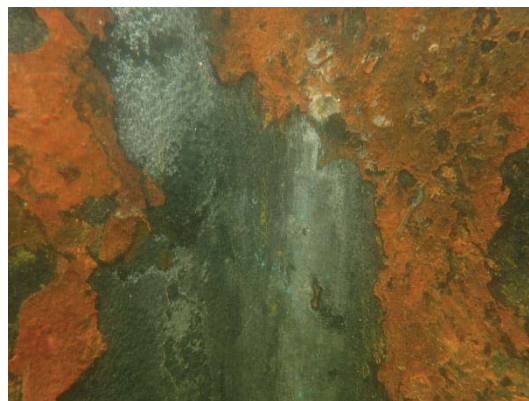
1.6

Sheet wall piling below LAT, in subsea areas had a consistent layer of surface corrosion with no localised scalloping or corrosion holes observed. All sheet wall piles below LAT are bare steel and are freely corroding. Calculated on the average uncoated depth of 0.738m multiplied by the 800 lineal meters of sheet wall piling, 590.4m² would require cathodic protection.

Designing a sacrificial anode Cathodic Protection system to sufficiently protect the submerged steel structure, within the recommended range of protection, for fixed immersed structures. Continuity welding of the Sheet Wall Pile clutches is recommended, for optimum performance of the sacrificial anode system.

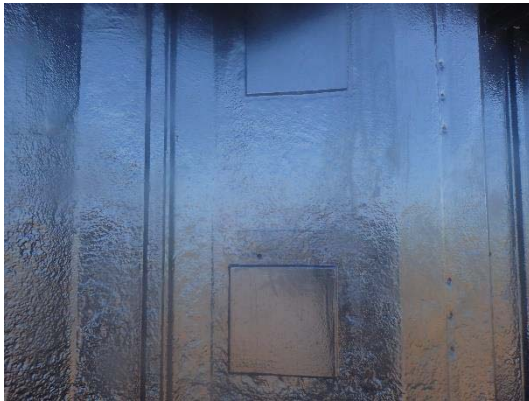
Within chainage areas 725 to 800 a number of patch welded plates covering corrosion holes have been installed. All patches are in good condition, however some do not cover all of the corrosion holes in that area, as seen in the below photos.

2.1 – Example of completed patch welding repairs.

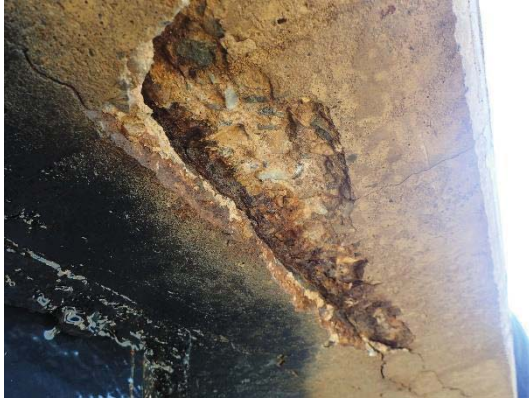
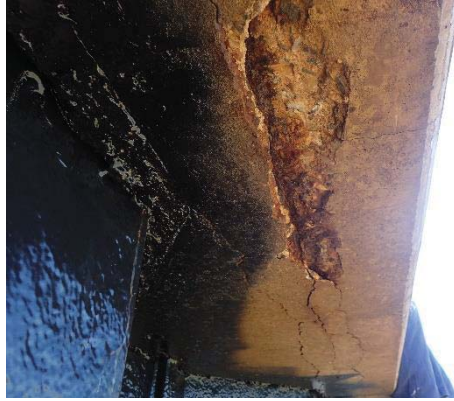
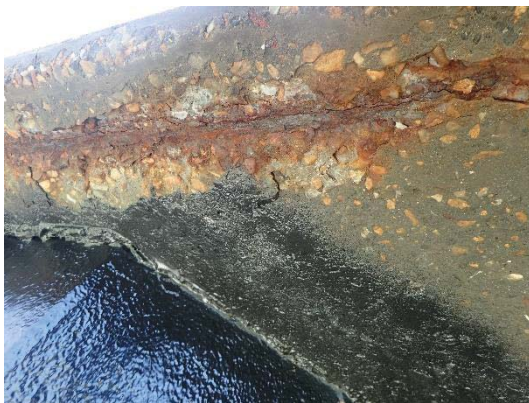
The concrete capping within chainage areas 0-709 has cracking forming in approximately 80% of the length of the concrete with a number of areas suffering concrete spalling and exposure of reinforcement, divers observed that there was very minimal coverage of concrete between the rebar and the outside edge of the concrete, resulting in spalling corrosion, exposure of the reinforcement and cracking.

3.1, 3.2 & 3.3 – Typical concrete spalling, leading to exposure of the rebar observed on the underside of the concrete capping. Photos also identify the minimal thickness of concrete between the rebar and bottom face

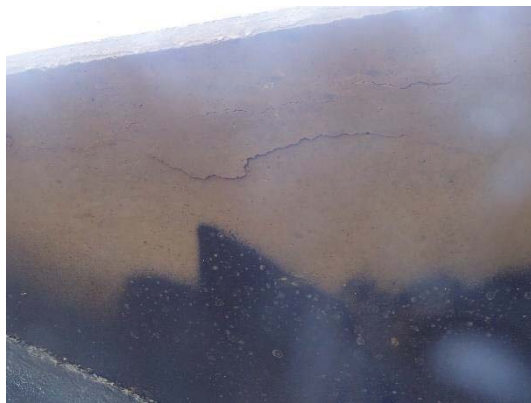
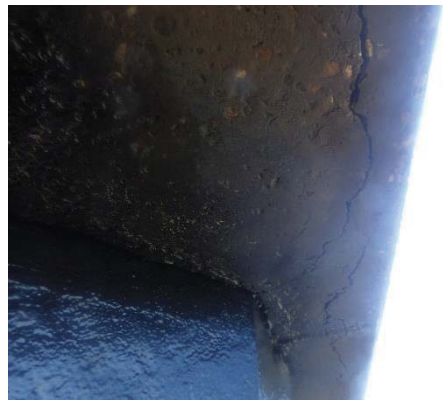
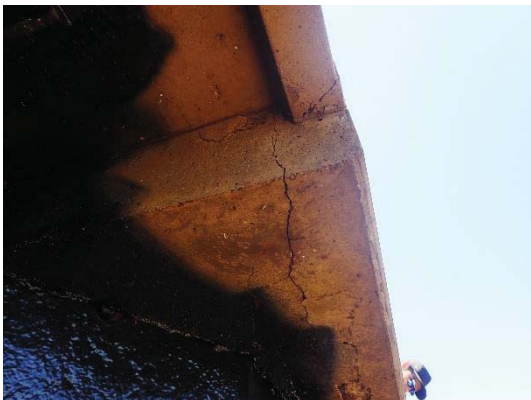
3.4, 3.5 & 3.6 – Typical concrete cracking observed on the underside of the concrete capping beam.

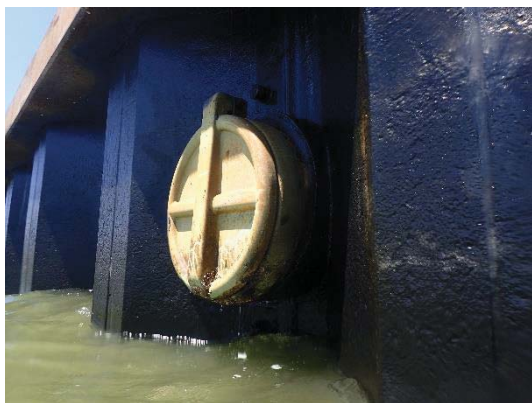
4.1 – Overview drainage outflow pipe and tide flap configuration. Seal between the sheet wall piling and outflow pipe is in a good condition.

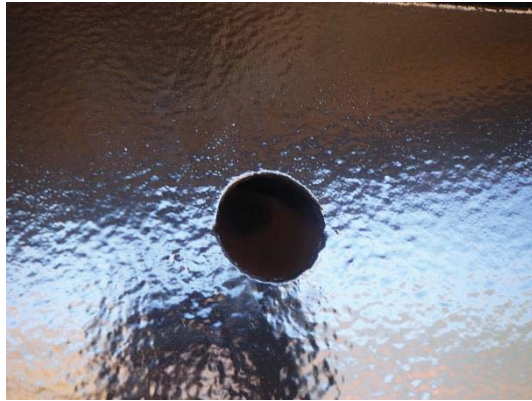
Within chainage areas 710 to 800 sheet wall piles have open holes, presumed lifting points during fabrication, that may lead to corrosion or back full material subsidence. As seen in the below photos.

5.1 & 5.2 – Example presumed lifting points.

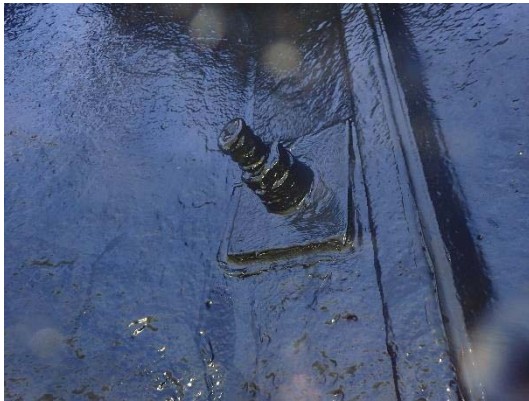
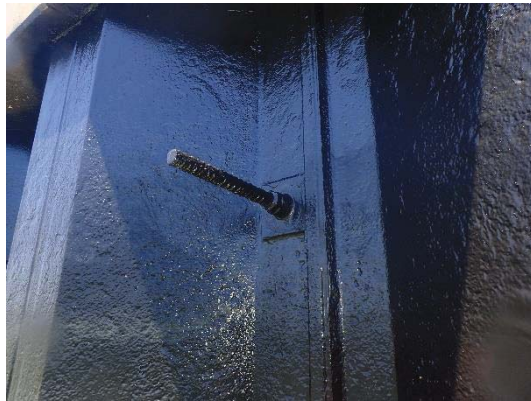
6.1 & 6.2 – Examples of retainment rod system in good condition, with no observed defects.

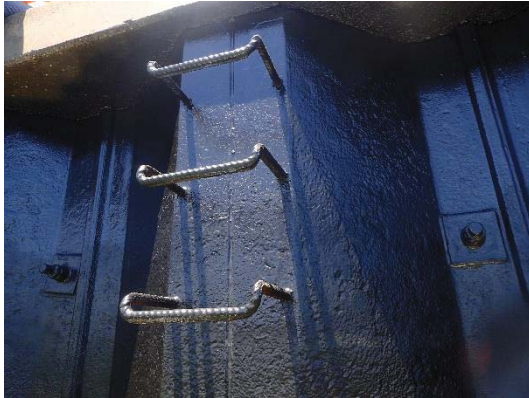
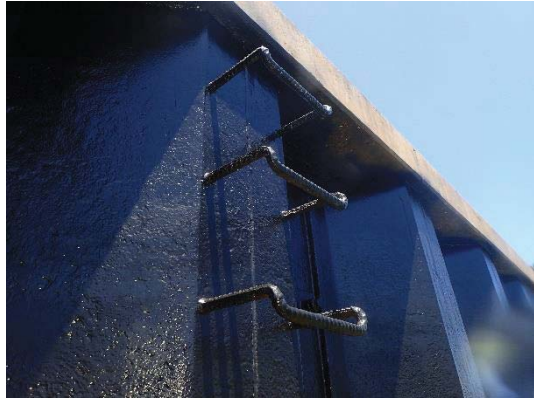
7.1 & 7.2 – Examples of entry/exit ladders with no observed defects.

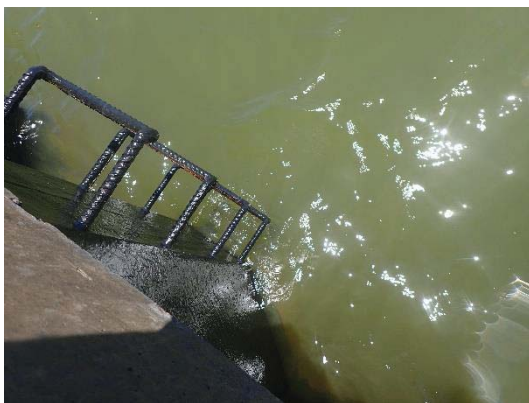
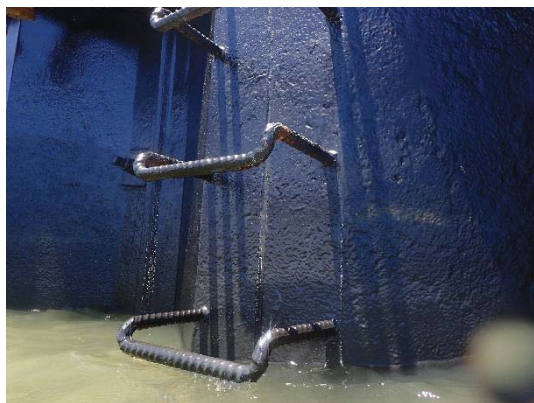
7.3 & 7.4 – Examples of entry/exit ladders with minor paint coating defects on rebar edges.
